ANDRZEJ KULICZKOWSKI¹
KAMIL MOGIELSKI²

Kielce University of Technology

RESULTS OF LABORATORY TESTS OF CONCRETE, VITRIFIED CLAY AND PVC SEWER PIPES WITH CIPP LINERS

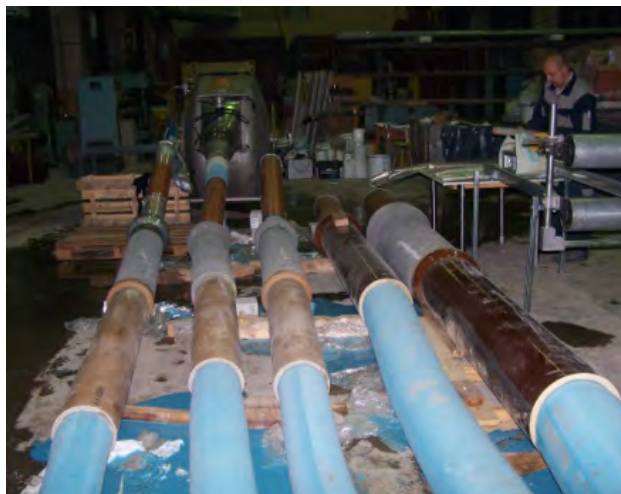
Fig. 1. Preparation of the test samples [2]

were removed, pipes cooled and cut into 30 cm long samples. Excessive amount of the cured liner has been removed. Figure 1 shows the samples preparation site.

kamionkowych i z PVC za pomocą bębna inwersyjnego, przy użyciu sprężonego powietrza. W następnej kolejności powłoki żywiczne zostały utwardzone za pomocą gorącej wody. Po odłączeniu urządzeń i ostudzeniu rur, zostały one pocięte na próbki o długości około 30 cm a nadmierna ilość utwardzonej powłoki żywicznej została usunięta. Na rysunku 1 pokazano stanowisko do przygotowania próbek badawczych.

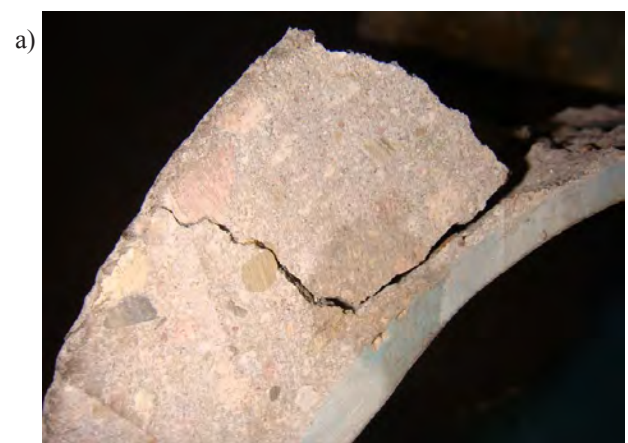
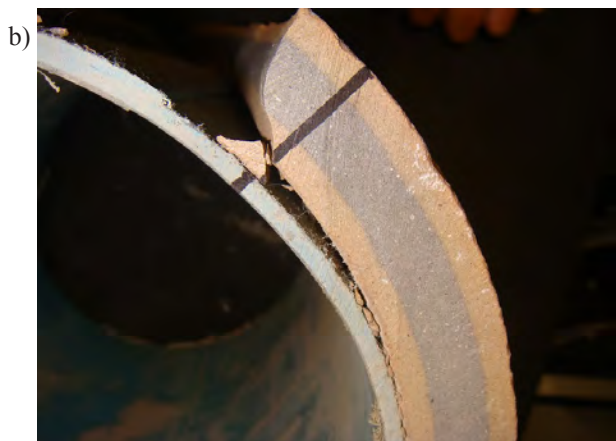
Figure 10a shows concrete sample after the test. Epoxy resin is well joined with the concrete pipe at the boundary line. There is also a crack along the inner pipe wall – concrete pipe was burst but the liner did not separate from it. Figure 10b shows the gap between epoxy liner and vitrified clay pipe – it proves the weak bonding degree of these two elements.

Fig. 10. Samples after the test: a) concrete pipe with liner and b) vitrified clay pipe with liner

Na rysunku 10a pokazano próbkę betonową po zniszczeniu. Na styku rury z powłoką epoksydową widoczny jest dobrze przylegający do żywicy beton. Zauważalne jest również pęknięcie wzdłuż

powierzchni stycznej do ścianki rury – rura betonowa pękła, ale powłoka nie oderwała się od niej. Na rysunku 10b dostrzec można szczelinę między rurą kamionkową a powłoką żywiczną – świadczy ona o słabym sklejeniu się tych dwóch elementów.

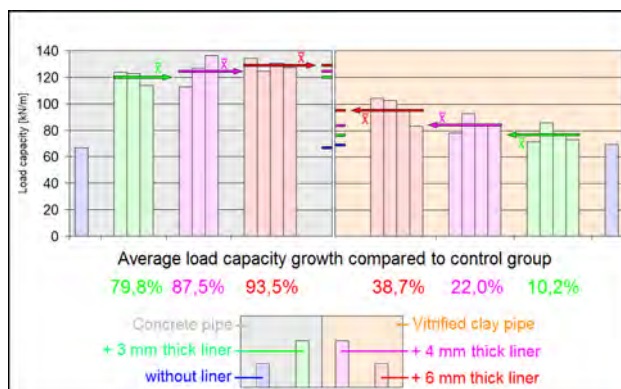
All data collected during the tests were used to make diagrams and tables showing the different load capacity growth level of concrete and vitrified clay pipes with liners compared to the pipes without liners. Table 3 and the left side of Figure 11 show data collected during the tests of eleven samples made of concrete DN 200 pipes. Data collected during the tests of thirteen samples made of vitrified clay DN 200 pipes is shown in Table 4 and on the right side of Figure 11. Summary of data collected during the tests of concrete pipes DN 300 and vitrified clay pipes DN 250 and DN 300 is presented in Table 5.

Fig. 11. Load capacities of concrete and vitrified clay DN 200 pipes with and without liners

Na podstawie danych zebranych podczas badań opracowano tabelaryczne zestawienia i wykresy obrazujące w jak różnym stopniu wzrasta nośność próbek betonowych i kamionkowych po montażu w nich powłok epoksydowych. Tabela 3 i lewa strona rysunku 11 zawierają dane dotyczące jedenastu próbek betonowych o średnicy nominalnej 200 mm, natomiast tabela 4 i prawa strona rysunku 11 dotyczą trzynastu próbek rur kamionkowych o tej samej średnicy. Zestawienie danych uzyskanych podczas badania rur betonowych DN 300 i kamionkowych DN 250 i DN 300 zostały zaprezentowane w tabeli 5.

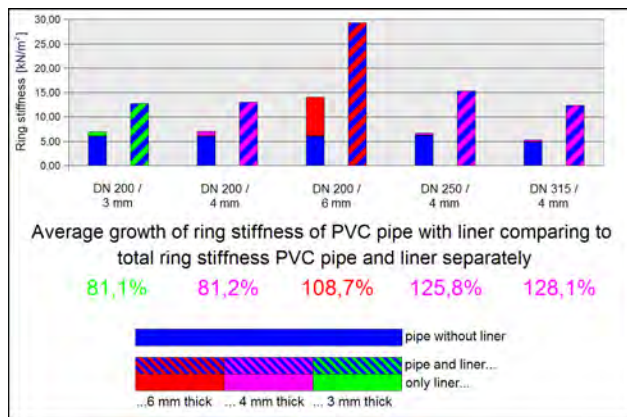
Figure 12 shows the ring stiffness tests results of liners, PVC pipes and PVC pipes with liners. PVC pipes are marked in blue color and other colors represent different thicknesses of epoxy liners. Hatched bars show ring stiffness of PVC pipes with liners. It is clear that the ring stiffness of PVC pipes with liners is greater than total ring stiffness of PVC pipes and liners separately. The increased stiffness is from about 81% to over 128%.

Fig. 12. Ring stiffness of liners, PVC pipes and PVC pipes with liners

Na rysunku 12 podano wyniki badań sztywności obwodowej rur z PVC. Kolorem niebieskim oznaczono rury z PVC, inne kolory reprezentują powłoki żywiczne o różnych grubościach. Słupki kreskowane pokazują wartości sztywności obwodowych rur z powłokami żywicznymi. Widoczne jest, że nośność rury PVC z zainstalowaną powłoką przewyższa nośność rury PVC i powłoki oddzielnie. Wzrost ten wynosi w przypadku badanych próbek od około 81% do ponad 128%.
