The Metallographic Characterization of Metal Artifacts Based on Late Medieval Examples

Abstract

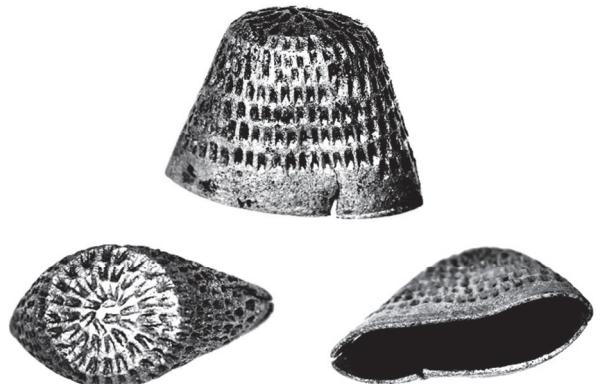
Fig. 1. Macrostructure of the thimble,
No. Pk.M.122.01E.46

For the detailed characteristics, three relics were selected from the extensive set of metal objects of different composition: a thimble (No. Pk.M.122.01E.46), fragment of ferrule (No. Pk.M.122.02C.11) and a weight (No. Pk.M.122.06.08). The thimble was made of a two-component Cu-Zn alloy with an average zinc content of 20.4%. The fragment of ferrule was casted of a multi-component Cu-Pb-Zn-Sn alloy, with a significant lead content (7.4%), but also zinc (4.66%), tin (3.55%) and iron (1.56%). The composition is completed by a small amount of antimony, arsenic, nickel and silver.

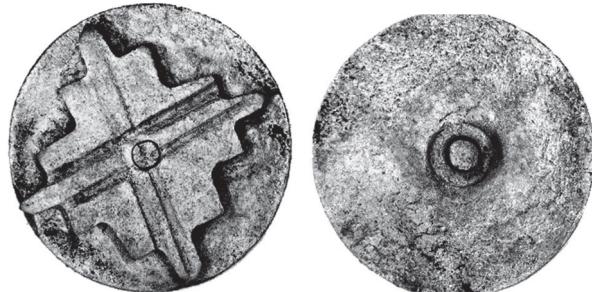
Fig. 8. Macrostructure of the application, No. Pk.M.122.08.09

In addition, three other artefacts were also analysed: a fragment of a bronze pot (grapen) (Fig. 7), applications (Figs. 8-9) and a ring (Fig. 10) with the following numbers: Pk.M.122.03.04, Pk.M.122.08.09, Pk.M.152.03.19A, respectively. The results of the

The application consists of two layers made of two-component-type of brass connected by a rivet. Both parts slightly differ in chemical composition: the first, top layer contains 83.45% of copper and 13,14% of zinc; the second, bottom layer contains 79,95% of cooper and 16,90% of zinc. Accompanied by a small amount of tin and lead.
