## Review paper

# Notes on the tests and vibration properties of hospital elevated helipad structures

W. Krzymień<sup>1</sup>

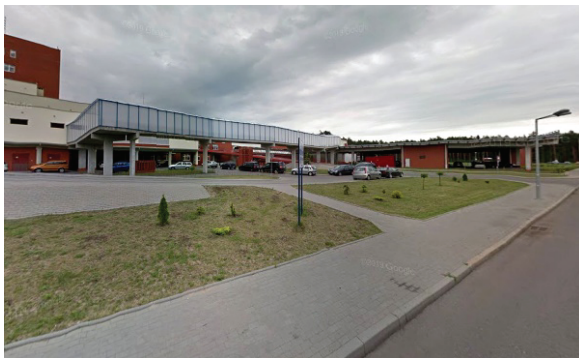
Fig. 1. Free-standing helipads: stand-alone and above a garage (e.g., hospital in Grudziądz) and a design scheme (photo: [www.google.pl/maps](http://www.google.pl/maps))

1. Figure 1 – free-standing helipads or helipads above a multi-storey garage: vibrations are not transmitted to the hospital building, but the noise remains an impact factor. However, their construction requires a significant financial investment.
2. Figure 2 – built on top of a building frame. The structure is typical of newly designed hospital buildings with an emergency department.
3. Figure 3 – placed on a rooftop of an existing building as a steel structure.

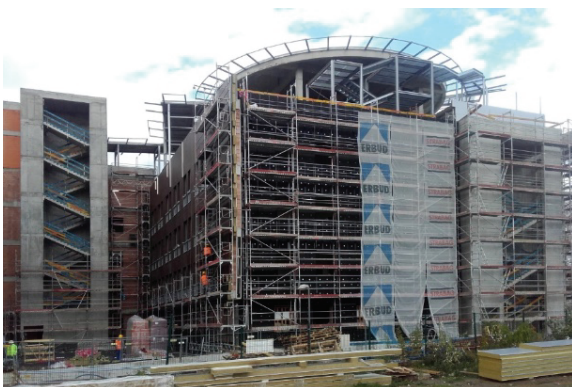
Fig. 2. Helipad on top of a building frame (e.g., Warsaw South Hospital) and a design scheme

One of the characteristic features of concrete landing sites is a heavy plate placed on several or more concrete pillars that are an extension of the building structure and form a consistent structure

with it (Figure 2). The top plate of the helipad, in which the heating system and pipes for draining water and fuel (from a potential leak) are installed, can be placed on an elastic-damping layer which provides vibro-insulation of the heliport. Such solutions are usually adopted when a new hospital is built.

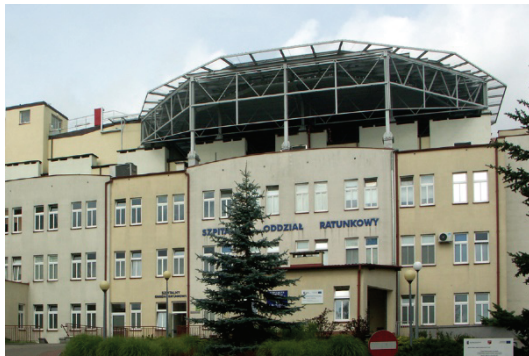
Fig. 3. Helipad on a rooftop of an existing building (e.g., hospital in Iława) and a design scheme

Helipads designed for existing buildings are usually made of steel and have a truss structure (Figure 3) – lighter and supported by up to several dozen steel pillars. The deck plate consists of duralumin or composite panels with heating and drainage systems and pillars placed on the vibroinsulators. Such a design can be found on the oldest (still existing) hospital buildings.

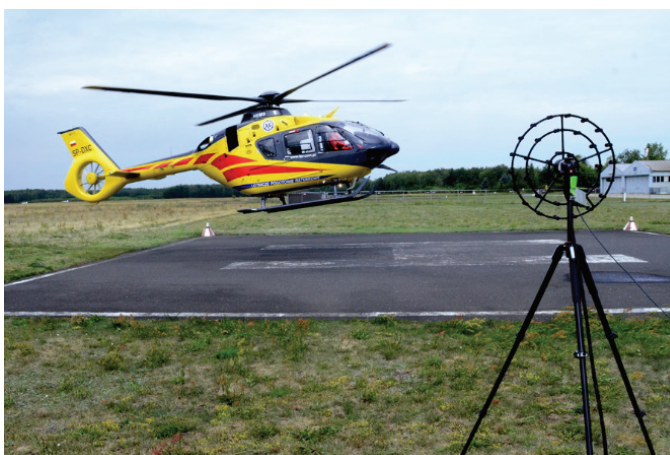
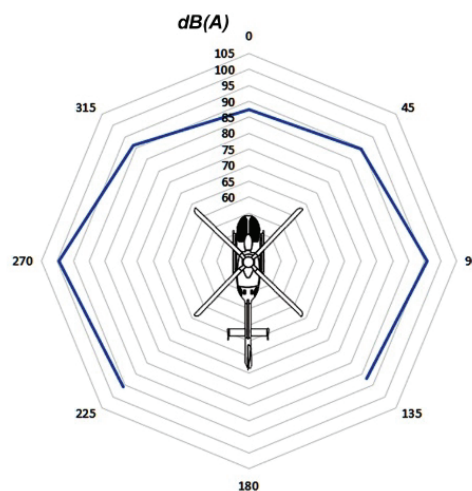
Fig. 4. Testing the noise sources of the landing helicopter and a directional diagram of the amount of noise emitted by the helicopter at the helipad

The author of this paper made preliminary measurements to assess the type and magnitude of the helicopter environmental impact, including the noise emitted [7].

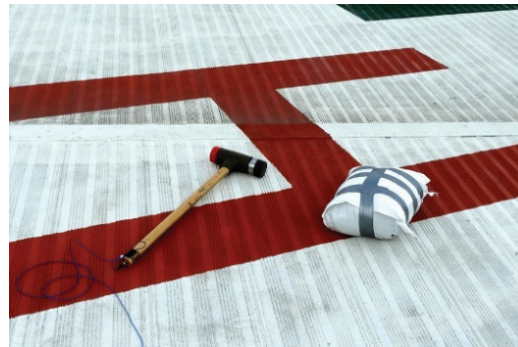
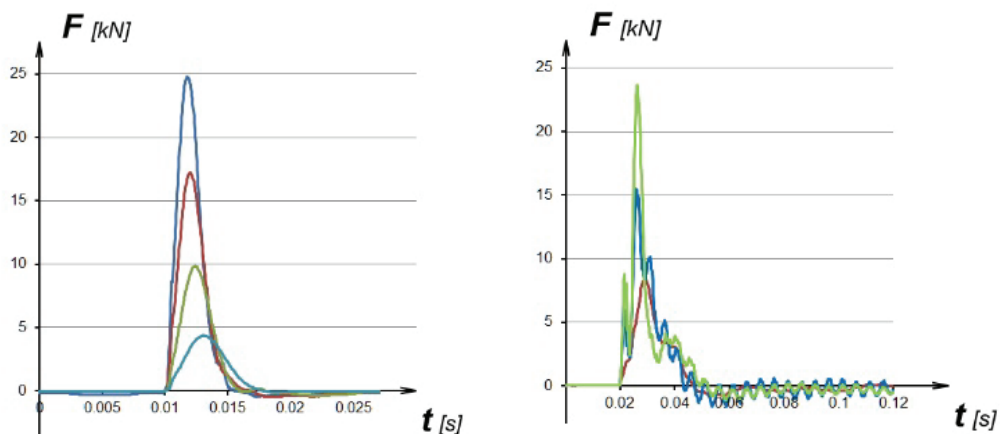
Fig. 5. Modal hammer (5.6 kg) and sandbag (20 kg) in the centre of the helipad plate. The graphs show the force patterns for four different hammer blows and dropping of the bag from three different heights

A modal hammer (5.6 kg) and a sandbag (20 kg) were used as vibration inducers to determine the vibration properties of the helipad. The signal from the sensors was recorded and analysed using measurement equipment with LMS software.

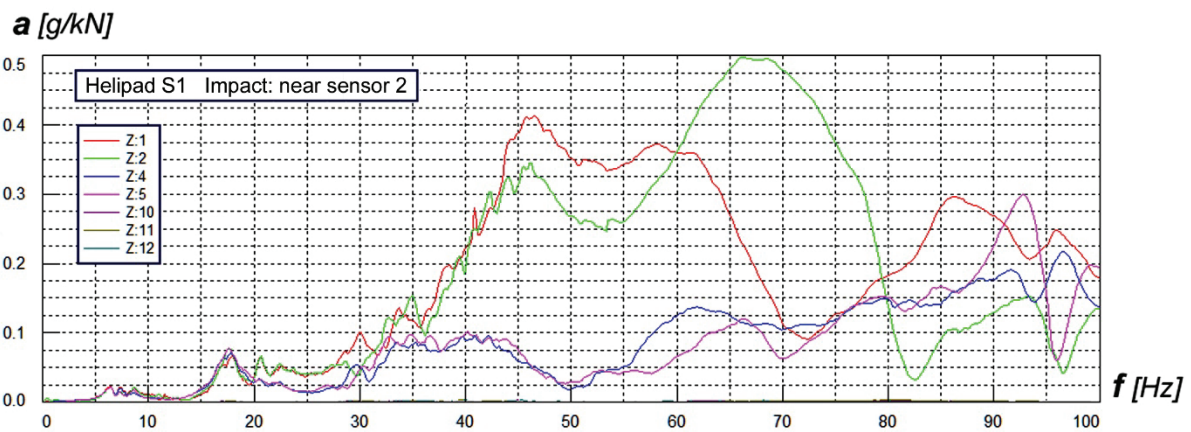
Fig. 9. Amplitude-frequency characteristics of a signal from the sensors placed on the helipad, vibroinsulators and on the floor of hospital room under the helipad

Figure 9 shows examples of amplitude-frequency characteristics of a signal recorded by the sensors after impulse excitation (with a modal hammer) at the centre of the helideck. The sensor numbers and their position correspond to the model as in Figure 6b. In this case, a very small amplitude of the signal from sensors 10, 11 and 12 proves the effectiveness of the vibroinsulators mounted in the base of the posts.

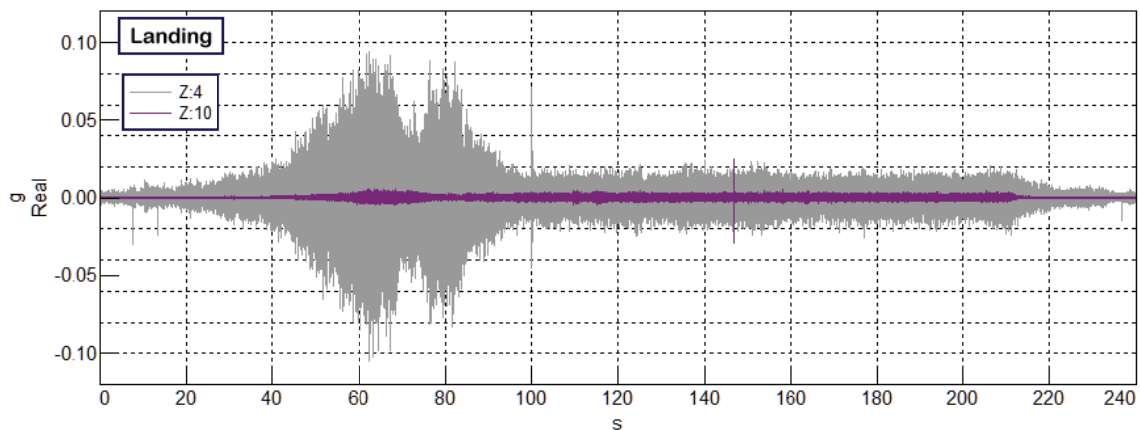
Fig. 11. Graphs of the signals recorded by the sensors placed on both sides of the vibroinsulator during the helicopter landing on the elevated helipad

Figure 11 shows sample graphs of the signals recorded by the sensors during the helicopter landing on the helipad: the time elapsed between the helicopter's approach to the helipad and the rotor stopping. The landing skid of the helicopter touched the helipad surface in 78. second of the recorded signal. The graphs illustrate the difference between the signals recorded on both sides of the insulator at the base of the central pillar. The effectiveness of the vibroinsulator has been proved by a tenfold reduction in the vibration levels.

The patterns of the signals indicate that the vibrations of the helipad are caused not only by the helicopter chassis but also by the airflow under the main rotor (turbulence, low frequency noise) [11]. The final verification of the vibration level in the building can only be carried out during the take-off and landing of the helicopter, but such actions involve a temporary disruption to the operation of the hospital. Taking the measurements involves a special helicopter landing and placing the sensors in the areas (rooms) that require asepsis (e.g. operating rooms) or the rooms with specialised testing equipment.
