Article

The influence of welding heat input on the quality and properties of high strength low-alloy dissimilar steel butt joints

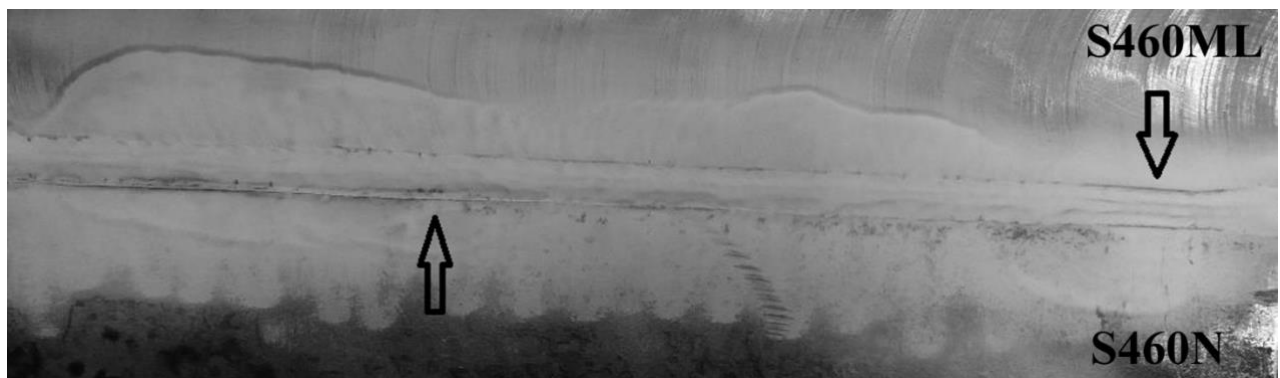
Fig. 4. Results of PT: a) Specimen 1, porosity in the middle, indication at right; b) Specimen 2, lack of fusion marked by lines

Before applying the penetrant, the surfaces were cleaned and the spatters were removed from them. A penetrant was then applied, the excess of which was removed with a cleaner after ten minutes, to then apply a developer layer. During the examination of the first sample, two indications appeared on both sides of the weld at the fusion line and a cluster of blisters at the place indicated during VT tests from the S460N steel side. Examination of a sample welded with lower heat input showed no other indications than in VT tests. The results of PT testing are presented in figure 4.
