Grzegorz ŻYWICA
Tomasz Z. KACZMARCZYK

EXPERIMENTAL EVALUATION OF THE DYNAMIC PROPERTIES OF AN ENERGY MICROTURBINE WITH DEFECTS IN THE ROTATING SYSTEM

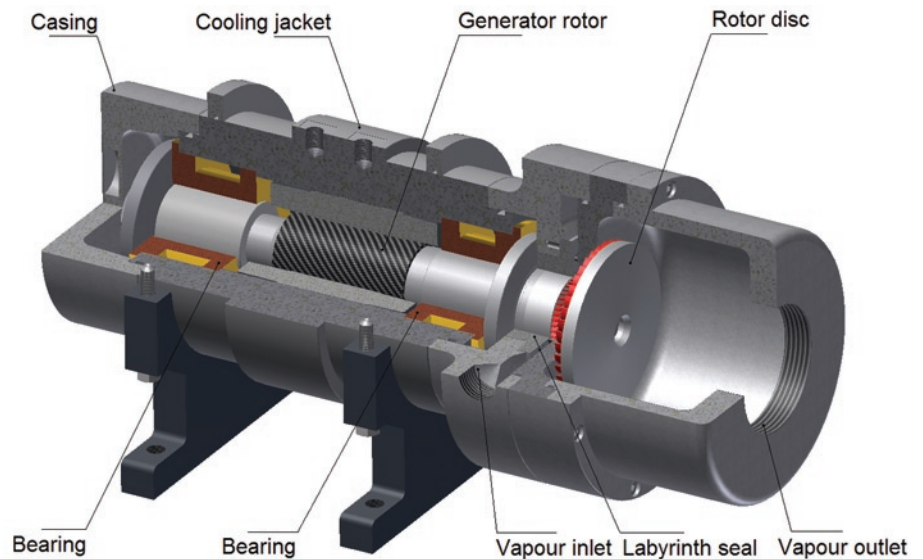
Fig. 1. The sectional view of the microturbine with its marked main parts

The tested microturbine was developed to produce electric energy in a micro-power ORC cogeneration system [29]. This is a prototypical machine designed within the framework of project No. POIG.01.01.02-00-016/08 (at the Institute of Fluid Flow Machinery of the Polish Academy of Sciences in Gdańsk), in cooperation with the Institute of Turbomachinery, Lodz University of Technology. The maximum thermal and electrical power of the cogeneration system was adapted to meet the average demand of residents of single-family houses. By using a boiler with a thermal power of approximately 25 kW, the microturbine is able to produce electric power of up to 2.5 kW. The microturbine with a generator is small in size due to its target use. The casing has a length of about 350 mm and an outer diameter of less than 200 mm. The sectional view of the microturbine, with its marked main parts, is shown in Fig. 1. In this figure, we can see how the rotor is placed inside the casing and how the bearings are arranged. The shaft is supported by two radial-axial gas bearings, constantly powered by the vapour of HFE-7100, which is the low-boiling working medium that also powers the fluid flow system of the microturbine. Thanks to the use of gas bearings, oil is not necessary for their lubrication and the rotor can reach very high rotational speeds with minimal friction losses in the bearing nodes. Since the bearing lubricant comes from the ORC, no additional lubrication system is required. There is also no possibility for the oil to mix with the low-

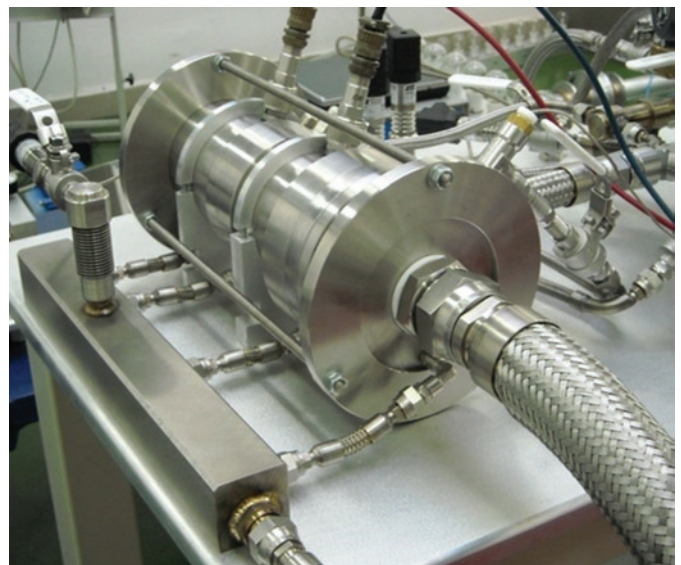
Fig. 2. The microturbine mounted on the test rig

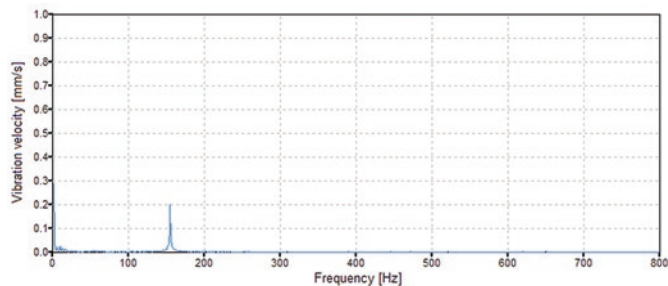
Fig. 3. The vibration velocity spectrum measured on the microturbine casing at a rotational speed of 9,300 rpm (155 Hz)

On all the spectral graphs presented, we can observe one dominant vibration component, occurring at the frequency that corresponds to the rotational frequency of the rotor (the so-called synchronous vibrations). In the consecutive figures, these frequencies are as follows: 155 Hz, 301 Hz and 351 Hz. The vibration velocity amplitude increased as the rotational speed of the rotor increased; it was 0.20 mm/s, 0.36 mm/s and 0.52 mm/s. The constant increase in the vibration level is natural in the speed range analysed as it results from an increase in the centrifugal force (coming from the residual unbalance), which forces rotor vibrations in the transverse direction. The rotor of the tested microturbine is subcritical throughout the operating speed range because the resonant speed (corresponding to the lowest resonant frequency of the bending vibrations), obtained from numerical simulations, was about 130,000 rpm [30]. As a result, a gradual increase in the vibration level as the rotational speed increased was in accordance with our expectations and did not indicate a dynamic problem. In the re-

By evaluating the recorded vibration levels according to the relevant standards, we can affirm that the dynamic state of the tested microturbine was very good. According to the ISO 10816 standard, the overall vibration velocity amplitude (V_{rms}), measured on the casing of rotating machines with a nominal power up to 15 kW, should not exceed a value of 1.8 mm/s. If this requirement is met, a long-lasting operation is possible without any limitations. As for the machine discussed, the highest vibration velocity amplitude was only 0.52 mm/s and was recorded at a speed of 21,060 rpm. Although the overall vi-

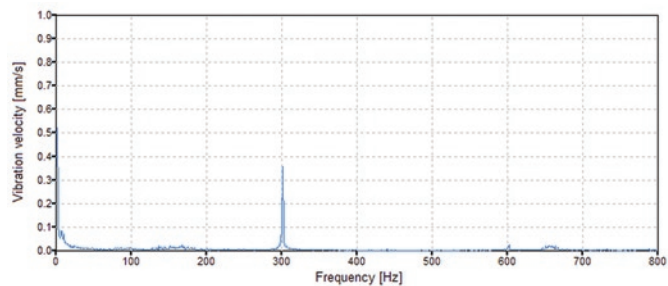
Fig. 4. The vibration velocity spectrum measured on the microturbine casing at a rotational speed of 18,060 rpm (301 Hz)

The results presented in this part of the article were obtained during one of the first tests of the microturbine, which took place several hours after the first start-up. It can be stated that it was a brand new machine without any defects. The vibration of the machine was constantly monitored during these experiments. However, because of the page limit of the article, only selected measurement results (obtained at different rotational speeds) are presented. During these measurements, the rotational speed, power as well as thermodynamic parameters of the working medium's vapour were stable. Fig. 3 shows the vibration velocity spectrum obtained at the rotor speed of 9,300 rpm, while Fig. 4 and Fig. 5 demonstrate vibration velocity spectrums obtained at speeds of 18,060 rpm and 21,060 rpm, respectively.

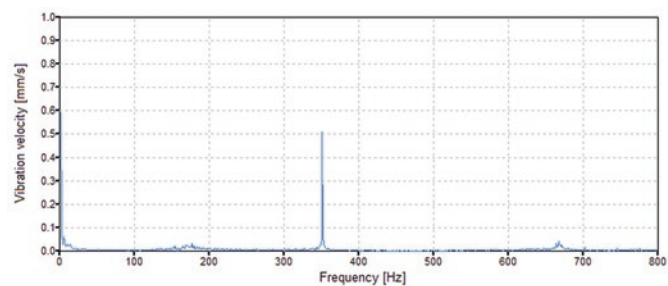
Fig. 5. The vibration velocity spectrum measured on the microturbine casing at a rotational speed of 21,060 rpm (351 Hz)

bration level was slightly higher (0.71 mm/s), it was still lower than the maximum value allowed for newly commissioned machines.

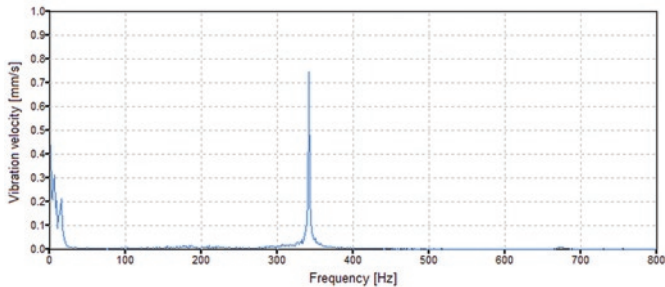
The first symptoms, which indicated the deterioration of the dynamic performance of the machine, were observed after less than 100 hours of operation. It was disturbing to see an increase in the vibration level of the microturbine casing, which was particularly evident at high rotational speeds. A detailed analysis of recorded vibration velocity spectrums showed that apart from the synchronous component (1X), there were no other components on the graphs, however, the level of synchronous vibrations increased significantly. The vibration velocity amplitude was 0.74 mm/s at a speed of 20,520 rpm (Fig. 6) and increased to 0.87 mm/s at a speed of 21,000 rpm (Fig. 7). Compared to the reference value, the vibration level increased by about 67% at a similar rotational speed. Apart from the increased vibration level, there were no other signs that suggested that the microturbine malfunctioned.

Fig. 6. The vibration velocity spectrum of the microturbine with an unbalanced rotor, measured on the casing at a rotational speed of 20,520 rpm (342 Hz)

After the disassembly of the microturbine subassemblies, the parts underwent cleaning to remove oil deposits and impurities. The microturbine was restored to its initial technical condition. Prior to further testing, the entire ORC installation was washed and the low-boiling medium was filtered. The actions undertaken have made it possible to re-launch the test rig with the microturbine. Vibration measurements were conducted and their results confirmed the very good dynamic state of the machine. To sum up this part of the article, it can be added

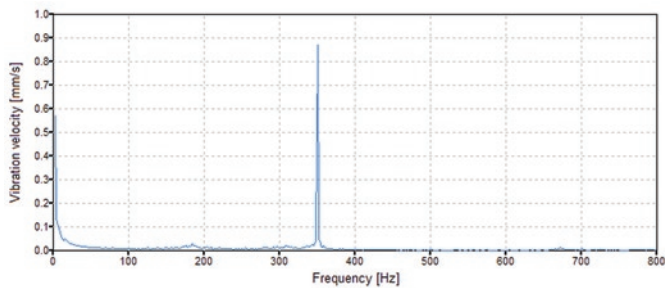
Fig. 7. The vibration velocity spectrum of the microturbine with an unbalanced rotor, measured on the casing at a rotational speed of 21,000 rpm (350 Hz)

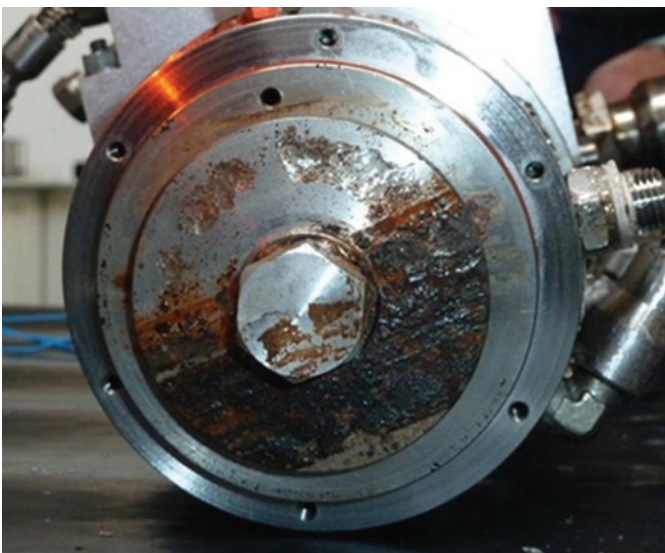
To uncover the reason behind such an increase in the vibration level, a decision was made to disassemble the microturbine and conduct a visual inspection of its parts. Already at the beginning of the disassembly, after removing the cover of the casing at the non-drive end (NDE), it was found that the keep plate of the thrust bearing was covered with impurities, as shown in Fig. 8. The cavities in the keep plate that are visible on the photo are not a sign of damage as they were made intentionally when balancing the rotor. When continuing the disassembly of the microturbine, it turned out that a large part of the surface of the rotor was covered with impurities, which caused, among other things, an increase in its unbalance. The increased amplitude of the synchronous component (1X), observed during the vibration measurements, was a typical sign which indicated that the unbalance of the rotating system was too big.

To find the cause of the appearance of impurities on the rotor, the previous tests, which were carried out on the same test rig, were analysed. As this is a general-purpose test rig, it was previously used to study various subassemblies of the ORC system, including different types of circulation pumps. It turned out that the working medium of the ORC system was found to be contaminated with oil that got into the cycle as a result of the failure of one of the pumps tested. This was the membrane pump whose membranes (made of plastic) were not sufficiently resistant to long-lasting contact with the low-boiling medium. Due to the rupture of the membrane, oil from the pump was flushed out to the ORC. Although the low-boiling medium was replaced in the ORC system after this incident, a significant amount

of oil remained inside the pipeline and other parts of the test rig (for example, in heat exchangers). In later tests, the oil mixed with the low-boiling medium entered the microturbine. When the microturbine ran at high temperatures, oil settled on its components. The surface of the rotor was affected by prolonged contact with the mixture of low-boiling medium and oil. After taking a look at Fig. 8, it becomes clear which part of the casing has been in contact with this mixture.

Fig. 8. The bearing keep plate with the defect causing the rotor unbalance

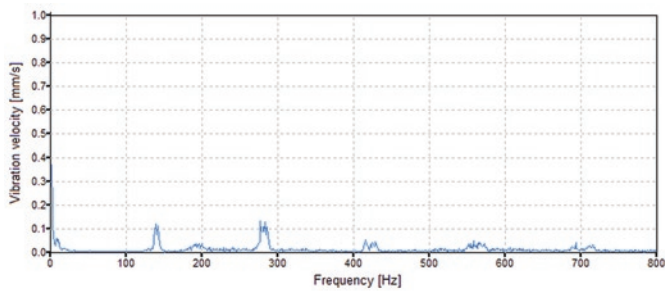
The removal of the remaining oil from the microturbine and the ORC installation restored the test rig to its original state, thus allowing further investigation. Next signs of the microturbine malfunction appeared after one of the several-week-long idle periods. The microturbine was able to operate correctly but only at very low rotational speeds (up to about 6,000 rpm). At higher speeds, it was observed that apart from the 1X component, harmonic components such as 2X, 3X, 4X (and higher) appeared on the vibration velocity spectrums recorded on the casing. In addition, each of these components was not only present at one frequency value but also at the neighbouring ones. The amplitude of the 2X component was similar to that of the 1X component and the amplitudes of subsequent harmonics decreased gradually, as shown in Fig. 9. Despite the disturbing increase in the vibration level, the research was continued, increasing the rotor speed. At rotational speeds above 12,000 rpm, higher harmonics began to gradually disappear but the main component of the spectrum (1X), whose frequency corresponded to the rotational speed of the rotor, also began to appear at the neighbouring frequencies. The vibration spectrum became chaotic, as shown in Fig. 10. These types of spectrums are typical for rotating systems in which there is physical contact between rotating components and the casing or other non-rotating components. Since the vibration characteristic did not improve after several subsequent measurements, it was decided to disassemble the machine and check the technical condition of all its components.

Fig. 9. The vibration velocity spectrum of the microturbine with a damaged thrust bearing, measured on the casing at a rotational speed of 8,340 rpm (139 Hz)

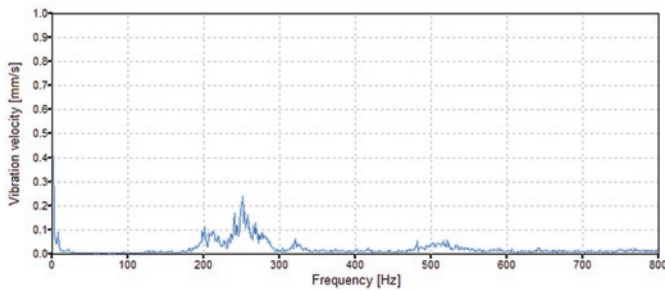
Fig. 10. The vibration velocity spectrum of the microturbine with a damaged thrust bearing, measured on the casing at a rotational speed of 15,060 rpm (251 Hz)

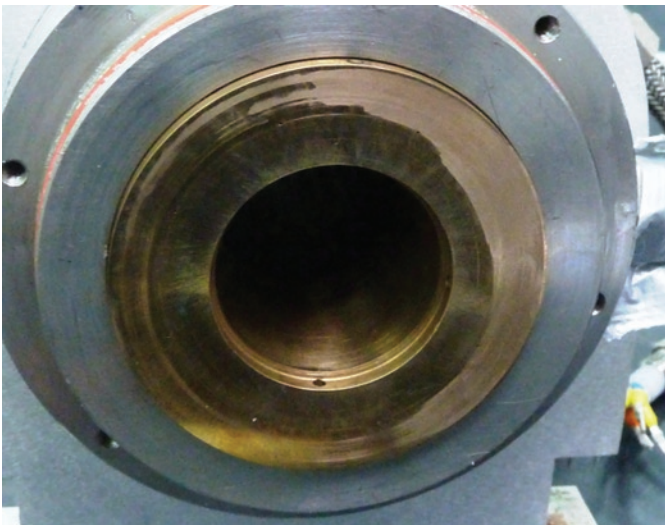
During the disassembly of the microturbine, both the front and rear cover of the casing was removed, and the rotor was taken out. Visual inspection of the components revealed clear signs of wear of one of the gas thrust bearings (Fig. 11), indicating that it malfunctioned. This bearing was located at the free end of the shaft (see Fig. 1). Nearly half of the sliding surface showed signs of friction, which were the result of physical contact of the bearing with the surface of the keep plate. On closer inspection, it was found that 3 out of 10 supply holes were clogged. These holes are used to deliver the lubricating medium (in the form of low-boiling medium vapour) into the space between the sliding surfaces. Since the holes are small in diameter (only 0.4 mm), small particles of different sediments, from different parts of the installation, clogged them. The long downtime was detrimental to the microturbine because impurities accumulated in the supply chambers of the gas bearings. Due to the clogging of the holes, the amount of vapour delivered to the bearing lubrication gap decreased, resulting in a decrease in capacity. The axial force, transmitted by the shaft to the thrust bearing, increased as the flow rate and pressure of the vapour delivered to the microturbine blade system increased. This force was too high for the defective bearing, which resulted in the physical contact between two mating bearing surfaces. Under normal operating conditions, these surfaces are entirely separated by a lubricating film.

A visual inspection of all microturbine components showed that only the sliding surface of one of the thrust bearings was damaged. Since the keep plate was made of a much harder material, the damage only occurred on the surface of the bearing sleeve (made of bronze). Constant monitoring of the vibrations enabled early detection of this problem, so it was easy to repair the damage; the entire surface was smoothed by grinding. After the repair, the operation of the microturbine seemed normal and both the vibration velocity spectrum and the overall vibration level differed only slightly from the reference values.

Fig. 11. Gas thrust bearing with a damaged sliding surface

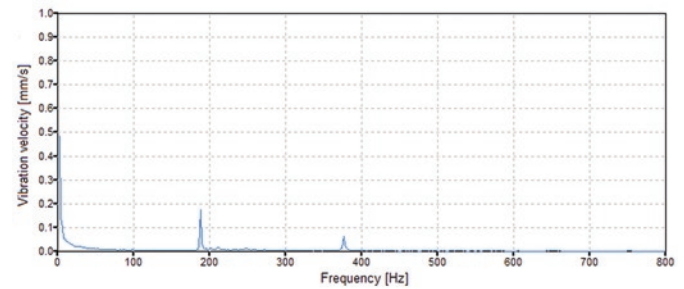
This section describes another case of malfunctioning of the 2.5 kW ORC microturbine. It was observed that in addition to the synchronous component (1X), the vibration spectrum also included the harmonic component (2X) with a frequency twice as high as the current rotational frequency of the rotor. The amplitude of the 2X component was generally two times lower than that of the 1X component, regardless of the rotational speed. Two exemplary spectral graphs, showing such a distribution of vibration amplitudes, are in Fig. 12 and Fig. 13. The results demonstrated on these graphs were obtained during measurements at 11,280 rpm and 13,260 rpm. With regard to the second graph (Fig. 13), we can notice that in addition to the 2X component, the vibration spectrum also has a component with a frequency three times higher than the basic frequency. However, the

Fig. 12. The vibration velocity spectrum of the microturbine with a bent shaft, measured on the casing at a rotational speed of 11,280 rpm (188 Hz)

When the 2X component is present on a vibration spectrum graph and is present after changing the rotational speed, it usually means that either the shaft is bent or there is a misalignment of two mating shafts. Since the rotating machine discussed herein has only one shaft, it was suspected that the bent shaft was the main reason for the appearance of the 2X component. An analysis of the microturbine design, as well as its start-up and operating conditions, confirmed that the failure of the shaft was very likely. The inlet of the fresh vapour that powers the blade system of the microturbine is located only on one side of the casing (see Fig. 1), which results in the rotor not being uniformly heated. The rotor of this machine starts rotating only after there is an appropriate differential pressure between the vapour inlet and outlet. This means that it cannot be evenly heated during the initial start-up period. A similar situation occurs with radial gas bearings, which are powered through small-diameter holes. If the pressure of the lubricating medium is too low, the bearing journals cannot be lifted. This means that the supply holes in the lower parts of the bearings are blocked by the journals and vapour flows through the remaining holes. Only after the pressure increases, causing the journals to move towards the centres of the bearings, a similar amount of vapour starts flowing through all the supply holes. What aggravates the situation more is that two inlets of hot vapour which power the bearings are located on the same side of the casing. When starting the machine, this may cause thermal deformations as the casing is not evenly heated. Since the bearing sleeves are tightly mounted in the casing, its deformations also cause changes in the geometry of the bearing lubricating gaps. All this clearly shows that the microturbine's rotating system is susceptible to thermal deformations and that they may be the reason behind the appearance of diagnostic symptoms associated with a bent shaft.

microturbine and then disappeared after a few minutes of operation. When the casing, bearings and the rotor were heated over a longer period of time, this problem practically did not exist anymore. Therefore, in order to avoid a temporary deterioration of the dynamic performance, the settings of the test rig control system were changed so that the start of the microturbine always takes place after the temperature distribution is uniform.

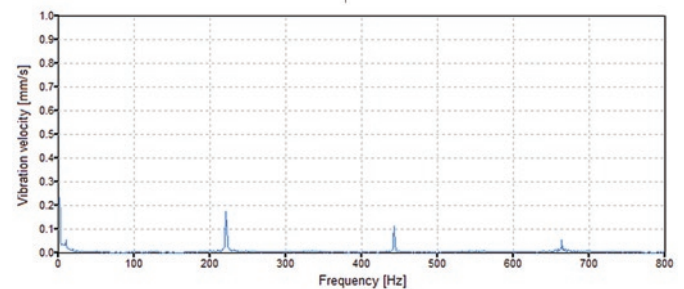
Fig. 13. Vibration velocity spectrum of the microturbine with a bent shaft, measured on the casing at a rotational speed of 13,260 rpm (221 Hz)
