Dominika GRYGIER*, **Aleksandra KĘSKA****

THE ASSESSMENT OF THE INFLUENCE OF THE MATERIAL USED ON THE WEAR AND TEAR OF FORKLIFTS AND THEIR OPERATIONAL SAFETY

forklifts, forks, wear and tear, microstructure.

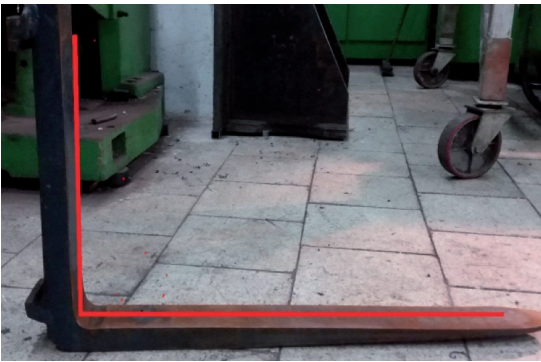
- all cracks and deformations of forks on their whole surface, especially on edges,
- visible deformations of fork tips in relation to the gauge put at the fork core – if the back of the fork was straight, the measure was adhered along its whole length (Fig. 3),

Fig. 3. Testing deformations of the fork tip core
Rys. 3. Sprawdzenie odkształcenia trzonu kła widły

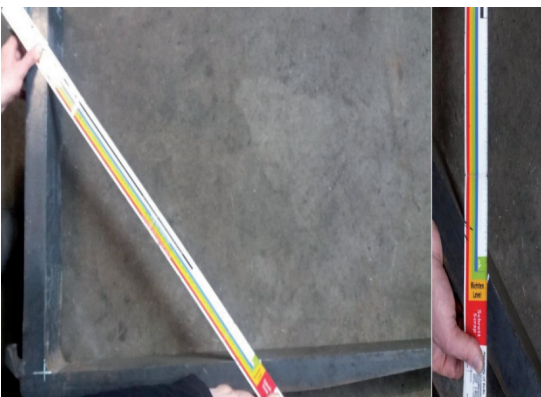
- fork line inclination angle exceeding 3° – in the tests, control points on a core and fork blade were measured at a distance of 500 mm from a previously set cut on a heel; when the points connected with the used gauge indicated a green area, the fork dilation was smaller than 3%, the yellow area indicated that it was necessary to control further dilation, while the red part disqualified forks from further service (Fig. 4),

Fig. 4. Fork dilation angle inspection
Rys. 4. Kontrola kąta rozwarcia widel

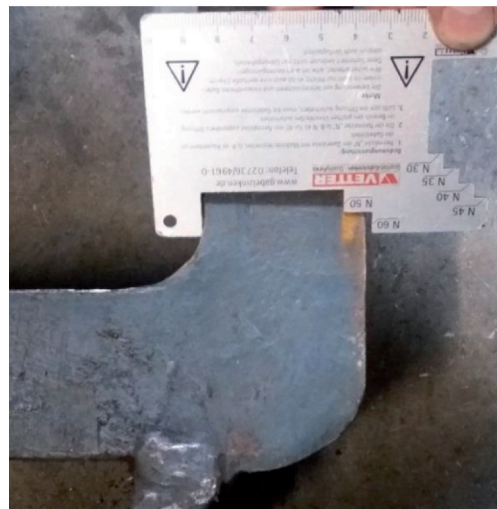
- fork tip abrasion up to 10%, however, not exceeding 5 mm, unless the manufacturer recommended otherwise – the inspections were made using a straight edge to measure fork cores, next an appropriate cut-out was applied to the tip; if the forks fell into the cut in the straight edge, they were no longer fit for use (Fig. 6).

Fig. 6. Inspection of fork tip abrasion using a Vetter straight edge
