SERVICE LIFE EXTENSION OF PARACHUTES WITH USE OF NON-DESTRUCTIVE AND PARTIALLY DESTRUCTIVE TESTING METHODS OF TEXTILE MATERIALS

Article Category: Research Article

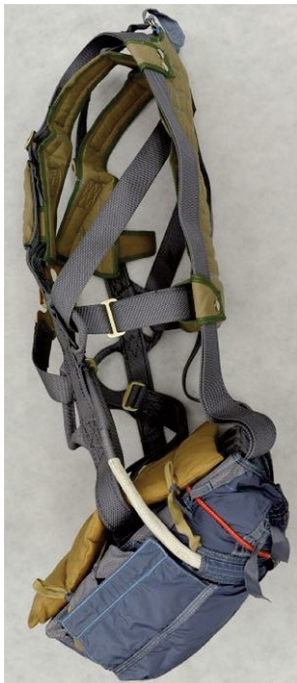
Fig. 1. S-4 seat rescue parachute [7].

Rescue parachutes are required for pilots and cabin crew members when flying by aircraft of the Polish Armed Forces and of the Border Guard [6]. Depending on the difficulty of the mission being carried out and the magnitude of the potential threat, it is required that the cabin crew wear rescue parachutes permanently, and pilots use rescue parachutes mounted in the seats, including ejected seats. When flying in standard peace conditions, rescue parachutes are carried on special racks with easy access in the cabin of the aircraft and in a number ensuring the possibility of rescue for each crew member. Fig. 1 shows a seat rescue parachute with the harness.

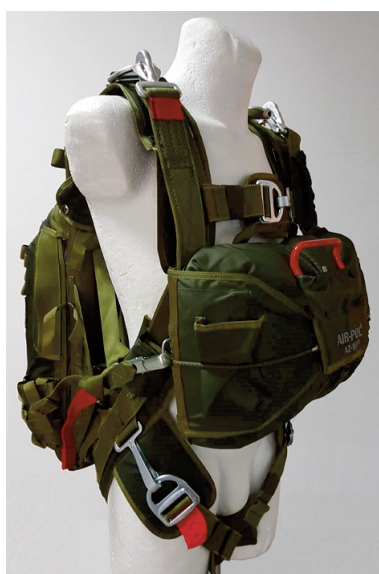
Fig. 2. AZ-95 chest reserve parachute [7].

Reserve parachutes are included in the parachute sets for performing jumps. Jumping is performed on the main canopy, and the reserve canopy is used to save the jumper in an emergency, when the main canopy does not open or opens incompletely. In this case, usually the main canopy is realised (detached) from the jumper's harness and the reserve canopy is opened. Therefore, reserve canopies are also used sporadically only when the main canopy fails. Figure 2 shows a reserve parachute produced in Poland.

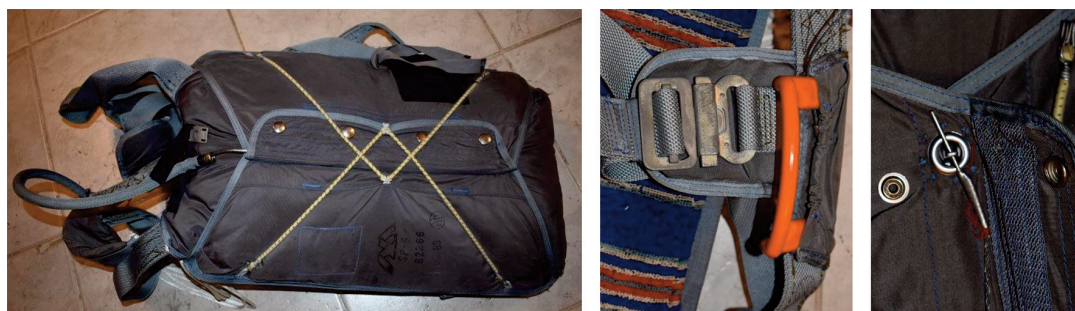
Fig. 3. Parachute SP-6 after 12 years of service life [Kramarski].

In the second half of the 20th century, the mass production of a Russian origin S-3 seat rescue parachutes for LIM and TS-11 Iskra airplanes and S-4 for An-2 and An-28 / M28 aircraft and for Mi-2, Mi-8, Mi-14, Mi-17 and W-3 rotorcraft was launched at the Aviotex State Technical and Tourist Equipment Plant in Legionowo, Poland. At ZSTiT Aviotex, the SP-6 rescue back parachute was designed independently. The technical condition of the SP-6 parachute after 12 years of operation is shown in Figure 3.

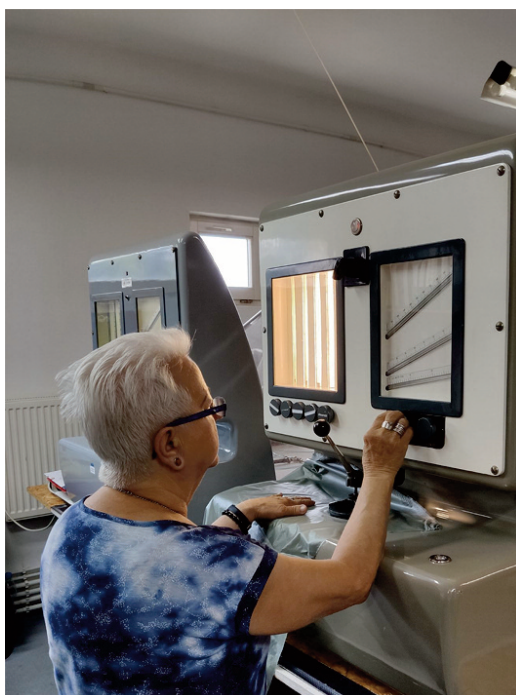
In this case and with any doubts as to the properties of the materials, a non-destructive method of checking the fabric's air permeability of the canopy is used. A change in air permeability indicates damage to the fabric fibers and / or damage to the coating that covers the woven fabric in the manufacturing process [2]. The coating is used to stabilize the fabric's air permeability within the range provided a given type, and it usually also protects the fibers from the effects of solar radiation, mainly UV rays [9]. In some parachute fabrics as well as in reinforcing tapes and suspension lines, an anti-melting coating is also used, whose function is to increase the material's resistance to increased temperature, when during rapid opening, the fabric, reinforcing tapes and suspension lines tear against each other. Evolving heat can damage the fibers of the textile materials and therefore an anti-melting coating is applied that heats up and evaporates first, thus reducing the amount of heat acting on the fibers under the coating. The device for testing the air permeability (air porosity) of the parachute fabric is shown in Figure 4.

Fig. 4. Testing of the air permeability (air porosity) of the fabric of the parachute canopy [7].

The canopies were initially subjected to the non-destructive test at the fabric air permeability test stand. Porosity was tested in randomly selected canopy sectors and at randomly selected points in a given sector. It is known that if the any increase in air permeability of the fabric indicates some damage has occurred even if there are no visible signs of defect. The parachute with the fabric with increased porosity was removed from service.

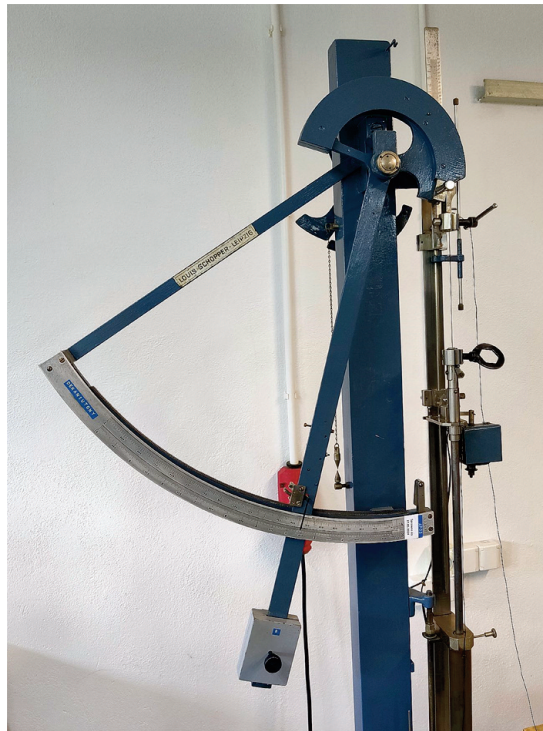
Then, from each canopy from the worst-looking sector, a fabric sample was cut out for strength tests. A sample of the suspension line was cut out similarly. The machine used for the lines and threads strength testing is shown in Figure 5.

Fig. 5. The parachute lines and threads testing machine [7].

In the case of civilian parachutes, the ULC agreed to extend the period of use if the strength of the fabrics and suspension lines was at least 80% of the strength of these materials required for new equipment. In the case of positive results of strength tests, the canopy was repaired by sewing patches at the place of cutting out the fabric sample for testing and a new suspension line was installed in place of the line used for strength tests. The tests performed were not destructive for the canopy as only a fragment of one of the twenty several sectors of the canopy was cut out and only one of the twenty several suspension lines. In the case of S-3 and S-4 rescue parachutes, the military accepted the requirements that the strength of fabrics and lines must be at least 100% of the strength required for new equipment.
