Original article

The problem and analysis of vibrations appearing in N10 and N11 groups military vehicles with manually-operated armament modules

Tracked Vehicles Testing Laboratory,
Military Institute of Armored and Automotive Technology, Sulejówek, Poland,
e-mail: maciej.dorczuk@pcosa.com.pl; przemyslaw.wachowiak@witpis.eu

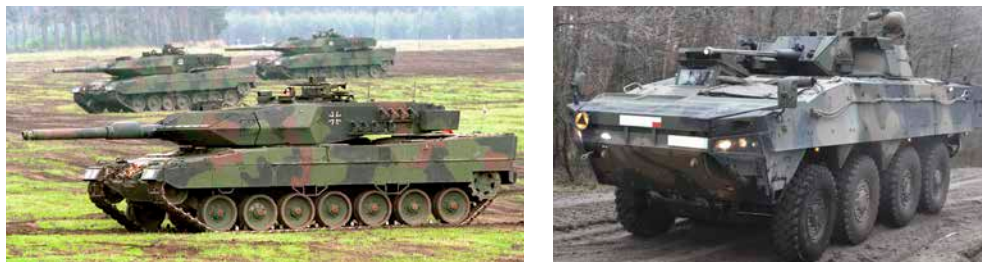
Fig. 1. Selected N10 and N11 groups vehicles
Source: Own study.

The article presents a continuation of the author's work on vibrations appearing on equipment elements of N10 and N11 groups vehicles (Fig. 1). Detailed results of tests, calculations, and analyses concerning the N10 vehicle are included in the study [1]. The following article provides information on two vehicle groups, with an emphasis on the N11 vehicle group.

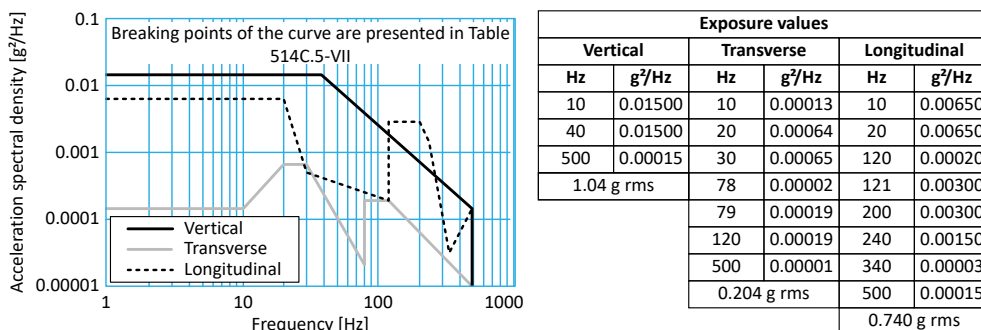
Fig. 3. Vibration exposure for wheeled vehicles
 Source: (METHOD 514.5, MIL-STD-810F) [10].

The requirements of MIL-STD-810F in accordance with procedure 514.5 contain detailed information and sinusoidal vibration values for testing devices intended for installation in military vehicles (Fig. 3).

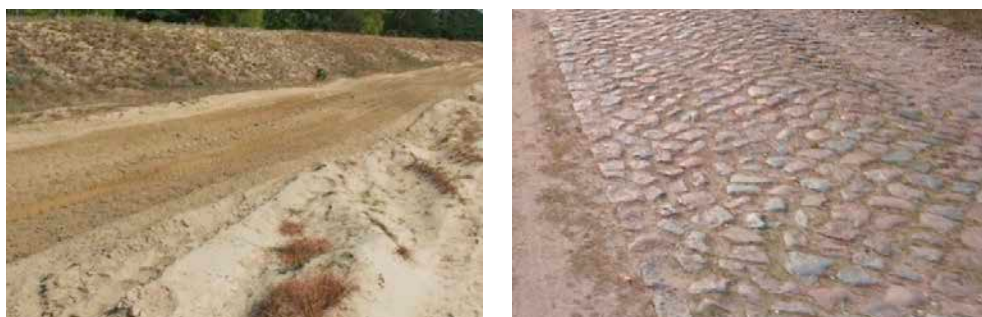
Fig. 4. Path section: military range on the left, cobblestones on the right
Source: Own study.

The test objects were a heavy tank from the N10 group and a wheeled APC from the N11 group. The tests were carried out on two types of ground, a military range path (Fig. 4) and cobblestones (Fig. 4) – these are the terrain conditions in which military vehicles operate. The tests were carried out for two different travel speeds, approximately 10 km/h and approximately 20 km/h, and, additionally, for speeds of approximately 30 km/h and approximately 20 km/h for the tank. The selected speeds of 10 km/h and 20 km/h are not accidental but result from tests conducted in the 1990s, which assessed the impact of vehicle speed on the probability of hitting the target [20].

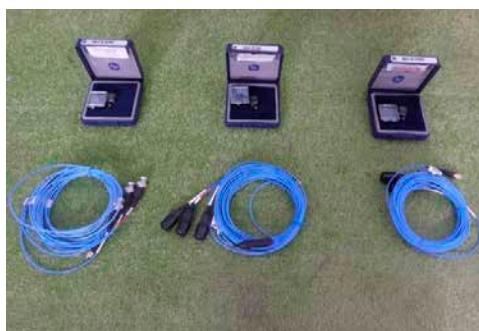
Fig. 5. A set of PCB sensors
Source: Own study.

Vibration measurements used three three-axis PCB 356A16 sensors with a 50 g range (Fig. 5) and a data acquisition station with the NI cDAQ-9172 module and three NI9233 (2 pcs.) and NI9234 (1 pc.) measurement cards (Fig. 6). The NI SignalExpress 2015 software with an algorithm developed for the test purposes was used for communication and data recording (Fig. 7).

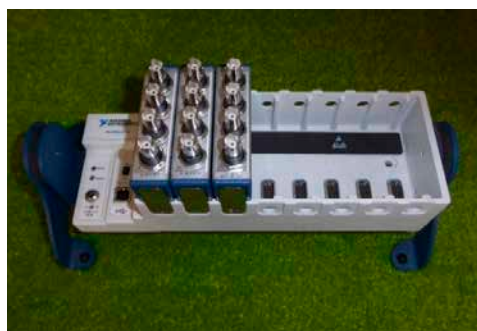
Fig. 6. Data acquisition station
Source: Own study.

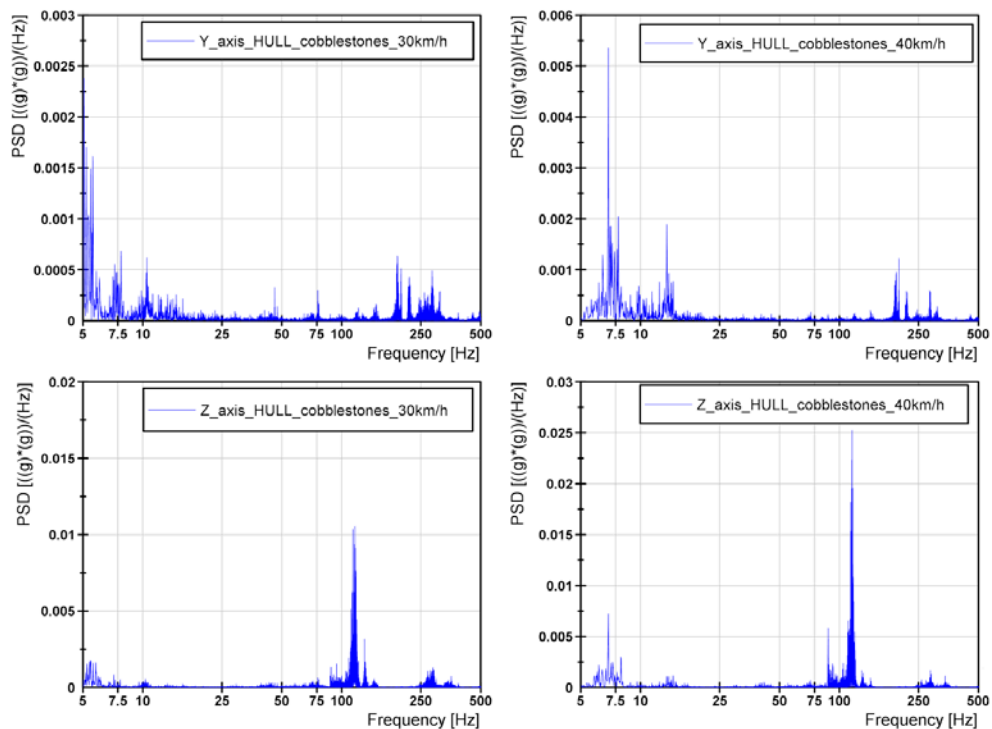
Fig. 16. The spectrum of accelerations in the Y and Z axes on the hull plate in the 5-500 Hz frequency range for driving on cobblestones at speeds of approximately 30 km/h and approximately 40 km/h
Source: Own study.

Figure 16 shows the spectrum of accelerations in the Y and Z axes recorded on the upper plate of the N11 hull, in the 5-500 Hz frequency range for driving on cobblestones at speeds of approximately 30 km/h and approximately 40 km/h.

From the presented Figure 16, one can observe the exceedances for driving at a speed of approximately 30 km/h by an order of magnitude in the Y axis for the requirements in accordance with MIL-STD-810F, and slight exceedances in the Z axis. For the driving speed of approximately 40 km/h, there are also exceedances in the Y axis by an order of magnitude, and slight exceedances in the Z axis. For all cases, the exceedances occur in the low frequency range.
