INVENTORY PHOTOGRAPHS AND DRAWINGS OF AN OLD FARMHOUSE (BUILT CA. 1922) IN OSTRA GÓRA, KORYCIN COMMUNE, BIAŁYSTOK REGION, N-E POLAND

Paula M. Brzozowska¹, Marzena Cwalińska¹, Jarosław Szewczyk²

INWENTARYZACJA DOMU Z 1922 ROKU W OSTREJ GÓRZE W GMINIE KORYCIN NA BIAŁOSTOCCZYŹNIE

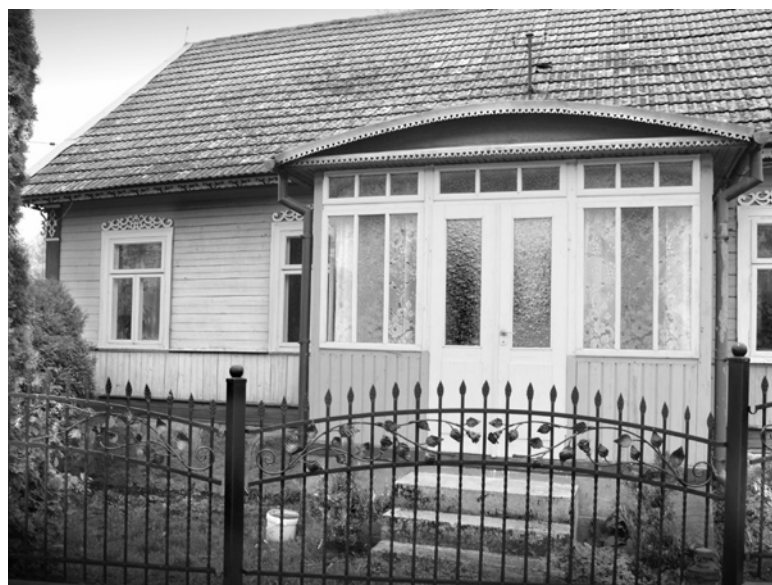
Fig. 1. The house in Ostra Góra: façade view; photo by the authors, 2018

The house was built in 1922 as a simple timber-made farmhouse with a glassed front porch (fig. 1). In spite of some subsequent major repairs, it still preserves a variety of its initial features in terms of construction, architectural form, external adornment, lay-

A similar cumulative nature can be seen in the architecture of the house. Originally, it had a simple rectangle-based layout with a glassed front porch (fig. 1), having all walls made of timber. Another porch-like annex was later added at the back (fig. 3). The back porch was constructed of hollow bricks.

The porches present another type of construction: the front porch (fig. 1, 9 and 10) has a „post-and-beam” lightweight construction with large stained-glass windows and fine wood plank clapboarding; at the back of the house there is another porch (fig. 3), made of foamed concrete bricks. This porch is actually a newer annex, added in the late 1970s.

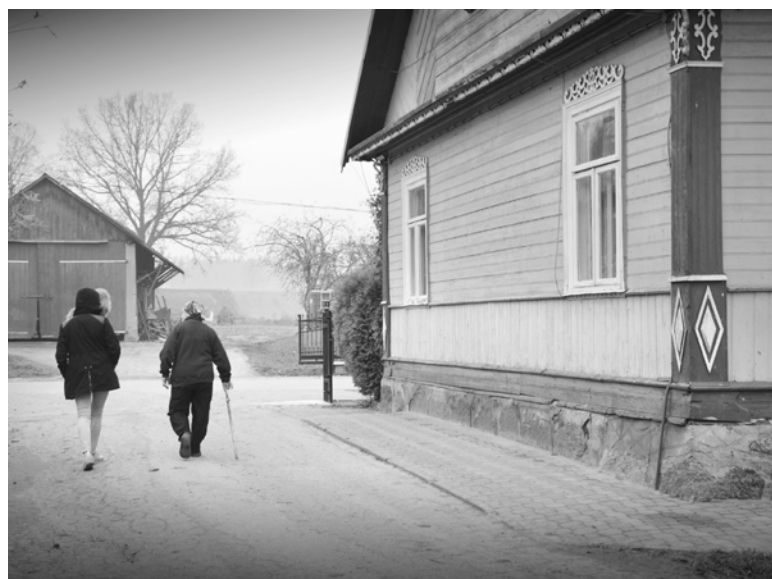
Fig. 2. The house in Ostra Góra (side view towards the street); photo by the authors, 2018

The farmstead reflects the cumulative nature of space as well. The house is only one of a number of buildings tightly located on a small farm plot perpendicular to the street. The characteristic feature of the farmstead is the coexistence of modern spacious stables with older barns and two farmhouses, aside from a dozen or so minor outbuildings – all those structures placed on the same farm plot. The farmstead also extends on the opposite side of the street (fig. 2).

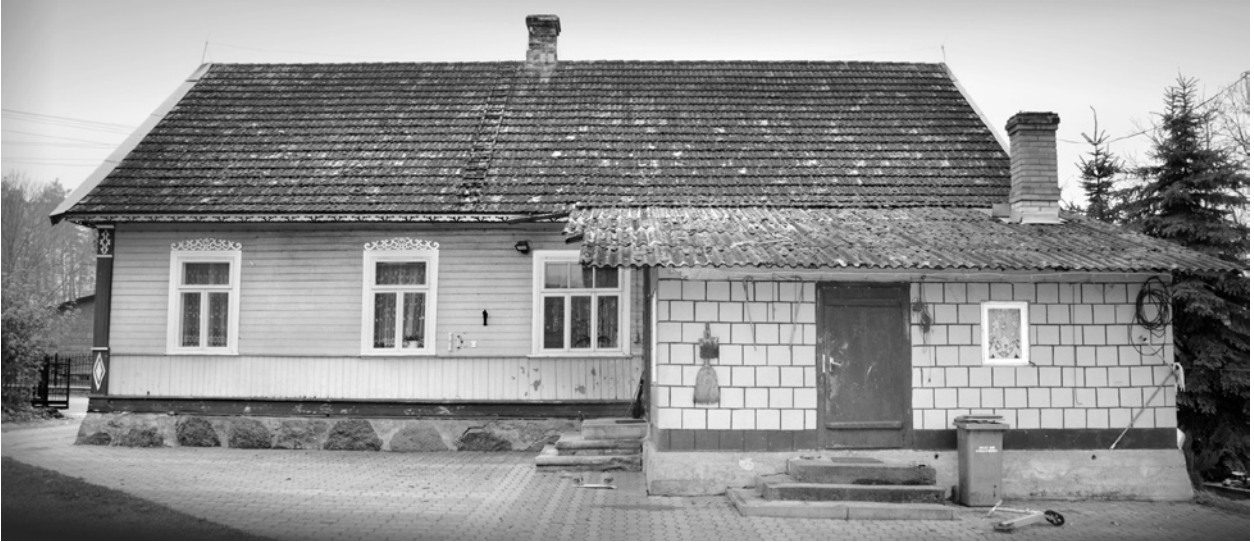
Fig. 3. The house in Ostra Góra (back view towards the street); photo by the authors, 2018
Ryc. 3. Dom w Ostrej Górze – widok od podwórza ku ulicy; fot. autorzy, 2018

On the opposite side of the house there is another penthouse, a larger porch (fig. 3 and 11) comprising a small hallway, a storeroom and an auxiliary kitchen called *letnia kuchnia* (a “summer kitchen”; fig. 24 and 25). Placed at the back of the house, it is assigned for workday activities only, with relatively little attention to aesthetic value. After all, this space is intended for auxiliary farming activities and seems arranged to enhance working comfort rather than to enable the inhabitants to enjoy life.

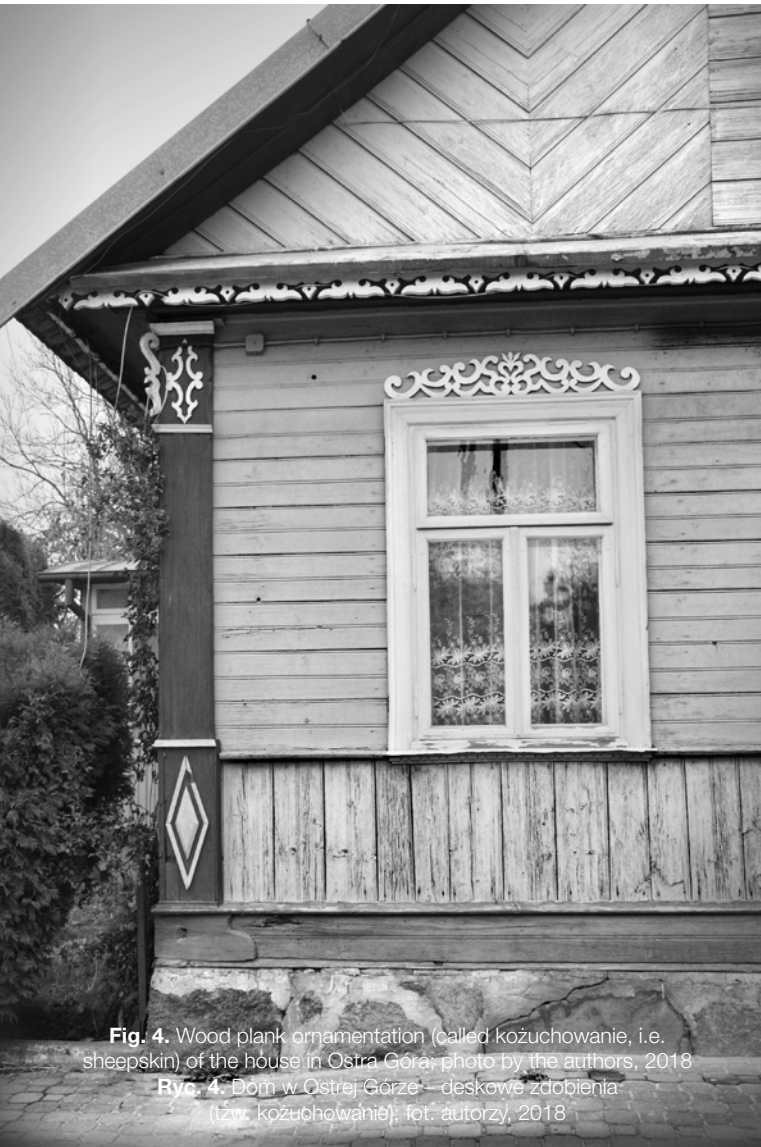
Fig. 4. Wood plank ornamentation (called kozuchowanie, i.e. sheepskin) of the house in Ostra Góra; photo by the authors, 2018
Ryc. 4. Dom w Ostrej Górze – deskowe zdobienia (tzw. kozuchowanie); fot. autorzy, 2018

Apart from the porches, the house has its original plank-made adornments, characteristic of the region (fig. 4-7). Traditionally, places of adornment accu-

The house, being supported with massive stone foundations, has timber walls made of 18x22 cm logs, sawed up and joined with full dovetail corner notches. The walls were then clapboarded with profiled 20-cm-wide planks (clapboarding and its ornamental additions are called *kożuchowanie*, i.e. a *sheepskin of the house*).

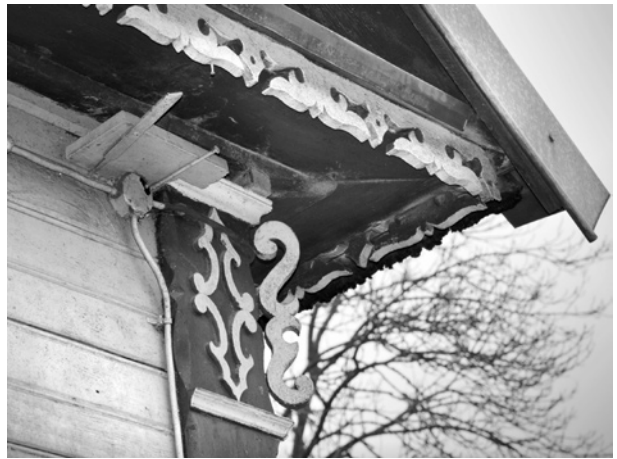
Fig. 5. Wood plank ornamentation of a cornice; photo by the authors, 2018
Ryc. 5. Dom w Ostrej Górze – deskowe zdobienia węgla; fot. autorzy, 2018

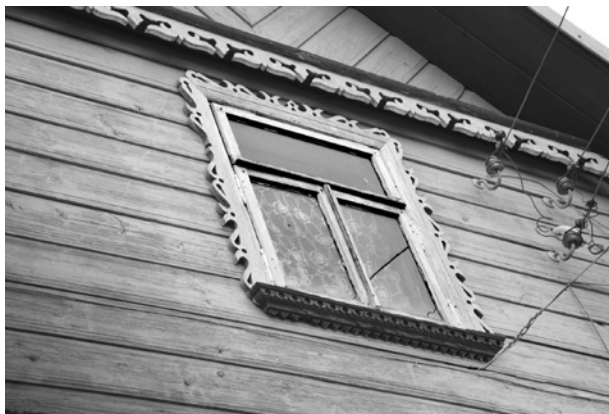
Fig. 7. Gable window decoration; photo by the authors, 2018
Ryc. 7. Zdobienie okna szczytowego; fot. autorzy, 2018

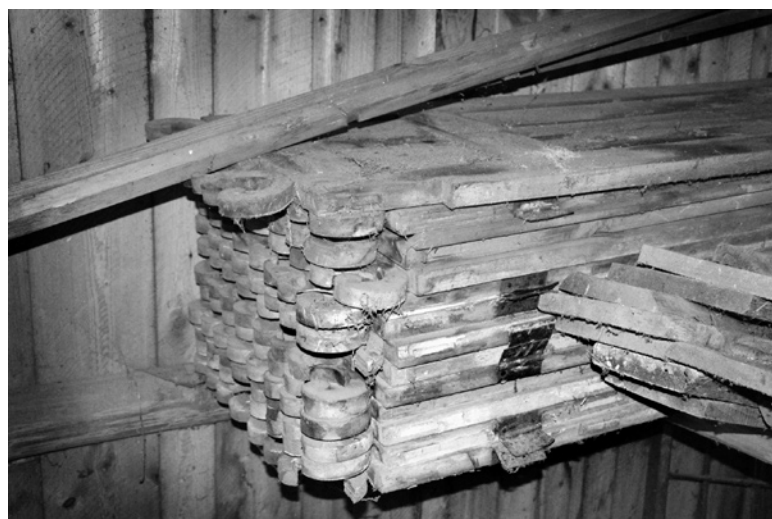
Fig. 8. Window shutters, removed and stored in an outbuilding; photo by the authors, 2018
Ryc. 8. Okiennice składowane w dobudówce; fot. autorzy, 2018

Originally, blue shutters supplemented the external ornamentation of the house. Yet recently they have been removed and are stored in an outbuilding (fig. 8).

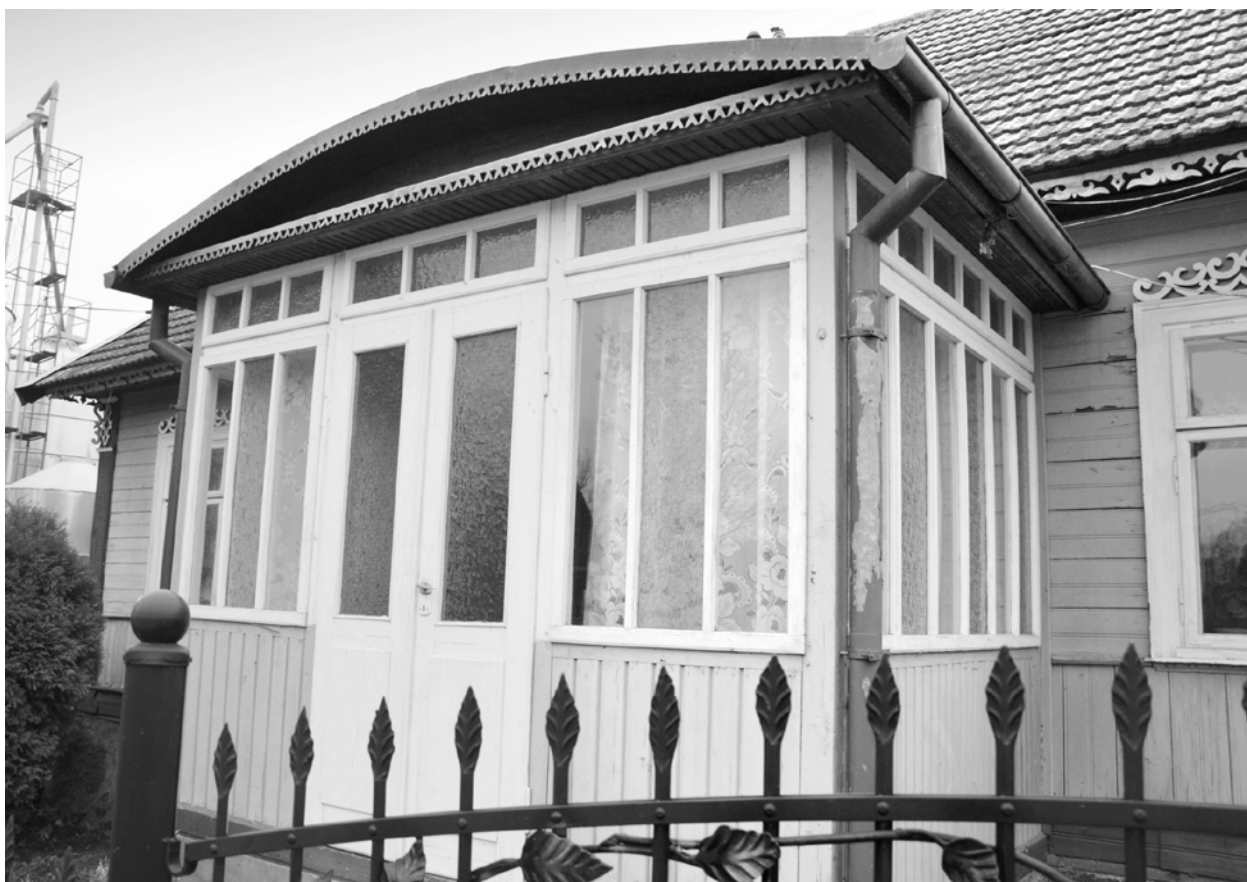
Fig. 9. The front porch glazed with stained glass; photo by the authors, 2018
Ryc. 9. Frontowa weranda szklona witrażowo; fot. autorzy, 2018

were decorated with stained glass instead of timber cuttings. The house in Ostra Góra represents the latter case (fig. 9, 10).

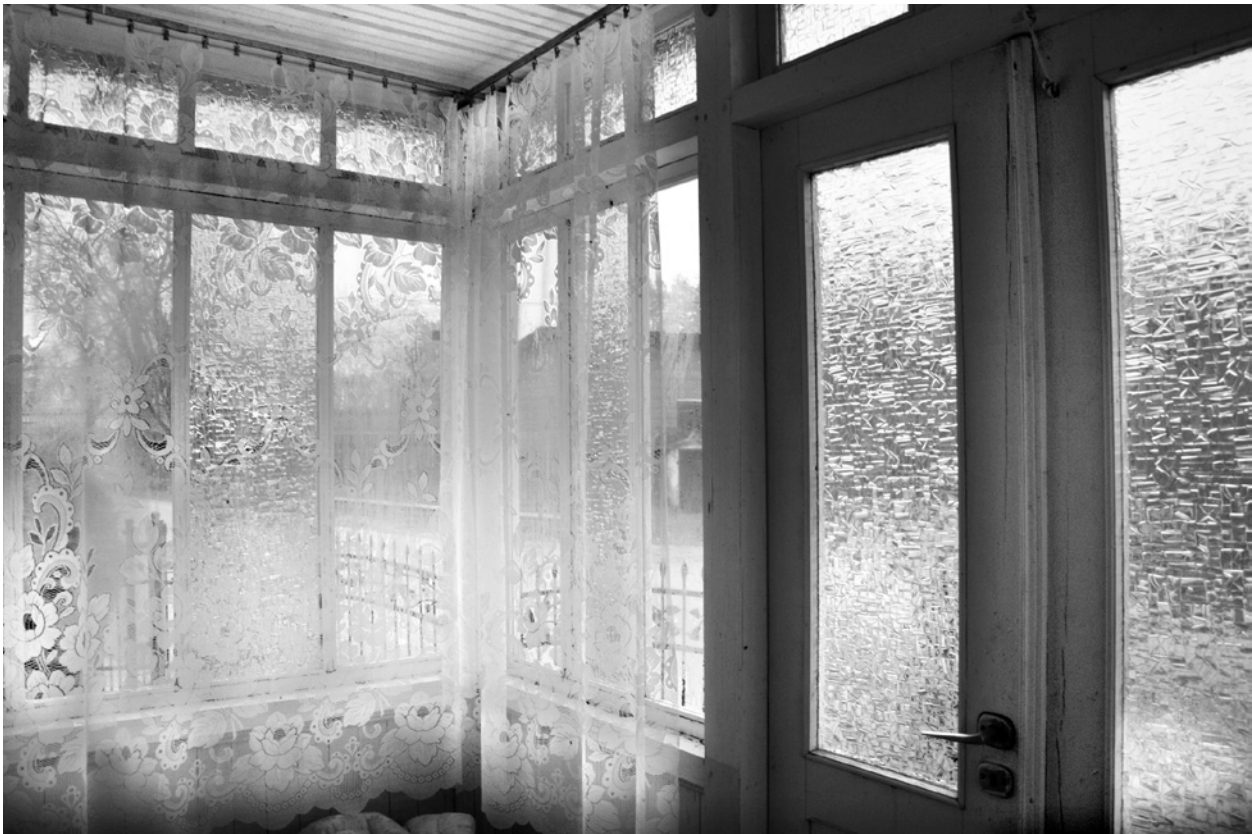
Fig. 10. The front porch glazed with stained glass; photo by the authors, 2018

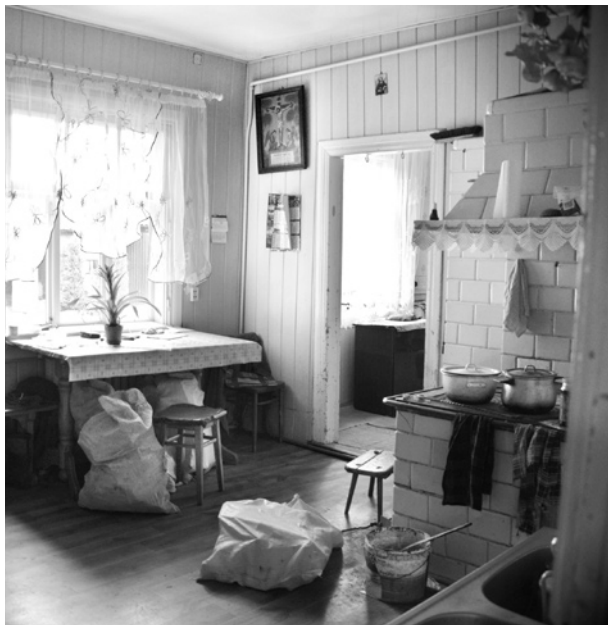
Fig. 12. The kitchen; photo by the authors, 2018
Ryc. 12. Kuchnia; fot. autorzy, 2018

Firstly, the most important room in the very center of the house is the kitchen, which inherits many functions of the old *izba*, serving as the room for everyday activities of the whole family and adjoined by 5 other rooms (fig. 12).

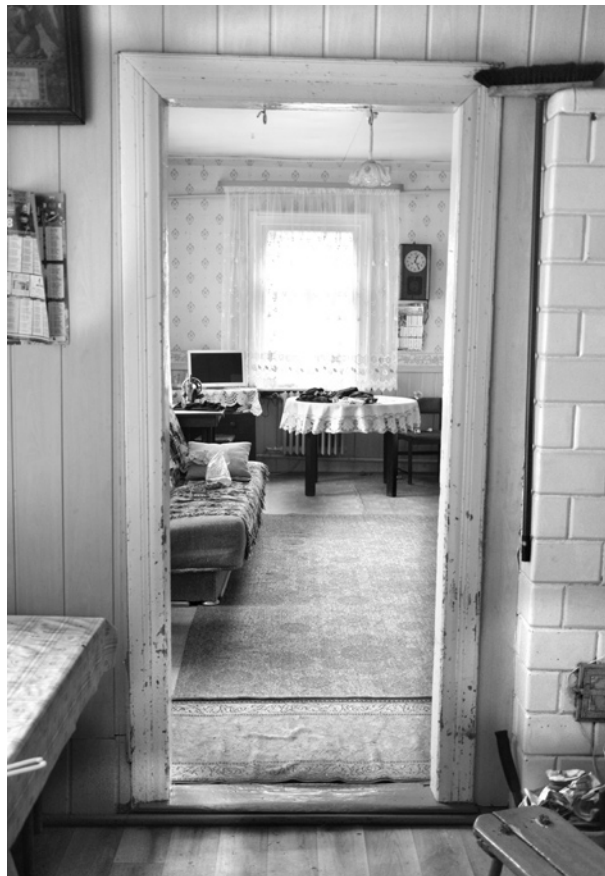
Fig. 14. A view from the kitchen towards the living room, with kitchen stove as the boundary; photo by the authors, 2018
Ryc. 14. Widok z kuchni na jeden z pokoi (granicą obu pomieszczeń jest piec); fot. autorzy, 2018

Thirdly, the multi-purpose stove is surrounded by an enfilade of rooms. Admittedly, a layout where the stove organizes all the surrounding enfilade spaces seems relatively common for vernacular dwellings in many regions or even countries of the cold climate; nevertheless, the placement of the stove and its functional and aesthetic significance in the home interior are still somehow unique, allowing the role of the stove as the dominant, the center, the „heart” of the house, the organizer of space, the symbolic and physical boundary between the rooms and spaces, etc. (fig. 14).

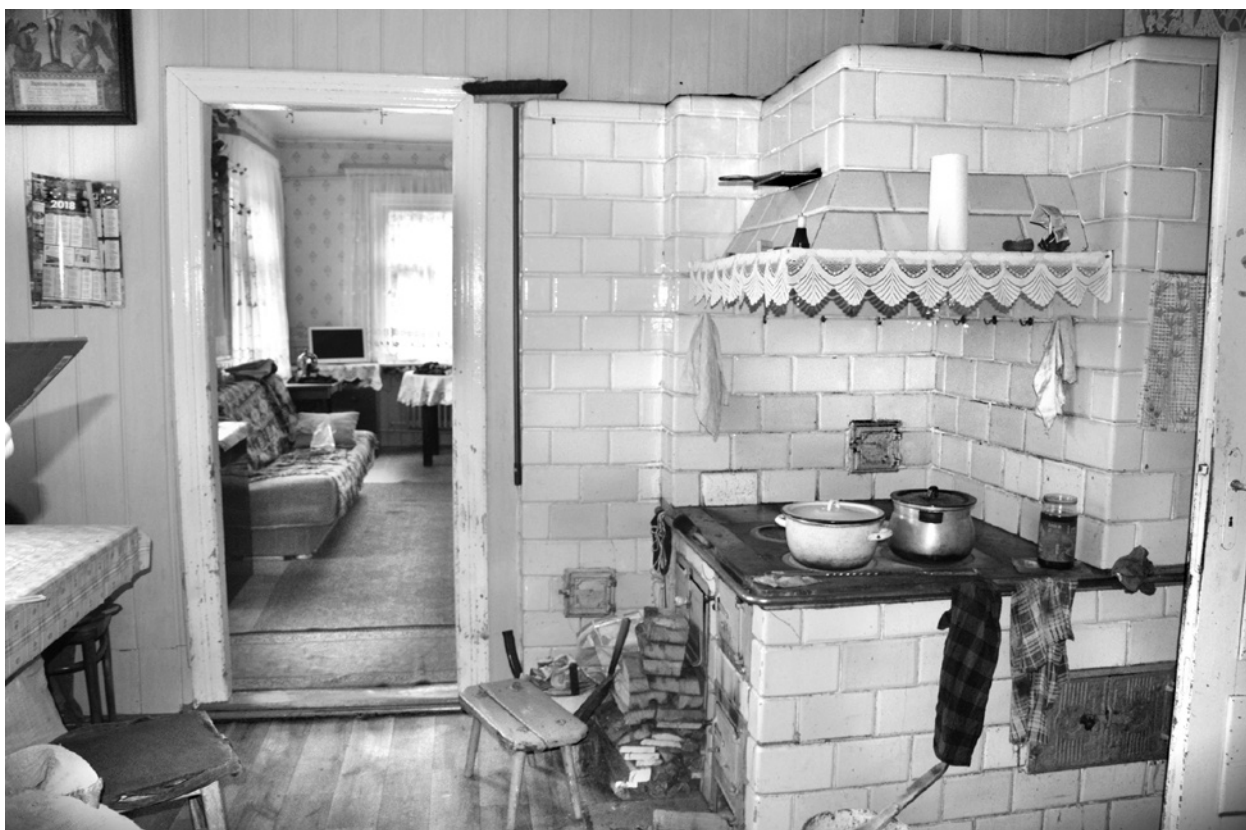
Fig. 13. The main kitchen stove and oven; photo by the authors, 2018
Ryc. 13. Piec kuchenny wielofunkcyjny; fot. autorzy, 2018

An essential element of the kitchen, and of the whole house, is a massive multi-purpose stove and oven (fig. 13), located in the center of the house to en-

able the heating of the four adjoining rooms directly. Nevertheless, an indirect central heating system was also added in the 1980s. The central heating system is fed by a multi-purpose kitchen stove with an adjoining bakery oven.

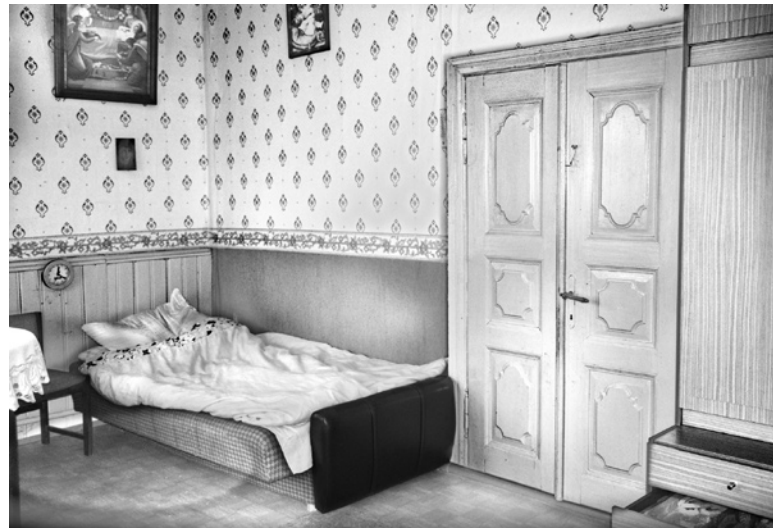
Fig. 15. A “festive room”, serving for sleeping at night and for ceremonial needs occasionally; photo by the authors, 2018
Ryc. 15. Pokój służący nocą za sypialnię, faktycznie zaś stale utrzymywany w odświętnym wystroju; fot. autorzy, 2018

occasional ceremonies, being unused on weekdays, or serving as sleeping rooms at night only. This is also the case for rooms nos. 5, 6 and 7, of which only room no. 6 serves for sleeping, if needed (fig. 15). All three rooms are embellished with devotional souvenirs and ornamental textiles, as well as wallpaper (rooms nos. 5 and 6) or plentiful potted plants (room no. 7). As a rule, almost every aesthetically important piece of furniture is covered with a piece of textile: a doily, a tablecloth, a lace curtain, a drapery, a carpet or a coverlet (compare [Marzec P. et al, 2016]; fig. 16, 19 and 25). Even tile stoves, or at least their hoods, tend to be adorned with lace curtains (fig. 13 and 23).

Devotional souvenirs are usually placed near sleeping beds (fig. 15) or above tables (fig. 16).

Furniture and devices are movable. However, there is also a system of immovable locations and items that adorn the house and its interior. On the external façade, there are corners, windows and cornices that accumulate adornments. Similarly, there are also some aesthetically pivotal places inside; namely, windows (decorated with a surplus of lace curtain), tables (fig. 16), tops of wardrobes (fig. 17), wall friezes (fig. 15) and doors (fig. 15-17, 19 and 22).

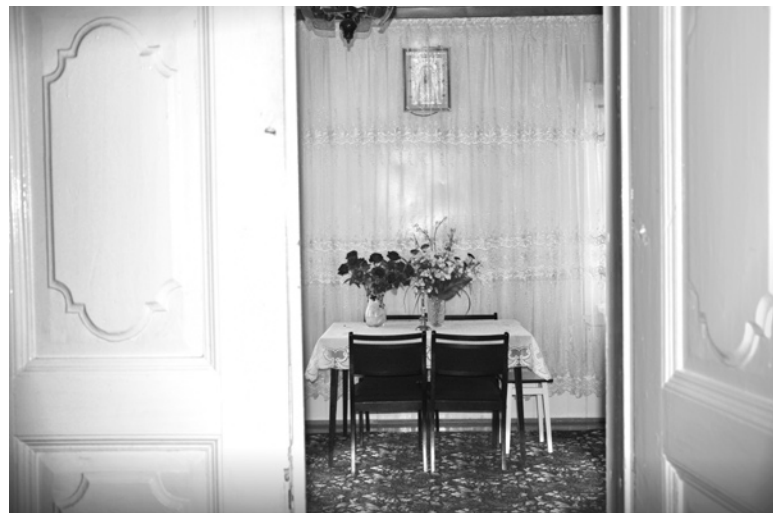
Fig. 16. A “festive room”; photo by the authors, 2018
Ryc. 16. Pokój odświętny; fot. autorzy, 2018

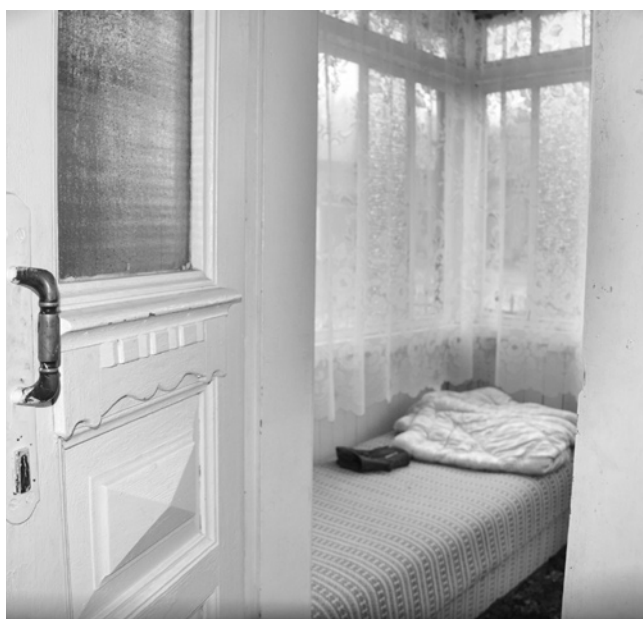
Fig. 19. Inside the front porch; photo by the authors, 2018

Ryc. 19. Wnętrze werandy frontowej; fot. autorzy, 2018

The front porch was the original annex of purely festive nature and showy aesthetics (fig. 19, 20). Although comprising a sofa inside, it does not serve for sleeping. According to the inhabitants, the porch, being the most exposed towards the public street, should also be the most showy of all the rooms. Its aesthetic uniqueness was achieved thanks to large stained-glass windows, a white lace curtain and vividly painted pieces of woodwork and clapboarding outside.

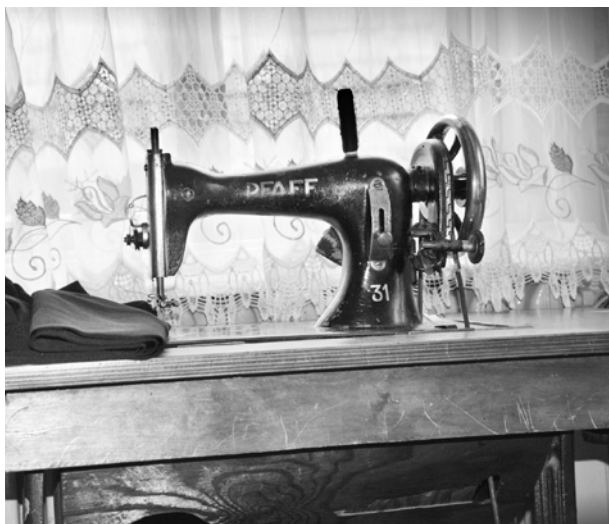
Fig. 21. An old sewing machine (PFAFF model 31, manufactured in G.M. PFAFF A.G. Kaiserslautern between 1916-1933); photo by the authors, 2018

The old pieces of furniture or utility devices, such as the sewing machine (fig. 21) or the old wardrobe (fig. 23), bear witness to the continuous transition between the old and the new, because while aging, such devices, though ceasing to serve as tools or practical pieces of furniture, still acquire new aesthetic mellowness and are gradually becoming purposeful elements of the internal aesthetics of the house.

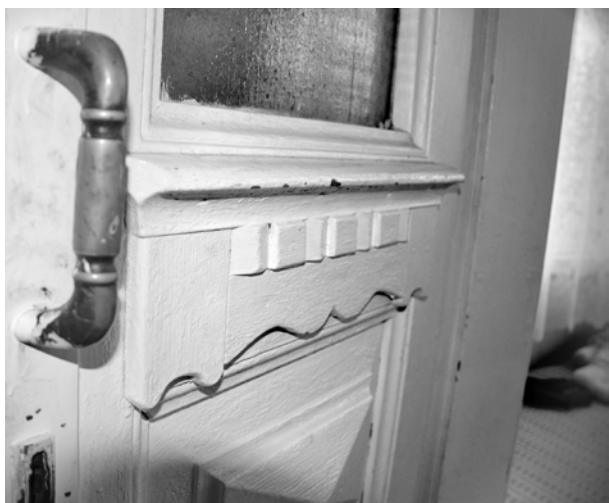
Fig. 22. A piece of decorative door woodwork; photo by the authors, 2018

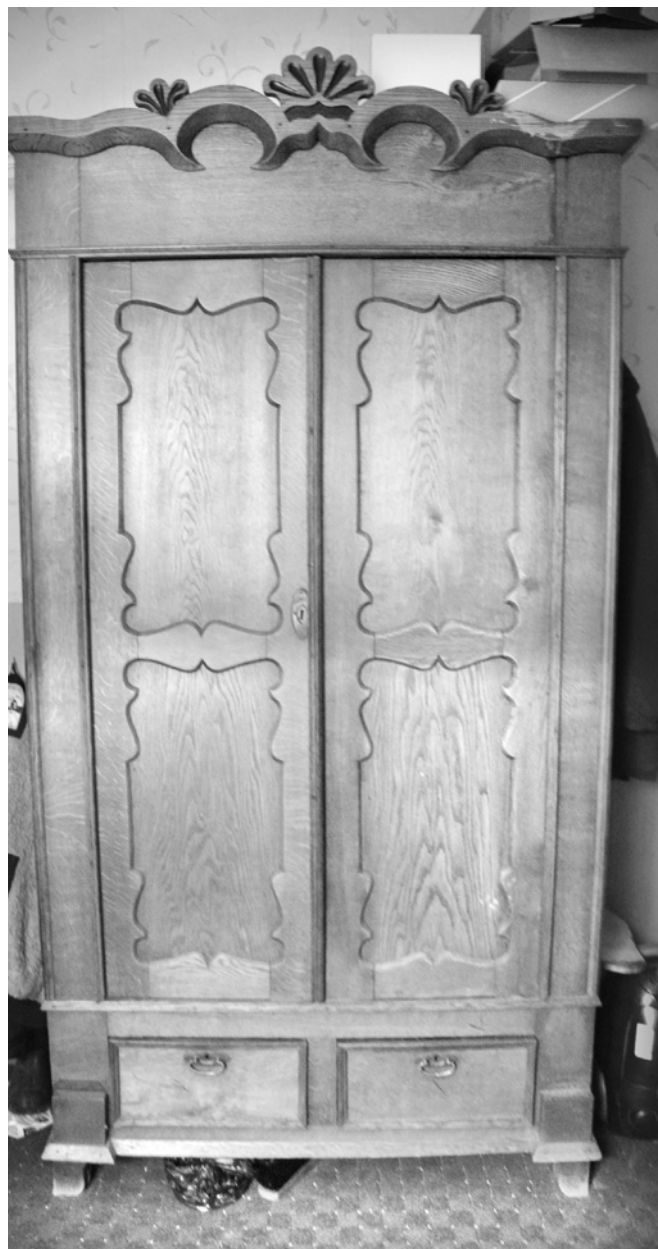
Ryc. 22. Drzwi ozdobnej stolarskiej roboty; fot. autorzy, 2018

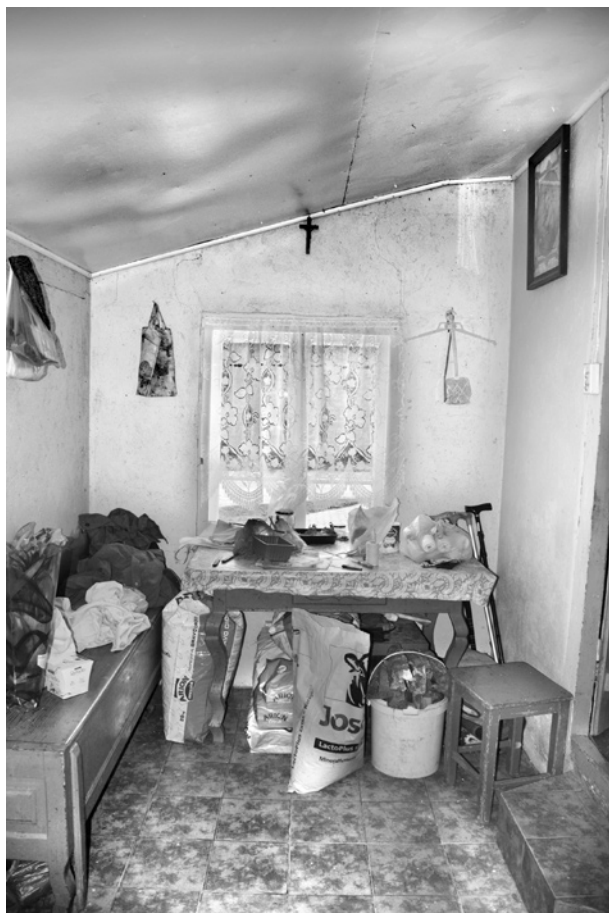
Fig. 23. The old wardrobe in room no. 10; photo by the authors, 2018

Ryc. 23. Stara szafa ubraniowa w pokoju nr 10; fot. autorzy, 2018

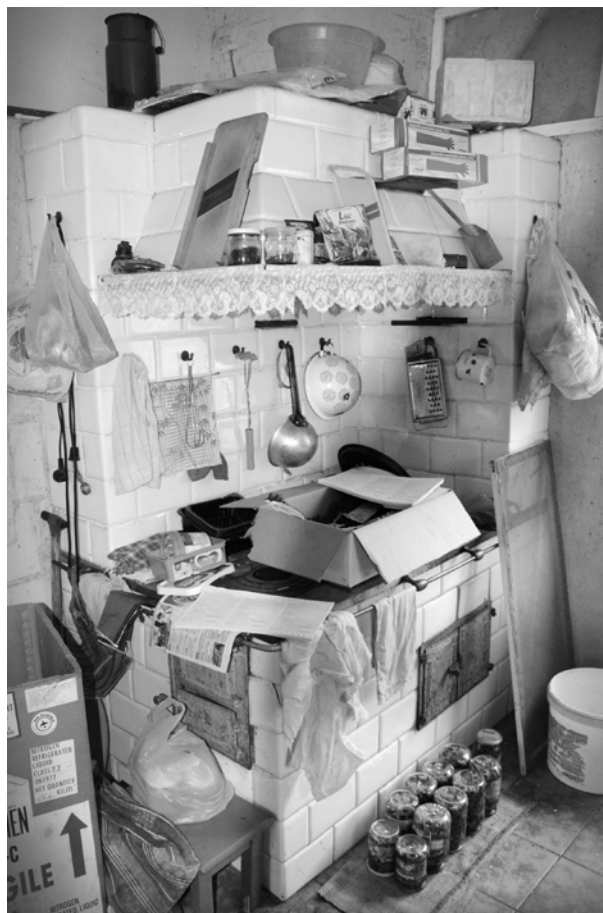
Fig. 25. The second multi-purpose stove in the auxiliary kitchen in the back porch annex; photo by the authors, 2018

stoves because stoves used to testify to the wealth and prestige of their owners and were associated with glamour. Here, stoves are not so huge, but there are two of them.

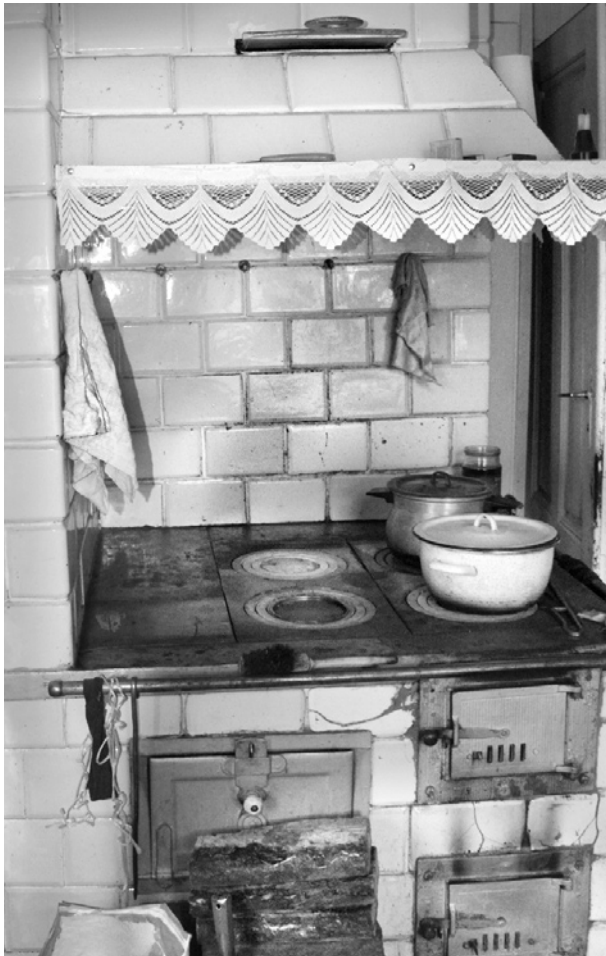
Fig. 26. The main kitchen stove; photo by the authors, 2018
Ryc. 26. Główny piec kuchenny; fot. autorzy, 2018

The key role of the kitchen stove as a ‘functional node’, i.e. an assembly of functions and equipment for heating, cooking, baking, storage, organizing space – reflects the aesthetics of the stove, as well, and sometimes makes it the most carefully adorned element of the interior. Here, it is not the case; nevertheless, there are still some remnants of textile ornamentation on both the main kitchen stove (fig. 13 and 26) and on the auxiliary one (fig. 25). Their white tile cladding became an aesthetic standard of the past decades, and in a number of villages and small towns, stove fitters purposefully assembled enormous

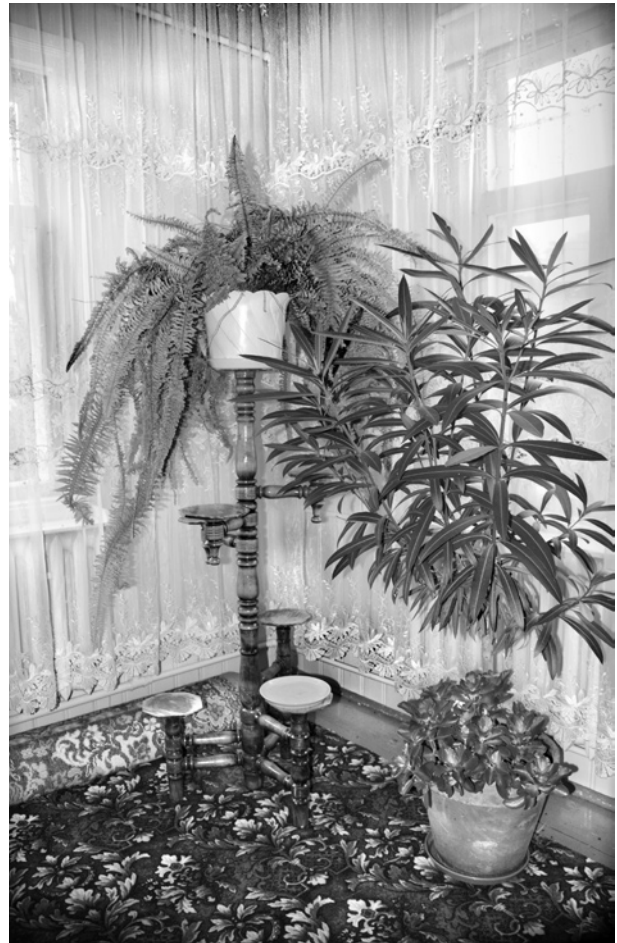
Fig. 43. Fragment of carefully laid out permanent artistic arrangement in a representative "festive room" (room no. 5); photo by the authors, 2018

And paradoxically, the house in Ostra Góra reflects both the opposite trends. Its interior is, in general, highly cumulative, but its owners tried to exclude some rooms and minor spaces, maybe unwittingly, as either *enclaves of tradition*, or – true or alleged, recent or obsolete – *enclaves of modern fashion* (fig. 43, 44, 45).
