LESZEK ZIĘTKOWSKI
JANUSZ MŁYNARCZYK
WOJCIECH SOBOLEWSKI

Optimization test of operation of URB/ZS-3 automatic machine for breaking oversized lumps under conditions of Polkowice-Sieroszowice mine

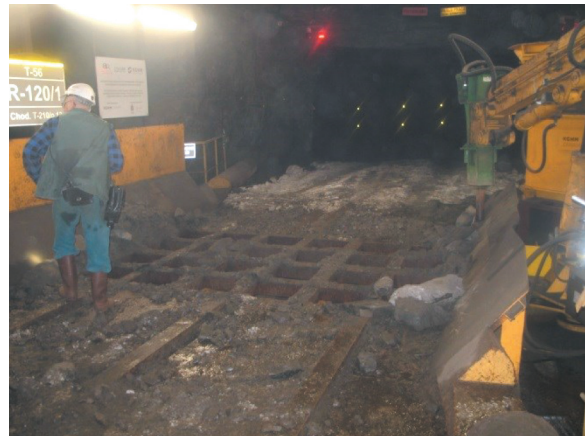
Fig. 1. Method of installation of URB/ZS-3 in Polkowice-Sierszowice mine

The prototype of the URB/ZS-3 automatic lump breaker was installed on the discharge point in the Polkowice-Sierszowice mine in drift T-210/crut P 13 with an R-120/1 discharge grate onto an Legmet L-120 conveyor. The installation of the machine is shown in Figure 1, and a diagram of the discharge point is shown in Figure 2.

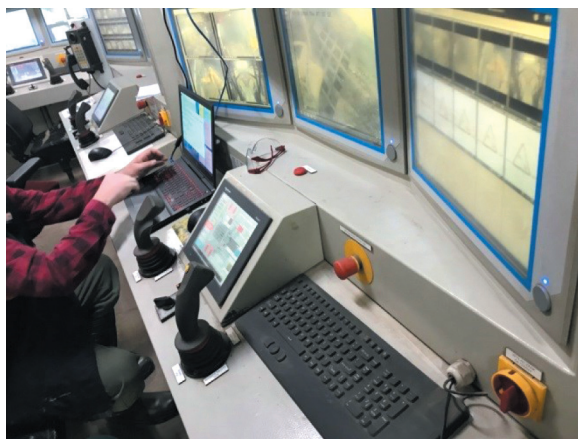
Fig. 3. Remote control console in SK-2 control room on shaft bottom of SW-1 shaft

At the same time, the URB/ZS-3 control station equipped with a remote-control console and control cabinets enabling remote work on the grate were installed in the SK-2 control room on the shaft bottom of the SW-1 shaft. The method of installation in the control room is shown in Figure 3.

The control room has access to the monitoring of the R120/1 grate, allowing for control of the entrance signaling (thanks to which, it is possible to cooperate with an operator of a haul truck).

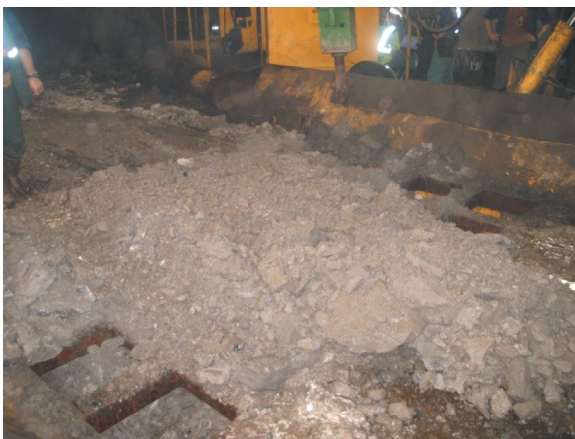
Fig. 4. Grate after LKP-0903 loader has unloaded excavated material

An example of a grate before cleaning is shown in Figure 4. About 7 Mg of excavated material with fine characteristics was delivered to the grate. Figure 5 shows the grate after cleaning with the URB/ZS-3 automatic lump breaker. The degree of clearing the grate was considered satisfactory.

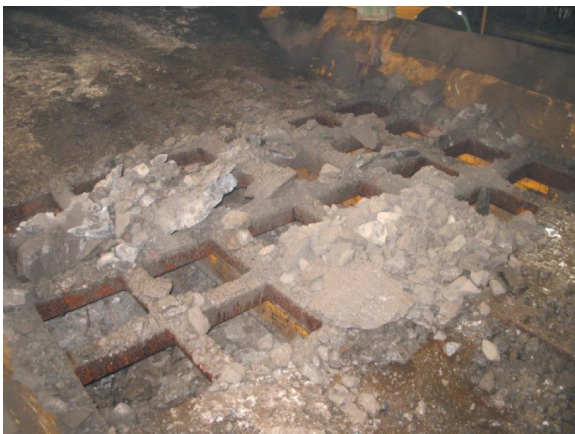
Fig. 5. Grate after URB/ZS-3 has automatically cleaned it
