## INITIAL ASSESSMENT OF THE QUALITY OF ROAD SURFACES

**Purpose:** The aim of the article is to check the quality of the road and classify the selected road on a four-level scale.

**Category of the paper:** Case study.

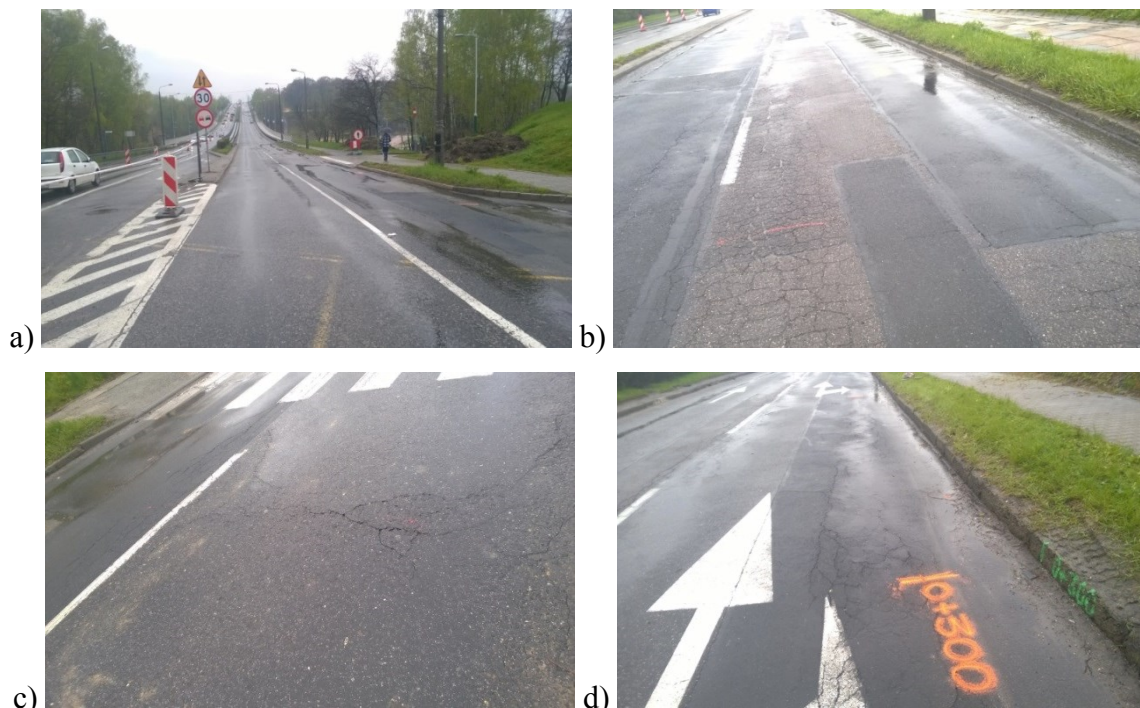
The road has two roadways with two lanes for each direction (Figure 1a). The preliminary visual assessment of the road shows that the dynamics of pavement degradation is advanced, significant damage to the pavement is visible, including mesh cracks and patches (Fig. 1b), transverse cracks along the entire width of the road (Fig. 1c) and longitudinal cracks (Fig. 1d).

**Figure 2.** Fragment of Matuszczyka Street in Wodzisław Śląski a) general view, b) mesh patches and cracks in the pavement, c) transverse crack, d) longitudinal crack (own elaboration).

The identified patches on the first section of the road under study (section marked 0 + 000 - 0 + 100) were assessed as high harmfulness, cracks were found at the joints of the patches with the remaining pavement. Patches occupy more than 50% of the width of the lane. The dimensions of the battens shown in Figure 1b were determined using the STANLEY

0-35-458 wooden measure. The batten shown in Fig.1b on the right side has dimensions of  $0.3 \text{ m} \times 0.6 \text{ m}$ , and the batten on the left –  $1.2 \text{ m} \times 6 \text{ m}$ . The remaining battens on the tested road section were measured similarly. The total area of battens on the 100 m road section is  $36.90 \text{ m}^2$ .

In the next stage of the research, mesh cracks were assessed, which were also classified as high harmfulness. The examination of the pavement revealed the presence of loose pavement pieces in the area of mesh cracks. Registered changes amounted to less than 50% of the width of the assessed lane. The pavement area with all identified mesh fractures on the tested road section was  $22.5 \text{ m}^2$ . Next, the damage was scored using the formula (1). After substituting the obtained measurement values and coefficients for the degree of harmfulness defined as high, the following results were obtained: for pavement damage in the case of patches  $P_{ij} = 49.85$  and for a mesh crack  $P_{ij} = 47.1$ .

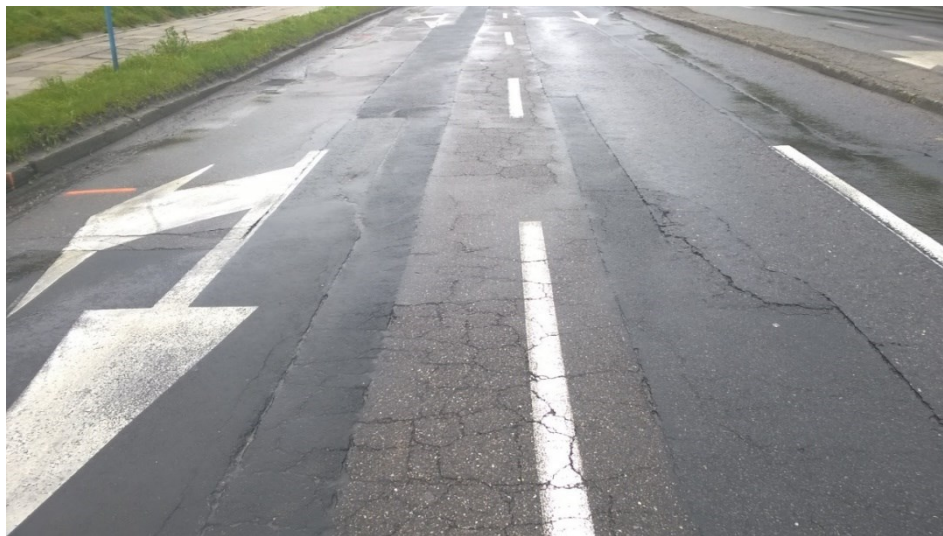
**Figure 3.** Patches and cracks on the section (0 + 300 - 0 + 400) of the tested road (own elaboration).

In the last section of the road marked (0 + 300 - 0 + 400) there are patches, mesh cracks and longitudinal cracks (Fig. 3). All the damage due to its nature and the area occupied was classified as damage of high harmfulness. The number of patches on the tested road section was 5 with a total area of 31 m<sup>2</sup>. Cracks were found between the patches and the surface. The calculated damage score, in accordance with the formula (1), was  $P_{ij} = 47.07$ . The length of longitudinal cracks was measured on the tested section of the road, the length was 24 m. The score for these damage was  $P_{ij} = 34.43$ . In addition, mesh cracks with a total area of 41 m<sup>2</sup> and a width exceeding 50% of the lane width were identified. For mesh cracks, the calculated damage score was  $P_{ij} = 54.72$ .
