**Maciej Pawlikowski\***<sup>I</sup>

## **Examination of the patina coating of natural Theban limestones as well as blocks of Hatshepsut Temple, Upper Egypt.**

**\*/** Institute of Mineralogy, Petrography and Geochemistry, University of Science and Technology – AGH, Cracow

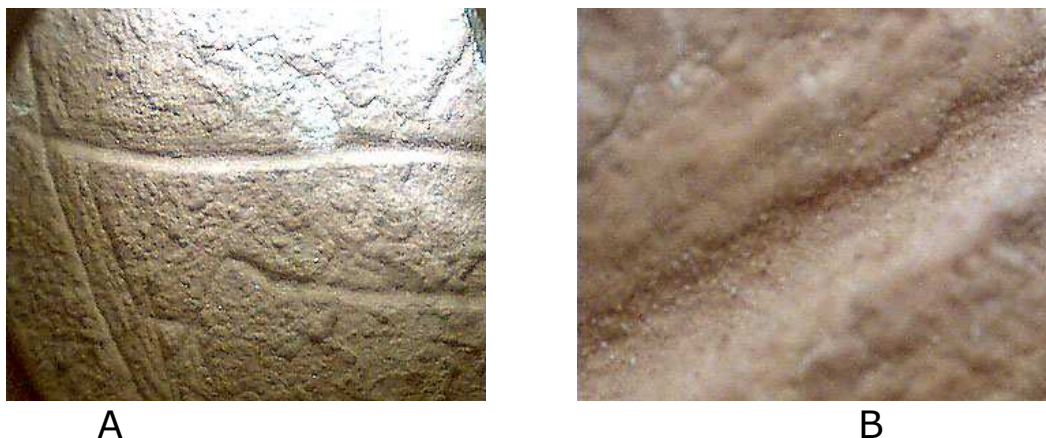
A thin groove of a signature of Butehamon cut on a natural surface of limestone is primary old and thick patina (Fig. 2A, 2B). This groove cut about 3100 years B.P. has been secondarily patinated. This fact documents that the patina over the groove was formed about 3100 years B.P. i.e. is 3100 years old.

Fig 2 A – A fragment of groved lines of signature of Butehamon. Digital microscope, magnification 5 x. B – single patinated line of signature of Butehamon. Digital microscope, magnification 50 x.

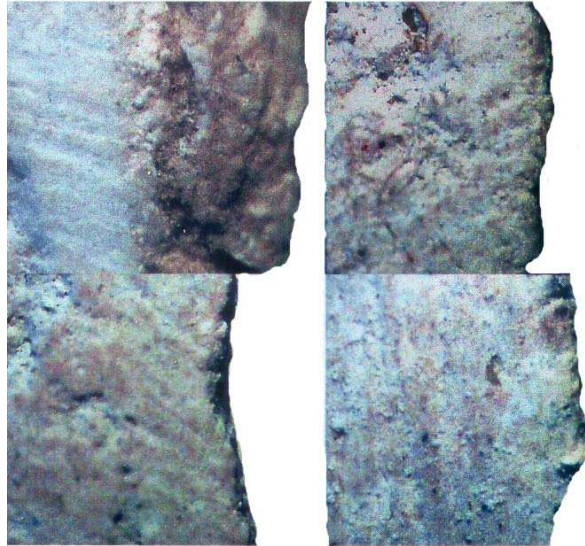
Microscopic observation of patinated surfaces of limestone blocks is shown in fig. 5.

Fig. 5. Various patinated coatings of four examples of limestone blocks from the Hatshepsut Temple. Digital microscope, magnification 5 x.

The general thickness of the patina is about 0.3-0.5 mm. The thickness of the patina of tested blocks is listed below:

Sample K1	- patina - 850 $\mu\text{m}$
Sample K2	- patina - 260 $\mu\text{m}$
Sample K3	- patina - 20 $\mu\text{m}$
Sample K4	- patina - 70 $\mu\text{m}$
Sample K5	- patina - 30 $\mu\text{m}$
Sample K6	- patina - 20 $\mu\text{m}$
Sample K7	- patina - 90 $\mu\text{m}$
Sample K8	- patina - 80 $\mu\text{m}$
Sample K9	- patina - 150 $\mu\text{m}$
Sample K10	- patina - 110 $\mu\text{m}$
Sample K11	- patina - 100 $\mu\text{m}$
