## EVALUATION OF THE STATE OF STRESS IN STRUCTURAL COMPONENTS OF A SCREEN SEPARATOR

This study summarises the results of FEM analysis of the state of stress generated in structural components of a PZ3R screen separator under the typical operating conditions. Simplifications underlying the numerical analysis were verified by measuring the stresses in selected parts of the machine.

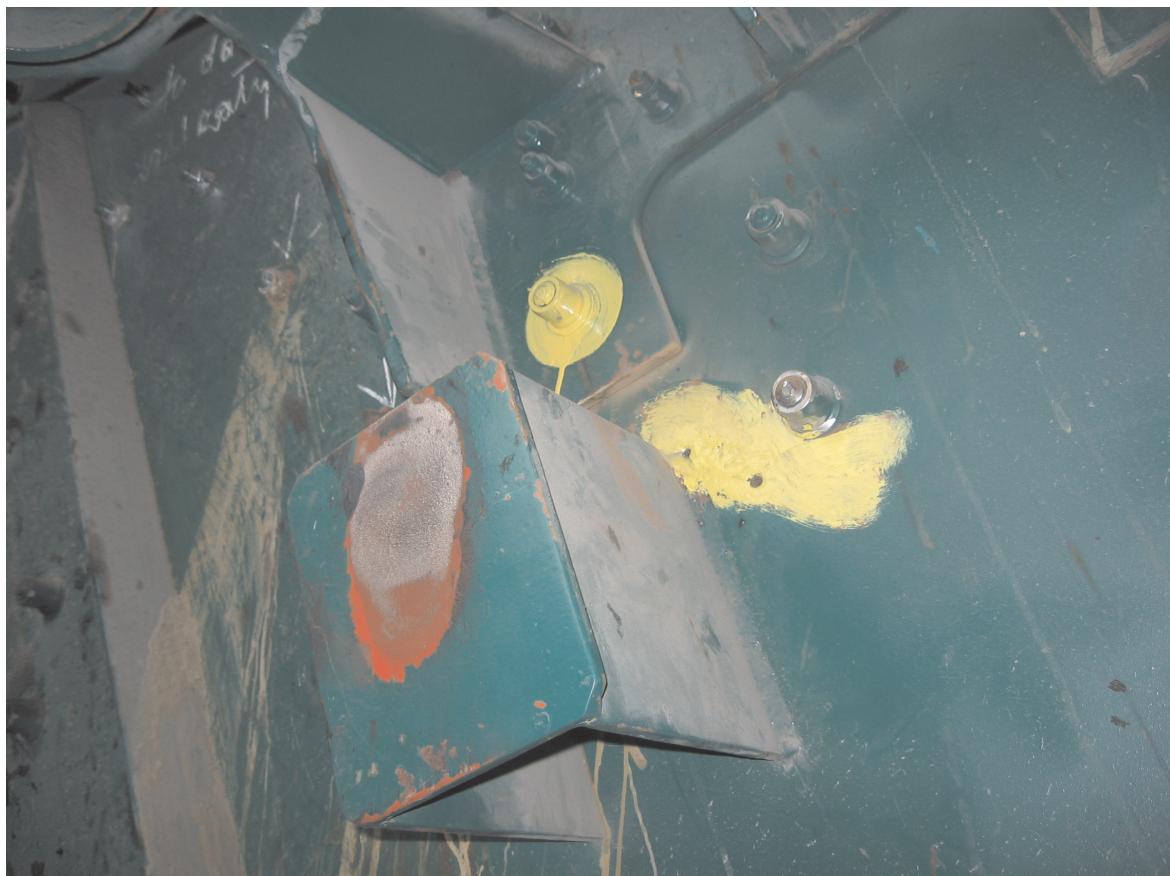
Fig. 2. Fractures in the regions of the sieve sideboard support, damaged HuckBolt bolts

- breaks in the area of the sieve sideboard support (Fig. 2),
- lasting deformation of the support (Fig. 3).

Attempts were made to restore the separator's operational efficiency through strengthening the most vulnerable points, yet the improvements were only temporary.

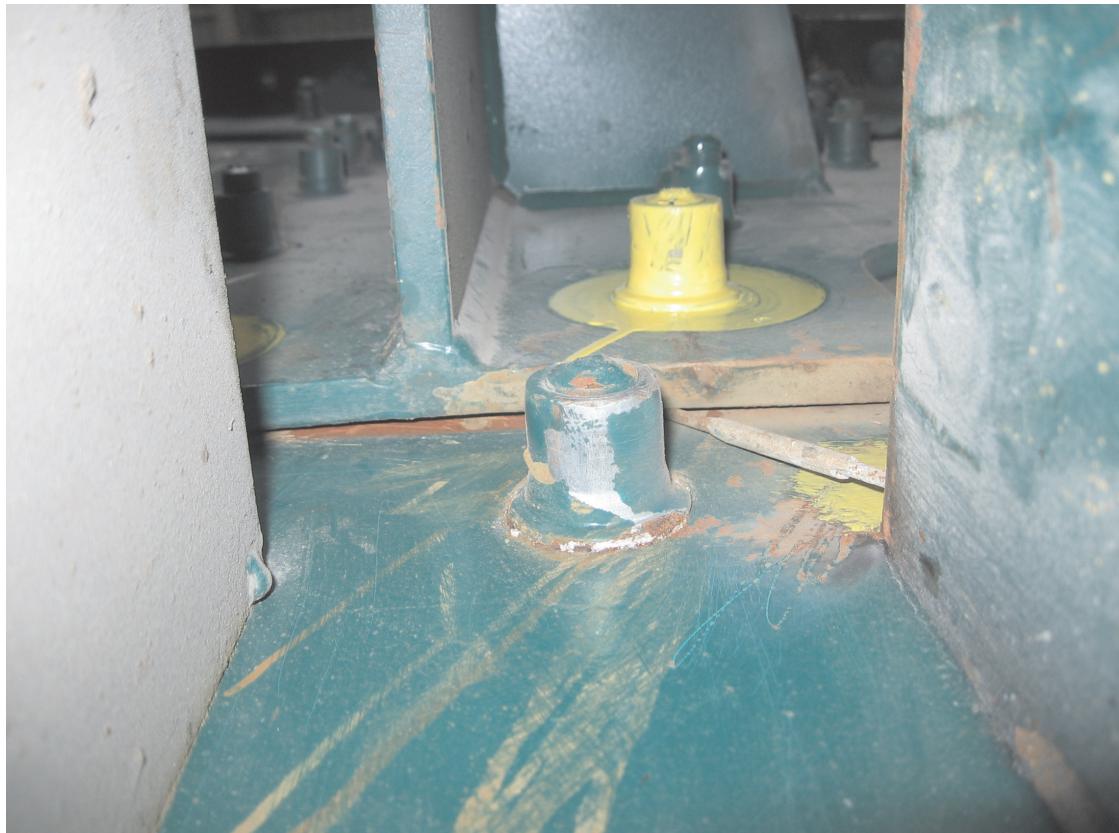
**Fig. 3.** Lasting deformation of the support

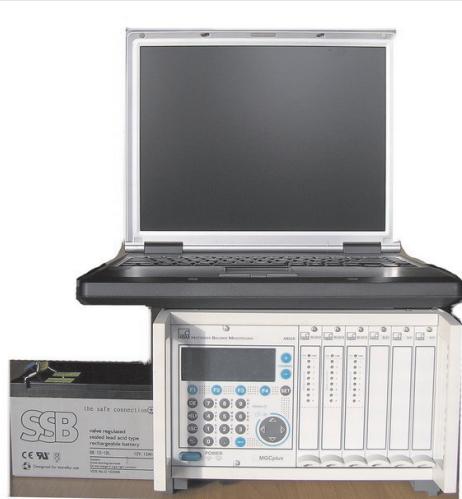
**Fig. 9.** Equipment used in strain measurements in the screen separator PZ3R

Measurements were taken with the bridge system HMB MGCPlus, adapted to handling measurements with the use of resistance and induction sensors. The bridge was connected to a portable computer (or laptop) supported by

the professional program "Catman" (HMB), which registered the signals from the sensors. The measuring equipment is shown in Figure 9 (Wolny *et al.* 2009).

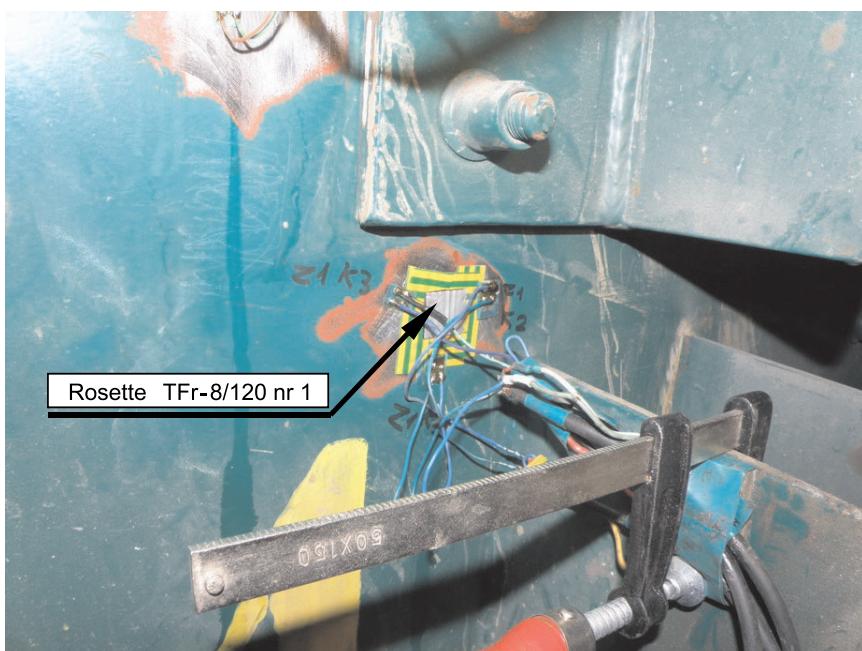
Fig. 11. Rosette 1 mounted in the bottom part of the separator's lower support

Strain rosettes were located around the attachment point of the lower support, three rosettes on each side of the structure. Delta rosettes 2 and 4 were mounted in the side section of the lower support (Fig. 10). Delta rosettes 1 and 3 were mounted in the bottom part of the lower supports (Fig. 11). In the upper part of lower supports are double-sensor rosettes (5 and 6), shown in Figure 12. Each strain gauge was temperature-compensated.
