*Joanna Pinińska \**, *Andrzej Domonik \**

## ROCK MINING INDUSTRY IN HISTORY. GEOSITES AND GEOLOGICAL AND ENGINEERING ASSESSMENT THEREOF

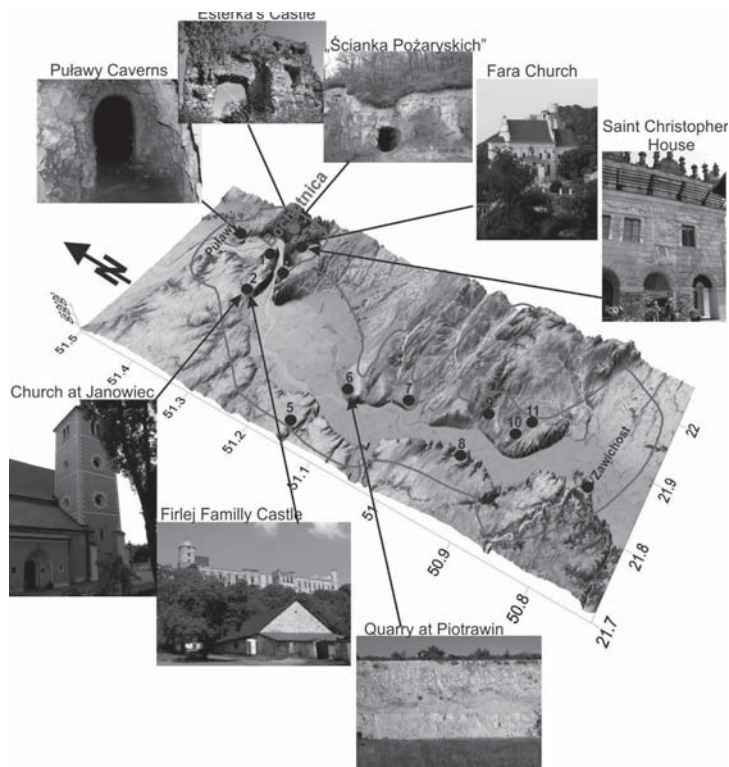
**Fig. 1.** Examples of locations of rock mining remnants and relation thereof with local architectural objects. 1 — Nasiłów, 2 — Janowiec, 3 — Kazimierz Dolny, 4 — Podgórz, 5 — Dziurków, 6 — Piotrawin, 7 — Józefów nad Wisłą, 8 — Nowe, 9 — Świeciechów, 10 — Annapol, 11 — Gościeradów. Grey line limits area of Geopark

The establishment of Geopark in the Vistula River Valley, with a number of geosites included, will be protected from the oblivion of the unique traces of the mining and construction trade with their roles in shaping the natural, settlement, and architectural spaces within the region (Fig. 1).

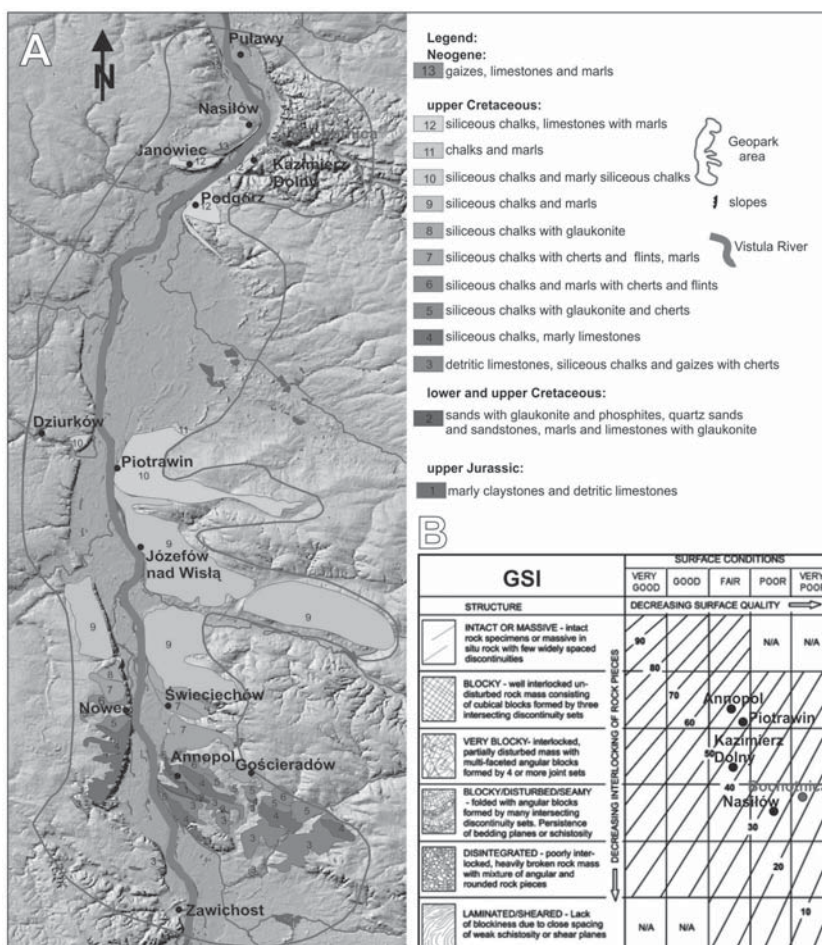
Fig. 2. Geosite locations against the geology map (A) with rock mass feature assessment for selected geosites (B) in their vicinity

Figure 2 shows the general characteristics of rock massif, against the geological structure at geosite areas, with examples of the valorisation in the GSI system (Geological Strength Index [3]).

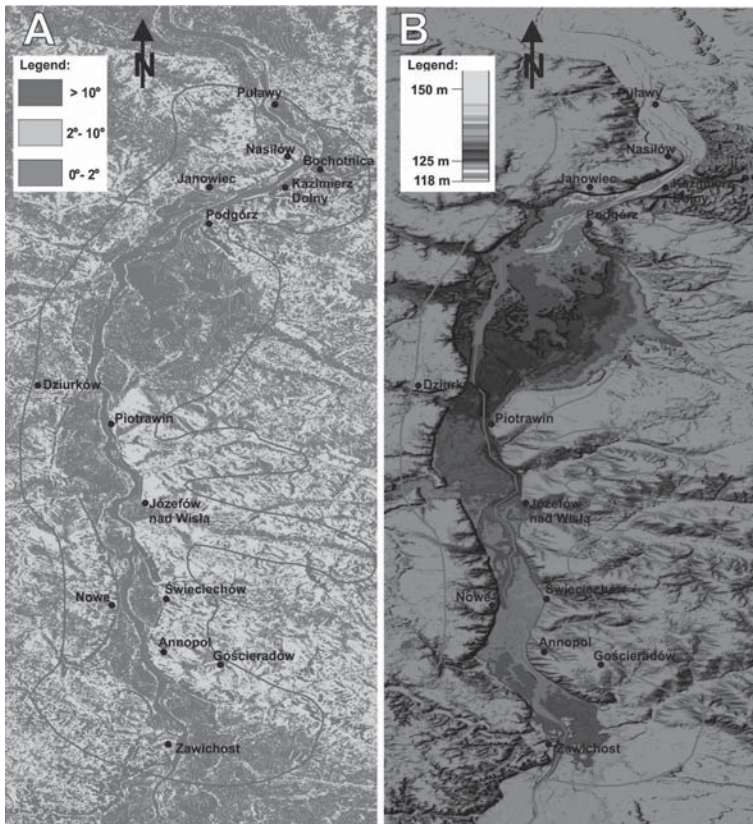
**Fig. 3.** Examples of data for assessment of geological and engineering conditions geosites. A — slope angle map. B — potential hazard map — for flooding due to flood water accumulation within the Vistula gorge section (map reproductions do not feature cartographic properties)

Figure 3A shows the location of geosites against the slope angle, in division in classes as follows: small inclination ( $0-2^\circ$ ), medium inclination ( $2-10^\circ$ ), steep ( $>10^\circ$ ) with the valley edges indicated and against the potential flooding hazard in case the flood wave would accumulate in the Vistula gorge section, that accumulation being shown in figure 3B for each

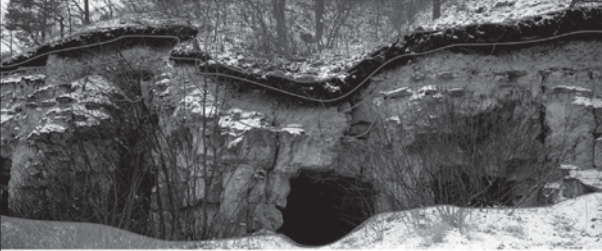
GEOMECHANICAL ASSESSMENT SHEET			
Designation		Bochotnica	
Coordinates		Φ 51 20 35 N      Δ 21 59 34 E	
WEATHERING PROFILE

FIELD TESTS			
ROCK MASSIF ACC. TO PN-EN 14689-1:2006		ROCK FISSURITY ACC. TO PN B-02480	
Description		linear	
rock type	sedimentary, siliceous-carbonate, siliceous chalk with bioclasts	per surface unit	12 mb
massif structure	massive, layers	per volume unit	6,95 m/m <sup>2</sup>
Discontinuities		per volume unit	2,58 m <sup>2</sup> /m <sup>3</sup>
layer thickness	thin, thick	class	III - intensely cracked, IV - very intensely cracked
discontinuity spacing	medium	ROCK MASS RATE IN POINTS-RMR (ACC.TO BIENIAWSKI)	
rock block size	medium	strength Rc	15 MPa
block shape	polygonal blocks	RQD	40%
discontinuity opening type	from partly opened up to very wide	discontinuity spacing	10
discontinuity fill material	clay filler, stone rubble	ground water	0
water content	small	discontinuity type	0

rock mass weathering	grade 3 - very weathered	discontinuity orientation	-60
		sum (per 100)	15
		class	V - very weak massif
LABORATORY TESTS			
NATURAL STATE		MICROSCOPIC IMAGE FOR NATURAL STATE	
bulk density (PN-EN 1936)	1460 kg/m <sup>3</sup>

porosity (PN-EN 1936)	40%		
bulk water absorption (PN-EN 13755)	37%		
abrasion (PN B4/B-04111)	4,5 mm		
uniaxial compressive strength (PN-EN 1926)	15 MPa		
Young modulus (ASTM D 3148-02)	4 GPa		
Poisson's ratio (ASTM E-132)	0,12	DIGITAL ANALYSIS OF POST-SALT CRYSTALLIZATION	
DETERIORATION SUSCEPTIBILITY ASSESSMENT

swell (expansion)	0,11%		
skurcz	0,09%		
frost resistance (PN-EN 12371)	good		
salt-induced deterioration index (I)	0,8-0,9

Fig. 4. Geosite geomechanical properties assessment sheet

with geological and engineering condition maps and with other documentation. An example of the Geomechanical Assessment Sheet for the medieval underground siliceous chalk mine at Bochothnica is shown in Figure 4.

Both the data contained in the Assessment Sheet and the field data are indicating that the Bochothnica mine roadside, ceiling and floor are located in the monolithic zone of the weathering profile. The massif is graded as intensely cracked and very intensely cracked, very weathered, but dry in practice. Cracks filled with a clay material located inconveniently towards the outcropped walls. According to the Bieniawski [2] grading system (complying with PN-EN 14689 requirements), the massif around the mine headings is graded V – very low strength. The geomechanical lab tests for monolithic zone material samples indicate that those rocks are very light, of high porosity and low strength. Nevertheless, those rocks feature a low susceptibility to frost and moisture as well as to anthropogenic corrosion-inducing factors like salt, swell and shrink. Their micrite structure, having a content of small-size Foraminifera and silica sponge needles, is of a low susceptibility to microcracking, which impedes aggressive solution circulation and corrosion centre growth. On the other hand, the GSI provides us with reasons for forming a conclusion that the Bochothnica Geosite (so-called “Ścianka Pożaryskich”) is located within an unfavourable conditions zone due to the very bad technical status of the massif, and due to the  $> 100$  slope angle creating a slope stability hazard.
