## **WEAR OF WORKING ELEMENTS MADE OF HADFIELD CAST STEEL UNDER INDUSTRIAL CONDITIONS**

Hadfield cast steel, crusher hammers, structure of cast steel, wear in service.

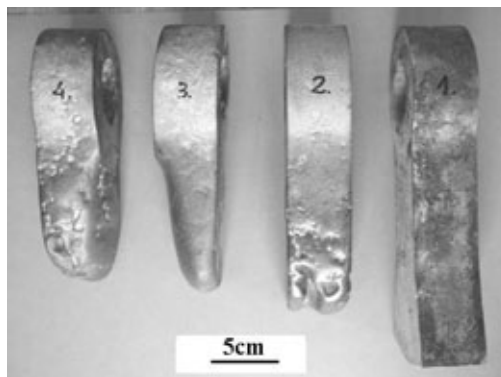
The wear of the hammers operating under real service conditions was observed to proceed in two phases. The first phase involves uniform, relatively slow loss of the material. Then after approx. 3-5 mm layer of the material is ground off, a catastrophic degradation occurs. It is particularly clearly seen in the zones corresponding to the geometric parting plane. The effects of wear are shown in the photographs, Figs 5 and 6.

Fig. 5. A view of crusher hammers after service tests (1- at the delivery state, 2-4 after service)

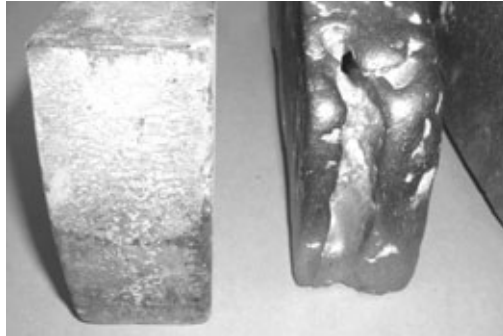
Fig. 6. A view of crusher hammers after service tests (the first hammer on the left – the delivery state, the other - after two months' in service)
