ACOUSTIC EXAMINATION OF EPOXY-GLASS INSULATOR MATERIAL

P. RANACHOWSKI, Z. RANACHOWSKI, F. REJMUND

Ultrasonic, microscopic and acoustic emission (AE) methods were applied to investigate the microstructure of composite rods, used as a carrying element of the medium voltage insulators. Such features of material structure as homogeneity level and the appearance of defects were discussed. The research was aimed at determining the influence of the technology of epoxy-glass fabrication on quality parameters of the insulator rods. The results of acoustic testing were compared with the effects of microscopic investigation.

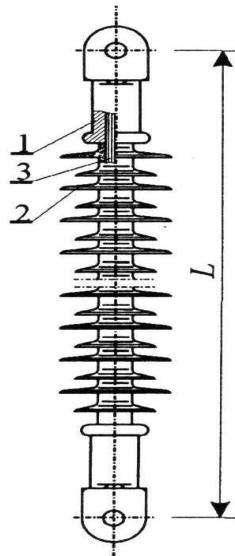
Fig. 1. The typical line composite insulator: 1 – metal fixing devices situated at both ends, 2 – the polymer cover with formed sheds, 3 – the glass-epoxy carrying rod [4].

The typical line composite insulator consists of three elements, as it is shown in Fig. 1: metal fixing devices situated at both ends; the polymer cover with disc sheds and the glass-epoxy insulating rod. The rod acts as a hard core to endure the mechanical load and voltage gradient. The synthetic rubber cover with sheds ensures the desired leakage path and rain spark-over voltage [3, 4].

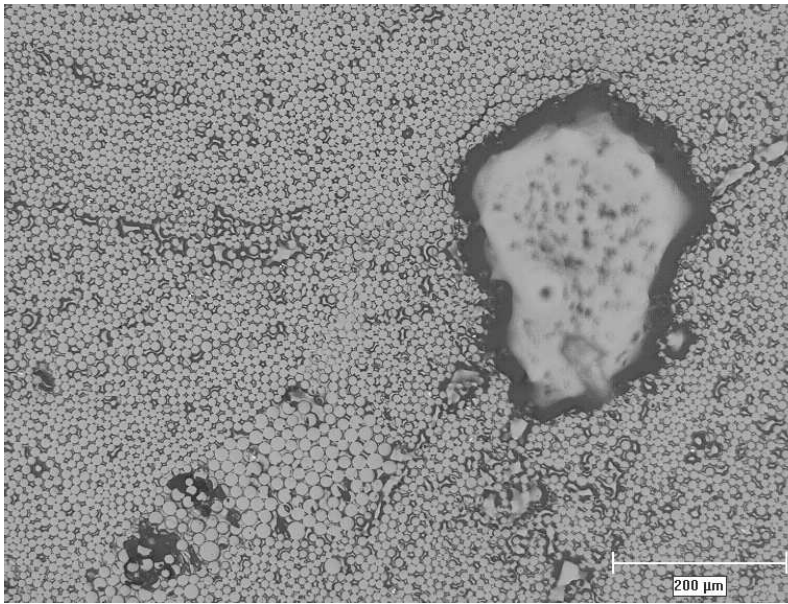
Fig. 2. An example of great pore cavity and other inhomogeneities found in epoxy-glass insulator rod of elder generation. Magnification $\times 50$.

The microscopic analysis revealed sufficient homogeneity of both composite materials. No major pore cavities and surrounding crack areas were noticed. These kinds of defects have been found in epoxy-glass insulator composites of older generations – Fig. 2. It has been found a little poorer roving filling of the matrix and more areas with no roving contents in samples of type A. The maximal pore diameters were approximately calculated to some scores of micrometers in both compositions. In composition A a small pore amount was detected. In material B the contents of pores was even smaller. The average fiber roving diameter in composition A was 11.2 μm , while in composition B the average fiber roving diameter was 6.3 μm , with remarkable presence of a population of greater fibers – analogous to those used in composition A. In both materials were revealed the cracks situated along the fibers.

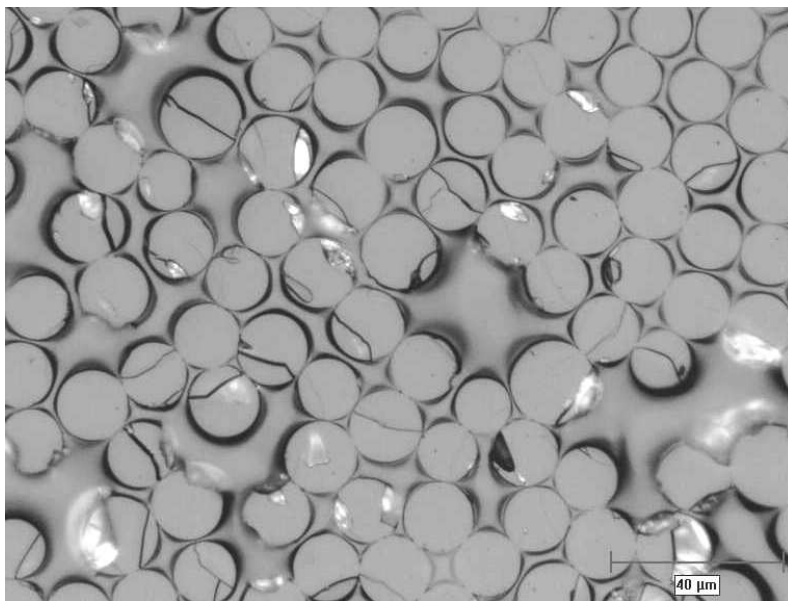
Fig. 3. The typical microscopic image of composition A structure. Faults in roving filling of the matrix and internal cracks of roving fibres are visible. Magnification $\times 200$.

However, these defects occurred more frequently in composition A and only incidentally in material B. The typical microscopic images of both materials are shown in Fig. 3 – composition A and in Fig. 4 – material B.

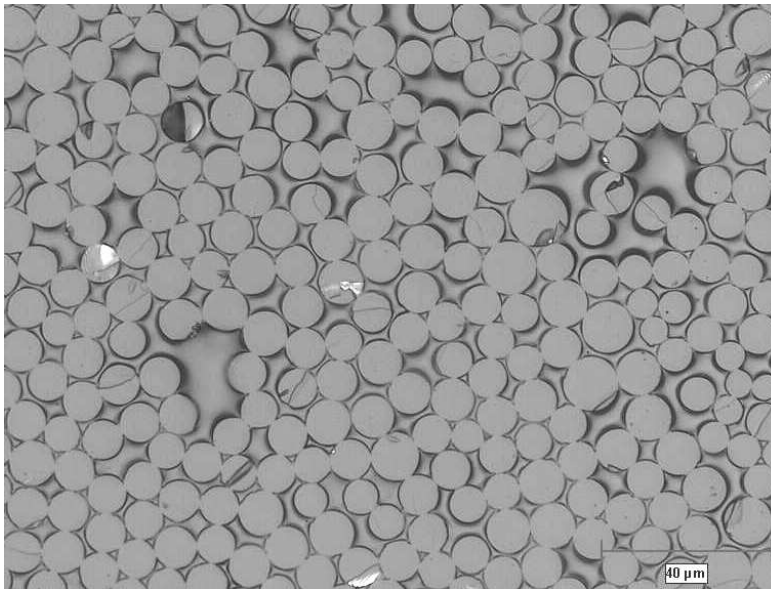
Fig. 4. The typical microscopic image of composition B structure. Sufficient homogeneity and small number of internal cracks of roving fibres are visible. Magnification $\times 200$.

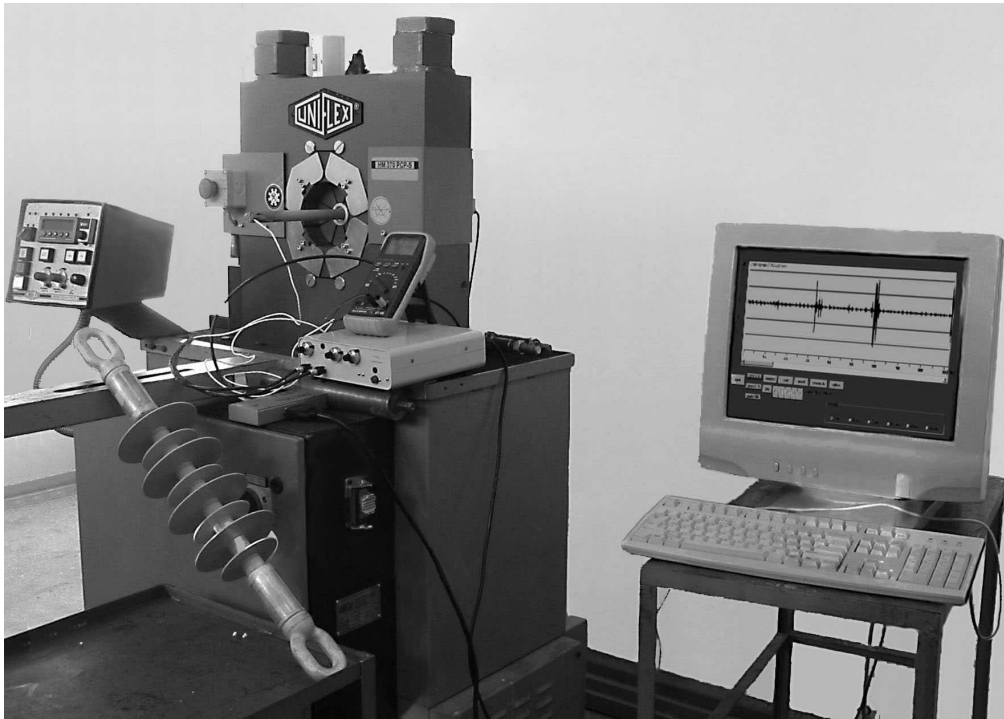
Fig. 5. View of the experimental set-up used to AE control the process of compressing the fixing devices on the medium voltage insulator rod.

Besides microstructural and ultrasonic measurements, the process of compression of the fixing devices on the carrying rod was investigated. This process was performed by a hydraulic press. Compression was realized by automatic multi-element jaw. Direct on-line control of the pressure acting on the carrying rod is difficult. Compressive forces acting on both ends of the rod are analogous. Therefore only one end of the rod was controlled during compression, while to the other end the wideband acoustic emission sensor WD Physical Acoustic Corporation type was coupled. The passband of AE transducer was between 80 and 1000 kHz. Transducer was connected with a preamplifier and AE analyzer, coupled with the computer. The applied instrumentation is shown in Fig. 5, presenting the composite medium voltage line insulator with installed fixing devices. In the central part of the picture there is a carrying rod with fixing device placed in the jaws of the hydraulic press. To the other end of the rod the acoustic emission sensor is connected.

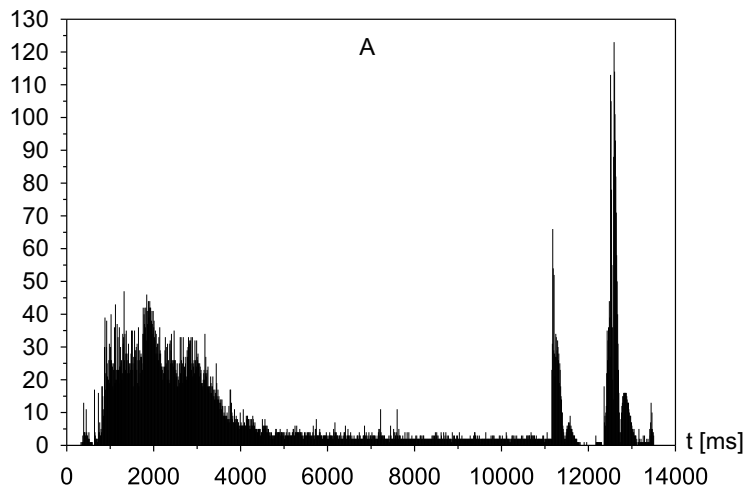
Fig. 6. Time dependence of AE RMS signals, generated in material of type A during fixing device assembly to the insulator rod.

devices. Experiments were carried out using pressure 17 MPa. The effective values of acoustic emission signals (RMS) generated during compression were registered. The typical time dependence of RMS signal is shown in Fig. 6 (epoxy-glass A) and in Fig. 7 (material B). The whole process can be divided into three stages. During the first stage of the process (4–4.5 s) the compression increased linearly to the value of 17 MPa. During this preliminary stage, a high acoustic activity was generated. Course of the AE activity in this stage was similar for all experiments. This is a consequence of the analogous effect of plastic deformation of metal fixing device. Metal deformation has been recognized as the source of AE signals. In two next stages the compression was maintained at constant level 17 MPa. During the second stage, AE activity remained at low level. The strong acoustic signals were generated in the last stage – after eleventh second. They originated from the deformed structure of the epoxy-glass rod. The high RMS value of AE signals can be result of cracking of roving fiberglass in the structure of composite material. Experiments showed a remarkable difference in the course of acoustic energy emission generated by the rods of type A and B. The amplitude of the signal generated by the structure of type A – two bursts, was approximately two times greater than that of type B – one burst. These results indicate lower mechanical strength and higher number of structural inaccuracies of epoxy-glass material of type A.

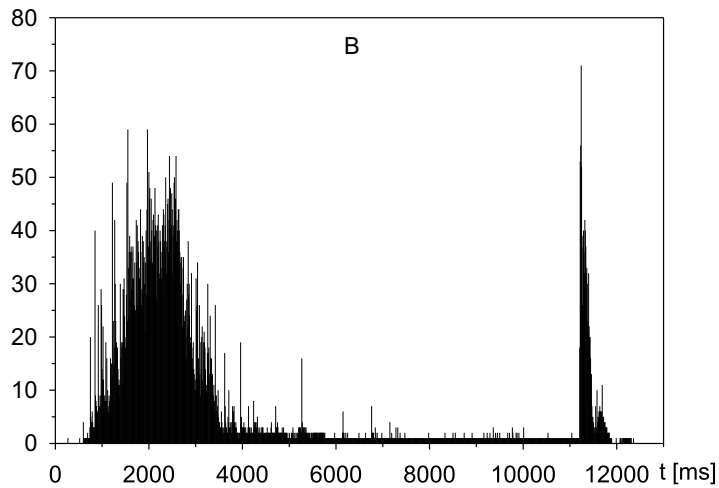
Fig. 7. Time dependence of AE RMS signals, generated in material of type B during fixing devices assembly to the insulator rod.
