Maladaptive use of a royal palace at Edfina, Egypt Niewłaściwe wykorzystanie budynku królewskiego pałacu w Edfina, Egipt

Keywords: Royal palace, Edfina, maladaptive reuse, deterioration, historical value.

This paper presents the Royal palace historical and artistic value. It also illustrates the maladaptive reuse and the deterioration processes of the palace. Regenerating this building can reinforce a sense of community, make an important contribution to the local economy and act as a catalyst for improvements to the wider area, i.e. Beheira governorate. New uses of this palace should be allowed with sensitive oriented adaptations.

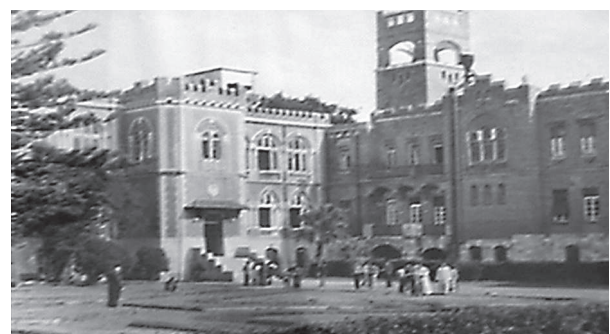
Fig. 2. The Edfina Royal Palace at 1979

Fig. 3. The Royal Palace at Edfina Nowadays

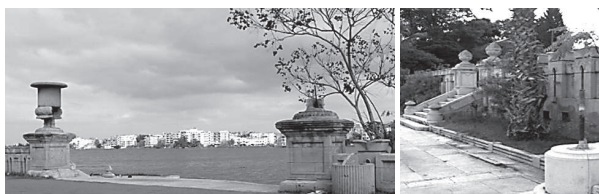
The palace have a marina directly on the Nile shore and extends along the eastern elevation, it's built of lime stone having the main entrance in the middle decorated with two big flower

Fig. 5. The main entrance in the middle decorated with two big flower pots on both sides

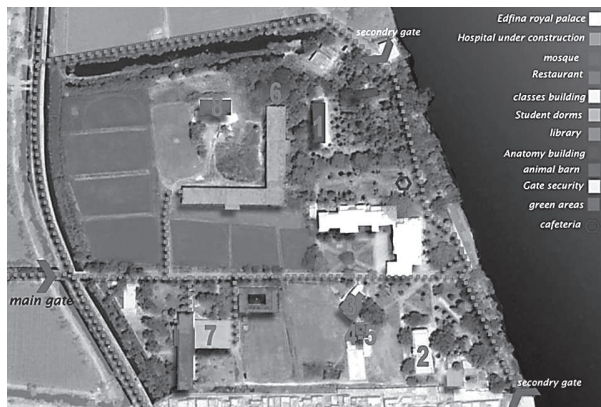
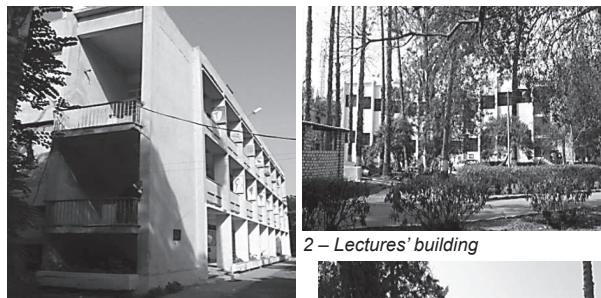
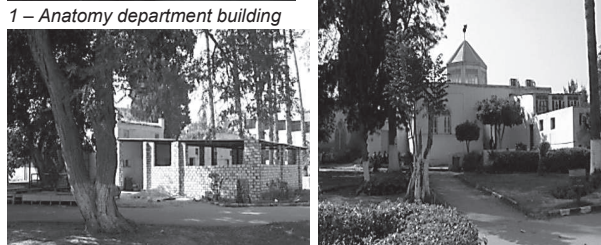
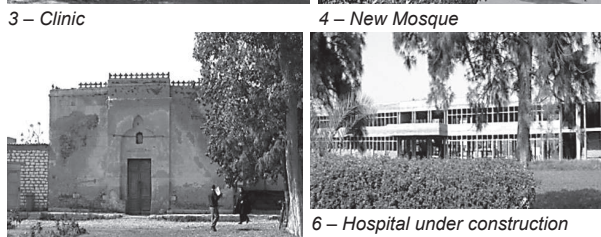
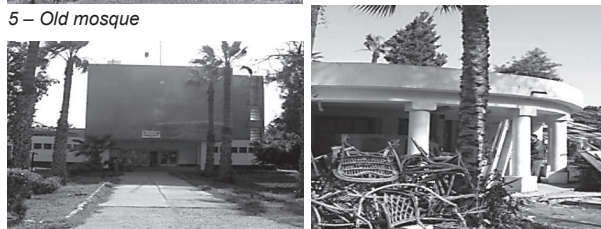
The palace is surrounded by the following buildings: Anatomy department building, lecture hall building, a small clinic, new mosque, old mosque, an under construction hospital, girl students' dorms and a garden pergola; as shown in Fig. 8.

Fig. 8. Buildings surrounding the Royal palace and land uses

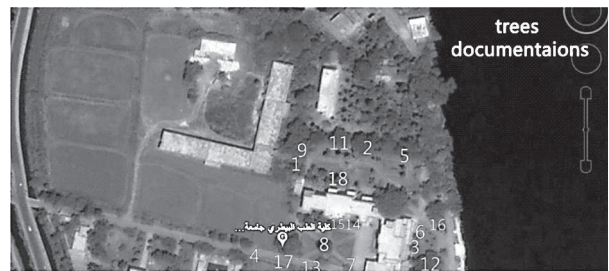
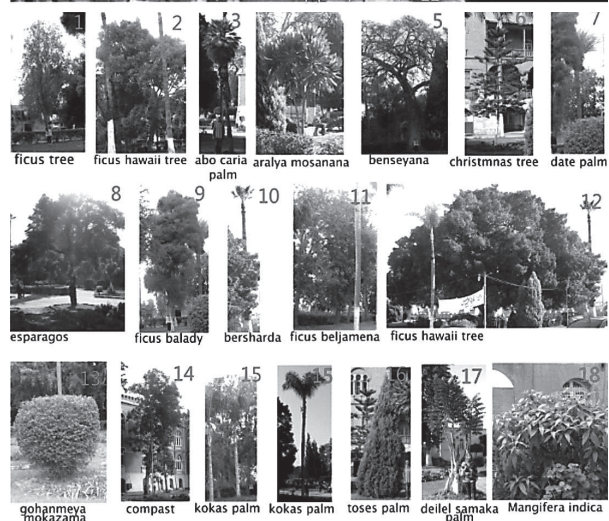
The garden of Edfina Royal Palace contains very rare plants from all over the World, as shown in Fig. 9. Some of these plants have survived till now surrounding the palace from all sides. Also an old octagonal shape marble fountain decorated the palace landscape from the North facing the north elevation of kings Fouad extension.

Fig. 9. Documentation of the garden of Edfina Royal Palace with its rare plants

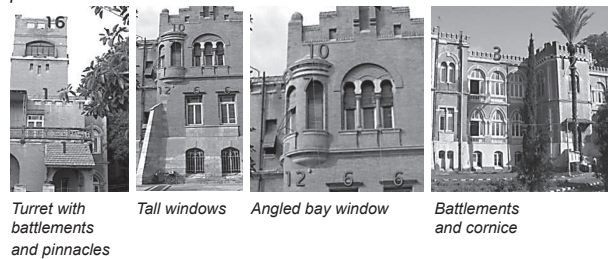
The palace architecture features vary from the Romanesque windows to the angled bay window, as shown in Fig.10. The palace buildings encompass new gothic revival architecture represented in the turret with battlements and pinnacles in the western and eastern elevation. The tower has square shaped plan, it was built from the red bricks with south direction entrance and having windows all around its four facades.

Fig. 10. The palace architecture features

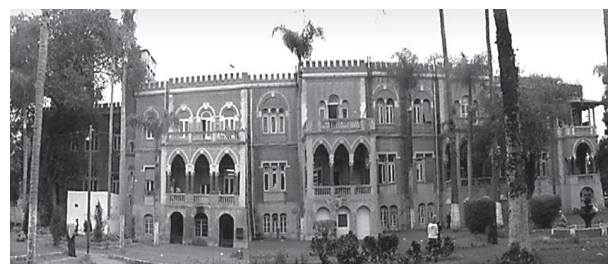
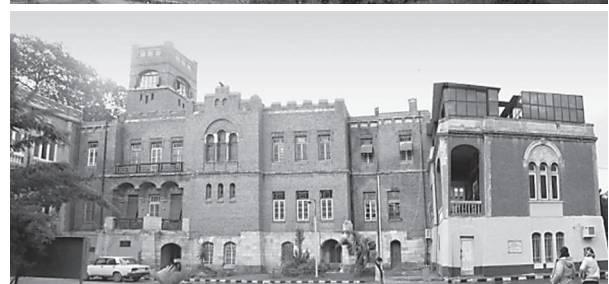
The northern and southern facades of the old palace were romantically asymmetry with tall narrow windows, Fig.11. Italianate architecture features also can be revealed in loggias and balconies with wrought-iron railings, or Renaissance balustrade, Low-pitched or flat roofs and projecting eaves supported by corbels. Motifs drawn from the Italianate style were incorporated into the building vocabulary, Fig. 10. Distinguish belvederes faced the Nile and the marina.

Fig. 11. Northern and southern facades of the old palace

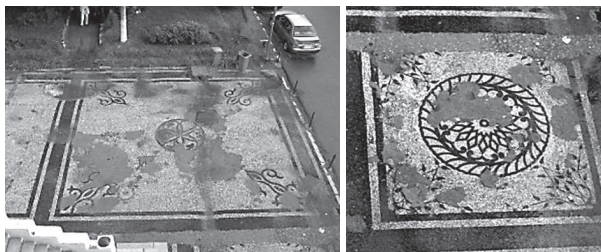
A black & white paved gravel mosaic insets are embraced with the whole palace building from the southern and western direction, as shown in Fig. 12. The entrance of the palace is decorated with two gravel mosaic tiles with large motifs to form unique carpets. By assuming & redrawing of the existing carpets, the designs in Fig. 13 imitate their original state.

Fig. 12. Two gravel mosaic tiles with large motifs to form unique carpets at the palace entrance

Foundation depth; water accumulation which is obvious in the main entrance mosaic settlement and some external cracks are signs for structural changes in the wall, as the wall settles with time and can lead to building failure. Shallow foundations also must be maintained.

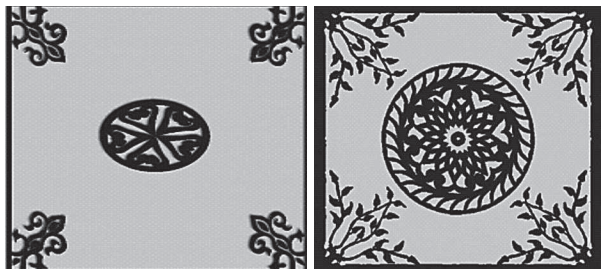
Fig. 13. Redrawing the two gravel mosaic carpets to imitate the original design

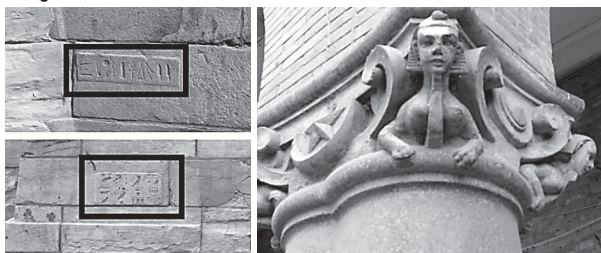
In King Fouad part of the palace, some pharaonic stones with hieroglyphic writing appeared in the eastern elevation with a very unique feature, Fig. 14. Also very rare column capital in which the architect used a feminine sphinx capital appeared in the same façade, as illustrated in Fig. 15. A motif with the letter “F” referring to the king who constructed this part remains there.

Fig. 14. Pharaonic stones with hieroglyphic writing

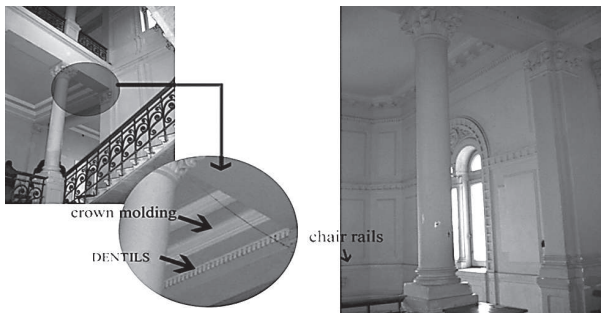
forms. Crown moldings, chair rails, Dentils egg and darts are common architectural details, Fig. 16. Linoleum, ceramic and wood are the most common flooring options. Some oriental features appear in using wooden crafts which were rare in the Italianate style. Also the combination between the Italianate

Fig. 16. Crown moldings and dentils egg in the ceiling, and chair rails as common architecture feature

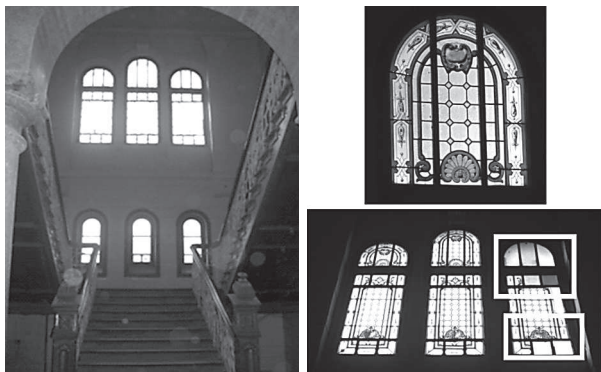
and oriental style is obvious in the iron of handrails of the spiral stair with remarkable stained glass used in windows as shown in Fig. 17.

Fig. 17. Stair with remarkable stained glass used in windows, and its current status

Sometimes treatment for the complete deteriorated materials (wood, stained glass, and wooden handrail is needed. If the treatment failed then replacing by new one identical in shape, color, texture, materials, and scales in order to preserve the historical image come as second choice.

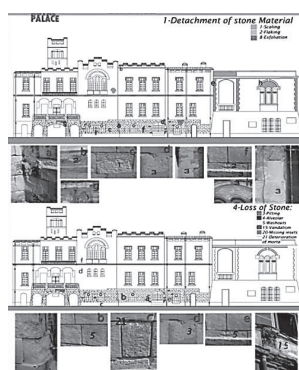
Fig. 20. Monument mapping details in the west elevation (weathering north and south elevation (weathering features))

Diagnosis of degradation of building materials and different type of damage to building elements are accomplished through visual examination and documentation of different litho types and deterioration mapping of the four facades, as documented in Figs. 18-25.

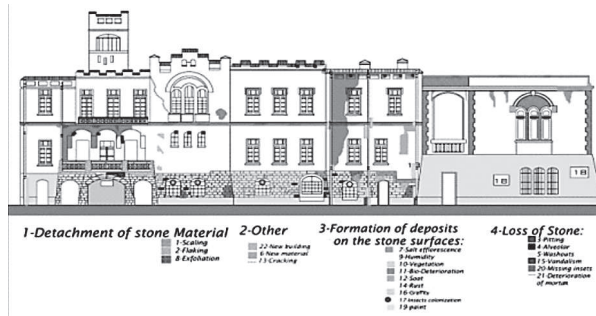
Fig. 22. Monument mapping of the west elevation (weathering features)

External Facade	Main deterioration problems	Treatment suggestions
The eastern elevation	detachment of stone materials (scaling flaking and exfoliation)	Dentistry and consolidation
The north elevation	Formation of deposits on the stone surfaces (salt deterioration and vegetations).	Poultice desalination techniques and Alkaline cleaner's method [8].
The western elevation	Formation of deposits on the stone surfaces (soot and rust), and also some cracks as signs for wall settlement.	Water or water mists, washing cleaner method. Fixing cracks, consolidation for foundation [8].
The south elevation	formation of deposits on the stone surfaces (paint, bad conservation and salt efflorescence).	Chemical method by using alkaline cleaners' method.

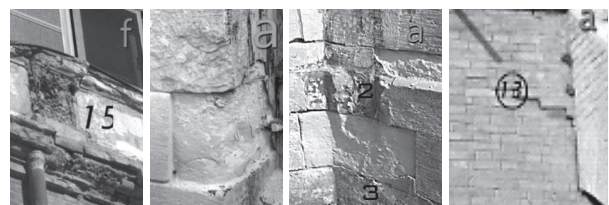
Human intervention; many of the palace rooms were turned into laboratories without any isolation work. Changing usage without any consideration of loads, materials durability and the adjacent spaces can destroy the palace; each wall panel stands on itself and is stabilized by a floor or roof slab. Thus, if there is any slight disturbance of the wall due to other external factors, the wall panel cracks or even collapses. Also ceramics tiles replaced marble in many spaces due to financial restrictions leading to more leakage problems.

Bio-deterioration; Lichen and algae affect the wall of the historical buildings. The activity of both organisms does not result in major changes, but the appearance of the walls is altered, Fig. 26. In addition, they have a corrosive effect on the substrate because they release acid metabolites [8].

Fig. 26 Photos showing different deterioration aspects such as human intervention, back weathering, bio-deterioration and water penetration respectively.

As for stones affected by bio-deterioration, it is preferred to be clean regularly, either by chemical or water cleaners. The stone affected by salt efflorescence we can use consolidate which reduces the salt efflorescent and protected the stone from being further deteriorated (scaling, flaking, exfoliation, alveolar, and pitting).

For Terracotta Bricks affected by bio-deterioration are preferred to be clean only regularly, either by chemical or water cleaners. The Bricks affected by salt efflorescence, we can use water repellent which reduces the salt efflorescent and protected the stone from being further deteriorated.

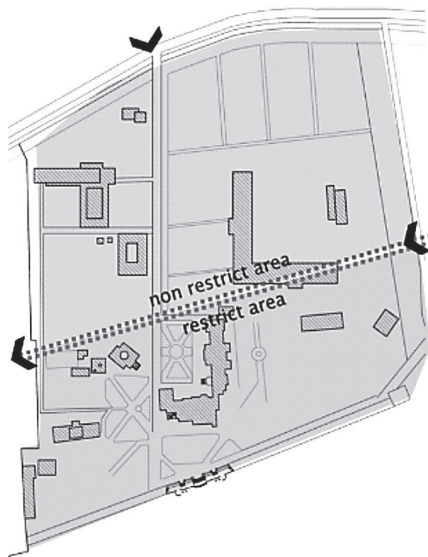
Restrict area with restricted intervention which means only to restore the palace and re-use it as touristic palace and open museum. The reusing of the palace as faculty of Art may be acceptable as the students will be the palace restorer. This will begin by removing the veterinary college to another place and to restore all the feature of the site beginning from the small detail inside the palace up to the outer landscape. Restrict area consists of main royal palace, the main Marina, the green house the mosque and the El-Makam . The rare landscape composed of old trees and plants can turn into a botanical open museum and labeling each tree with full description including age. Unwanted buildings such as buildings for classes, a cafeteria, an animal barn and small shops can be removed.

Unrestricted area in which all new built buildings can be removed or altered freely such as the hospital under construction, student dorm, a restaurant and parking.

Fig. 28 Dividing the site into restricted and unrestricted areas
