The history of renovation design of the front facade of the Main Post Office Building in Lublin

Elżbieta Pytlarz

*Faculty of Architecture, Town and Space Planning, Lublin University of Technology,
e-mail: e.pytlarz@pollub.pl*

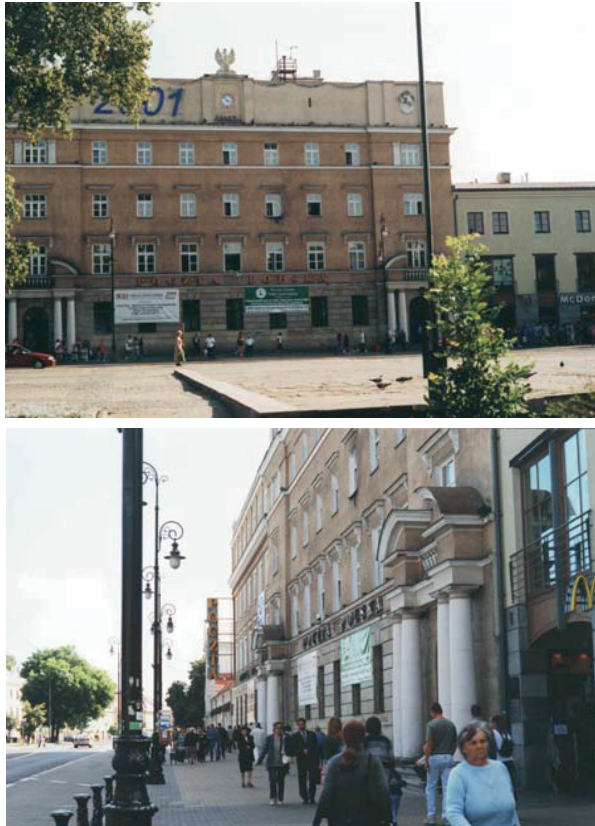
Photo 2. View of the Main Post Office Building, 2001.

and structural renovation design for the Main Post Office Building facade. During initial negotiations with the Client, the design assignment formulated as “refurbishment design” was changed into a “renovation design”, although the name used in the tender documents had to be maintained in the working plans. All the cooperating representatives of the Post Office shared our opinion that the structure should not only be renovated but also embellished [Photo 2].

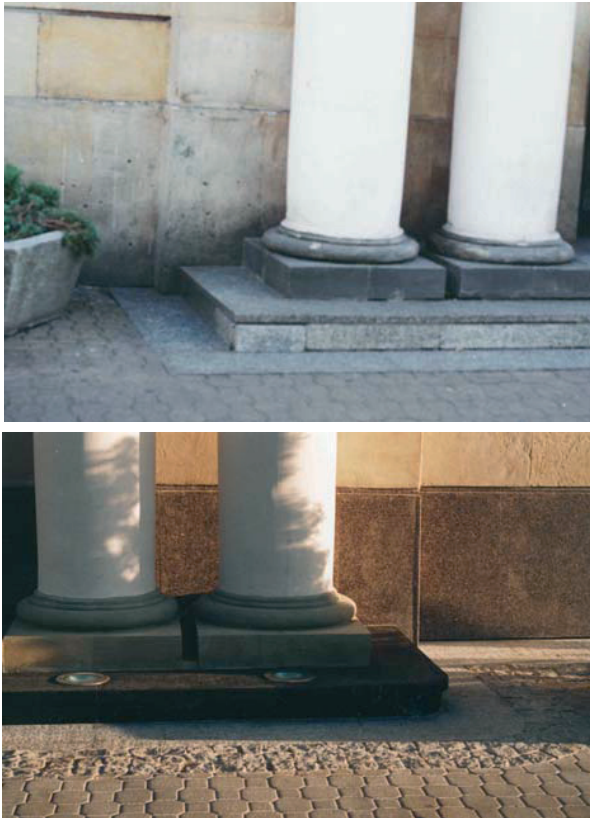
Photo 3. View of the pavement at the main entrance before and after renovation.

ing pavement through a belt of granite stones. According to the first idea of the building's illumination, floodlights lighting up the front wall of the building from the floor level were to be fixed among the granite plates on the ground. The idea of illumination was changed but the granite belt was built which, in my opinion, softens the vicinity of the building's plinth ground course made of precious stone and the pavement made of yellow concrete stones [Photo 3].

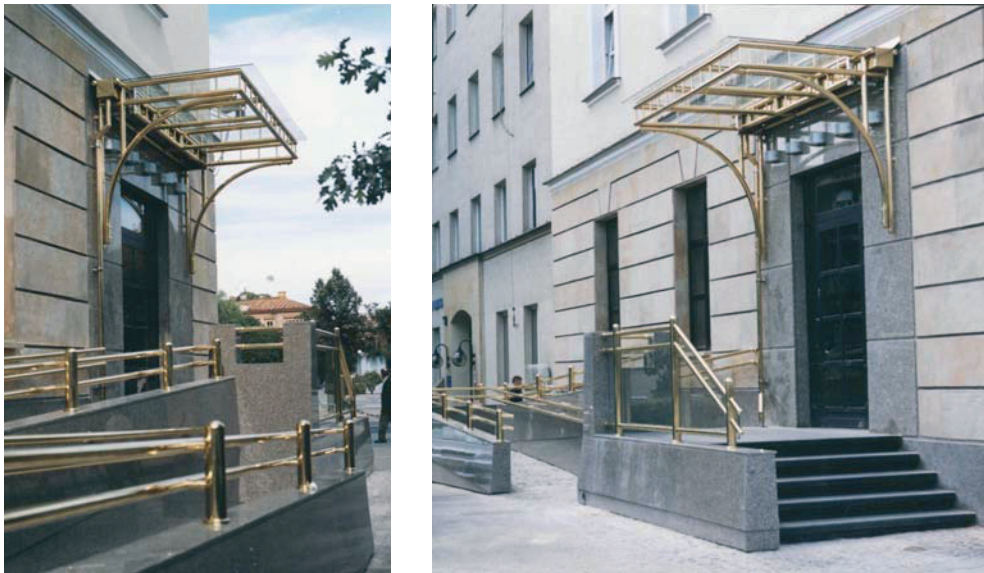
Photo 6. View of the side entrance from J. Czechowicz Square, 2003.
