Microstructure and Microhardness of Ti6Al4V Alloy Treated by GTAW SiC Alloying

W. Bochnowski*

Institute of Technics, Rzeszow University, Rejtana 16 C, 35-310 Rzeszow, Poland

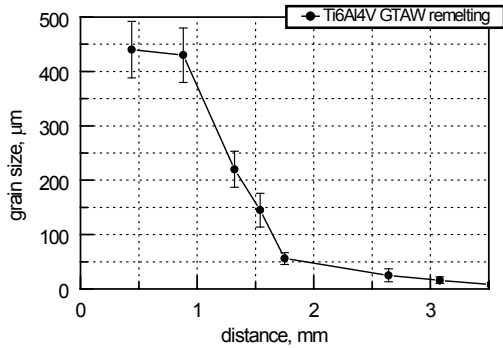
Fig. 4. Grain size of prior β phase in remelted zone

of the grain was about 440 μm . Diameter of the grain decreased in the direction of substrate, as shown in Fig. 4. Bottom remelted zone the diameter of grain was average 50 μm . The microstructure of grains at the top of remelted zone is shown in Fig. 5a. As a result of fast cooling an α phase titanium (shown light) structure was formed in matrix of β metastable solution. The plates of α phase are thin, have less than 1 μm thick.

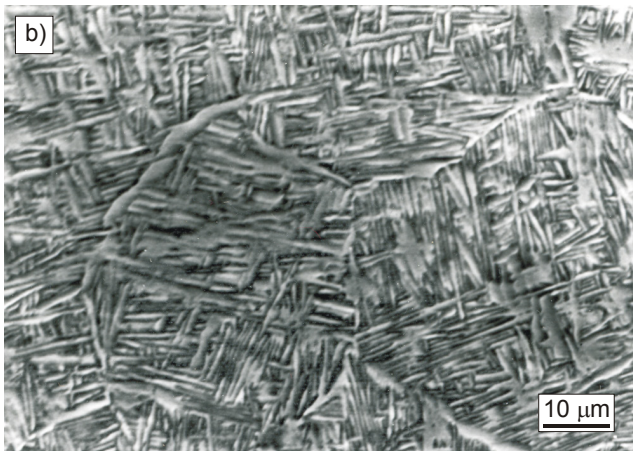
Fig. 5. Remelted zone, a) the grain boundaries of prior α phase is visible, b) bottom structure of RZ

Following the fast cooling no deposition of grain boundary α was recognized. In the bottom of RZ where cooling rate was lower, on the borders of prior β grains an α grain boundary are formed (Fig. 5b). Inside of the grain of prior β phase are visible colony or basket weave of lamellar structures $\alpha + \beta$, α - shown light, β - shown dark. The bottom region of the GTAW treatment is dominated by colonies of lamellae starting at grain boundaries. The value and gradient of temperature and slow cooling rate, no influenced on the explicit change of the microstructure in the second area - HAZ (heat affected zone). The microstructure on the border RZ and HAZ is shown in Fig. 6. Microstructure of HAZ is similar to the microstructure of substrate, consist of colonies of primary α and lamellar $\alpha + \beta$, with an average grain size of less than 10 μm .

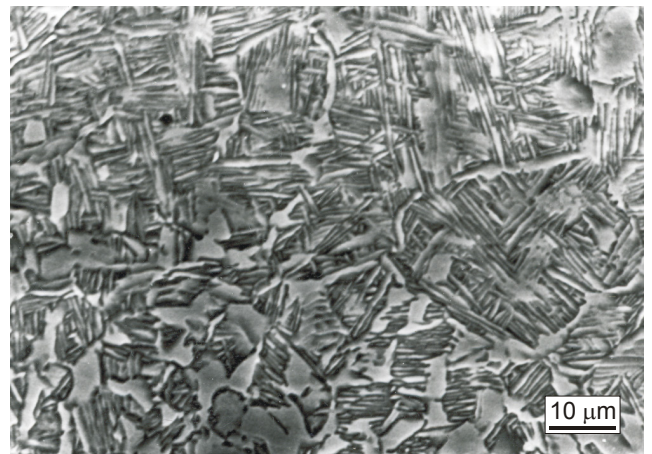
Fig. 6. Microstructure on the border RZ and HAZ

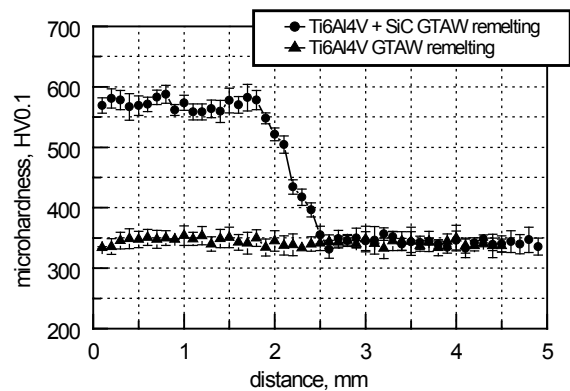
Fig. 10. Microhardness HV0,1 of the Ti6Al4V after remelting and alloying by arc plasma treatment

The microhardness HV0,1 of the remelting zone and of the alloying zone in dependence on the depth is shown in Fig. 10.

For the remelting, lower values (330 HV0,1) are recorded near the surface remelted (at a depth of to 200 μm), then the hardness in RZ, HAZ and SUB is maintained at a constant level – 350HV0,1. The hardness depends on the cooling rate, which is determined by the process parameters. In the literature [11] depending on process parameters remelting (at higher cooling rate) an increase of hardness in the RZ and HAZ of was recorded. Performance of SiC alloying resulted in increase of hardness in the alloyed zone. The difference in hardness between the alloyed zone and the base metal is 220HV0,1.

On the bottom alloyed zone and in border of zone alloyed and HAZ (on the 500 mm length) a continuous decline of the hardness was showed in fig 10. The hardness HAZ in alloyed specimens was on level hardness of substrate.
