railway wheels, laser strengthening zones

INVESTIGATION OF POSSIBILITY OF LOCAL LASER STRENGTHENING OF RAILWAY WHEELS

Summary. It was shown possibility and necessity of local laser strengthening of cove zone of railway wheels tread by coming out of bainite structure.

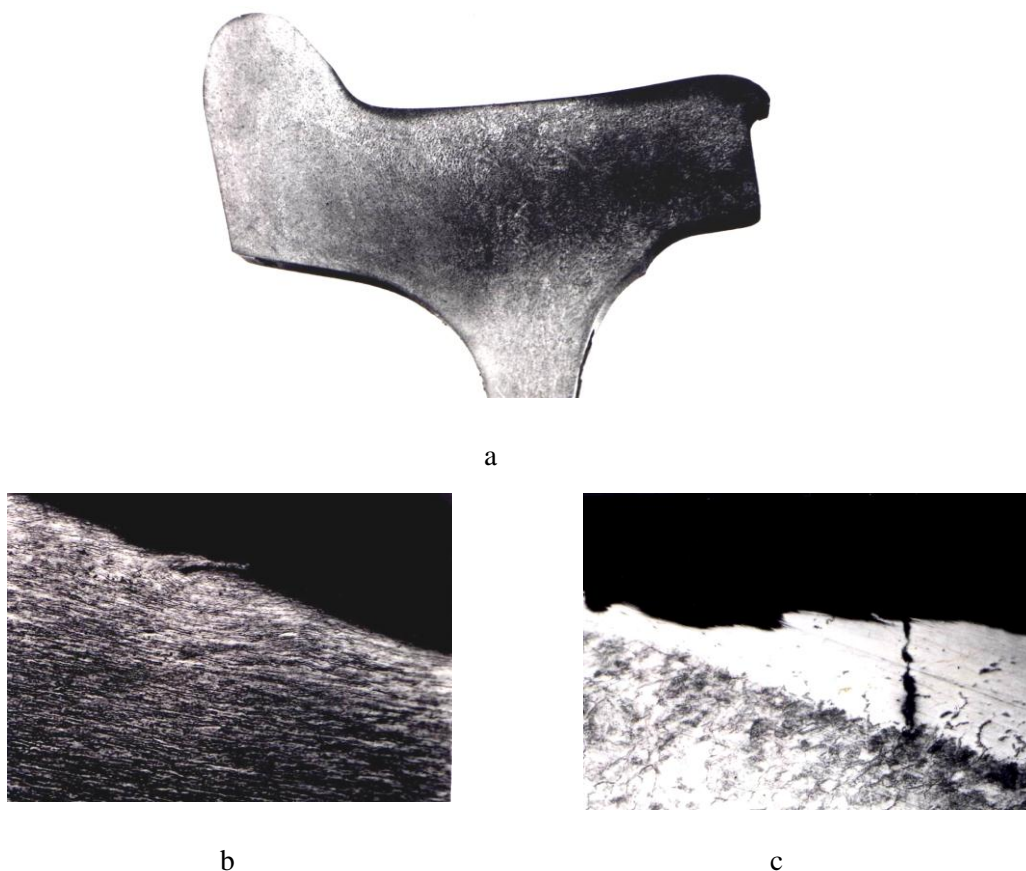
Fig. 1. Macrostructure (a) and microstructure (b,c, x200) of railway wheel with worn-out tread
Рис. 1. Макроструктура (a) и микро (б,в, x200) колеса с изношенной поверхностью катания

Macroanalysis of worn-out tread of railway wheel was shown that different areas of tread are worn in different ratio (Fig. 1a). Obviously cove zone is “weak place” owing to development of considerable contact stresses [1-3].

Microstructure of wheel rim in cove zone of worn tread is area of deformed perlite and ferrite grains and also areas of “white layer” (Fig. 1b, c). Appearance of deformed zone is connected with bearing strain of metal by contact interaction wheel-rail. Plastic shears in thin surface layer passed in conditions of high pressure and cycling temperature. Character of microstructure of worn tread bears witness about heterogeneous deformation along section of wheel rim, that connected with heterogeneous distribution of contact stresses. It is known in cove zone these stresses are higher than in the middle of tread [3]. In cove zone the grains are significantly elongated and grinded, at the passage to tread degree of grains elongating is reduced and in the middle of tread it is less. Values of degree of grains elongating ε , depth of plastic shears zone h and dislocation density ρ_{\perp} in different areas of worn tread are showed in Table 1.

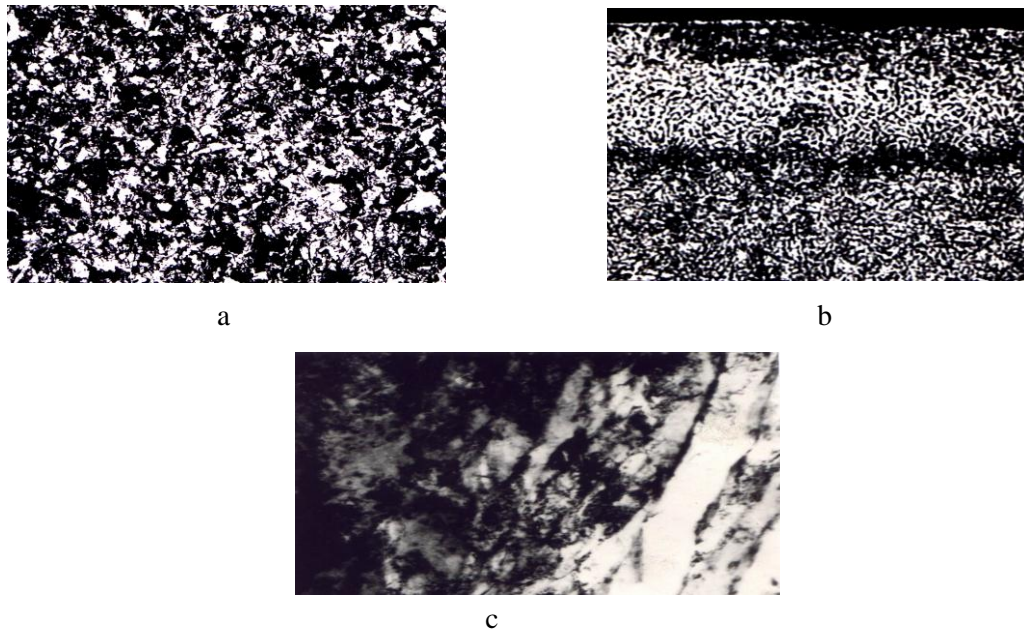
Fig. 2. Microstructure of wheel steel after ordinary quenching (a) and laser quenching (b,c); a,b - x500, c - x20000

Microstructure of wheel steel after ordinary quenching was perlite with different dispersivity (Fig. 2a). After tempering at temperature 400, 480 and 520⁰C the microstructure of wheel steel was the tempering troostite and dispersed carbides. After tempering at higher temperature the microstructure of wheel steel was tempering sorbite and carbides, but at temperature 600⁰C the microstructure of wheel steel was coarser by all quenching temperatures. Microstructure of tempering wheel steel is hereditated all principles connecting with different quenching temperature [1]. At the all tempering temperatures microstructure of wheel steel after preliminary quenching from 950⁰C is less dispersed by all the same conditions. Laser treatment of tempering wheel steel is the possibility of supplementary rise of service life.

Microstructure of laser treatment zone of wheel steel is dispersed martensite or bainite and also residual austenite and dispersed cementite (Fig. 2b, c). Character of principal structure is defined by rate of laser beam: at 20 mm/s when cooling rate of steel is maximum the martensite was formed, with the others conditions of laser treatment the bainite was formed. Parameters of laser treatment zone depend on temperatures of preliminary quenching and tempering and also the rate of laser beam. More dispersed microstructure of laser treatment wheel steel was formed at temperature of preliminary tempering 400, 480 and 520⁰C (at all temperatures of preliminary ordinary quenching). Apparently, the effect of microstructure dispersion is observed by the rise of treatments quantity. Dispersivity of laser quenching microstructure of tempering wheel steel rose concerning preliminary quenching and tempering steel. But difference of degree of microstructure dispersivity existed before laser treatment in dependence on temperatures of preliminary quenching is stable after laser treatment.

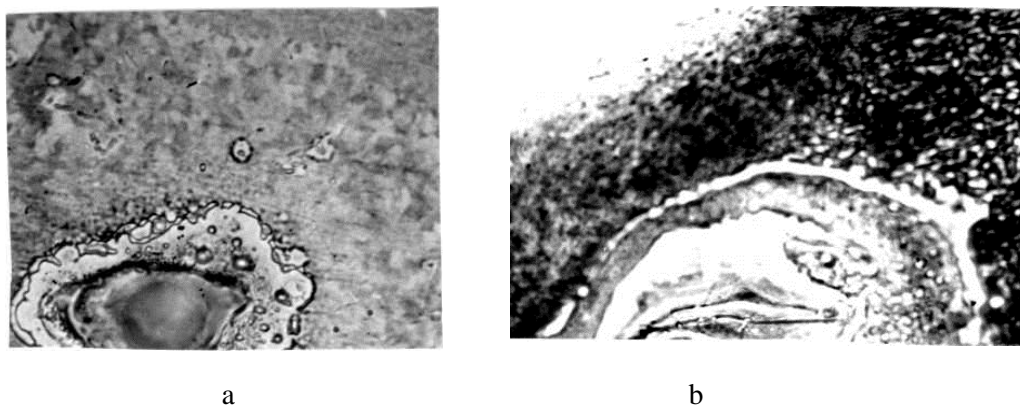
Fig. 3. Zones of local strengthening near non-metallic inclusions of oxide (a) and sulphide, (b) after laser treatment; $\times 500$

Nonmetallic inclusions being in wheel steel promote heterogeneous strengthening of wheel steel by laser treatment. Nonmetallic inclusions are melted or partially dissolved in metal matrix and also are promoted formation of contact interaction zones in steel matrix (Fig. 3a, b).

In the results of alloying of local areas of steel matrix in the condition of abnormal mass transfer from internal sources (nonmetallic inclusions) liquation strengthening zones near inclusions are formed. These liquation zones have different type of composite structure: laminated type with cascade or “stain” distribution of chemical elements and microhardness, dispersal type with different hardened phases, and also combined type.
