## MECHANOACOUSTIC AND MICROSCOPIC STUDY OF ALUMINOUS PORCELAIN RESISTANCE TO STRUCTURAL DEGRADATION

The paper presents mechanoacoustic and microscopic testing of degradation processes of modern C 120 electrotechnical porcelain of domestic medium voltage line insulator. Samples of small dimensions, cut off from the rod of insulator, were subjected to compressive loading, with recording of acoustic emission descriptors. Microscopic analysis enabled determining the advancement of degradation effects. Three stages of the structure degradation were distinguished. The effectiveness of dispersive and fibrous reinforcement of modern aluminous porcelain C 120 type has been described. Structural strengthening by corundum grains and mullite needle shaped crystals improves mechanical parameters and distinguishes this material from typical aluminosilicate ceramics. The presented results enable drawing up the conclusions concerning the resistance of investigated material to the ageing degradation process development during long term operation.

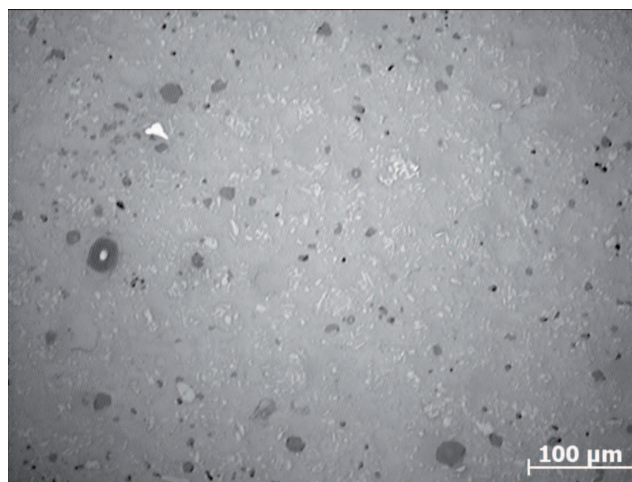
Fig. 1. Image of the structure of examined insulator material, magnification 200x. Fine, bright grains of corundum, a little greater quartz grains and white particles of cullet are visible. Darker precipitates of mullite are almost indistinguishable from glassy matrix. Dark areas of crushed out cullet and quartz as well as fine black pores can be observed

The microscopic phase analysis of examined samples of the insulator material revealed generally satisfying homogeneity along the length of the rod (macro-scale) as well as in semi-macro scale. Grains of corundum, pores and particles of cullet were uniformly distributed in a glassy matrix in the micro-scale. The typical image of the material structure was presented in Figure 1.

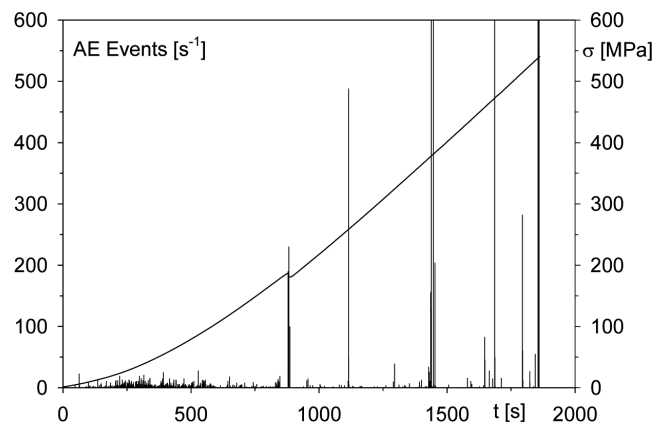
Fig. 2. Course of the rate of AE events versus increase of compressive stress for the tested sample, whose loading was stopped at 541 MPa, just before destruction. Only the preliminary and subcritical stages of degradation in stress range 0 ÷ 538 MPa are displayed. Strong signals of the last – critical stage are not included

with the typical strength of C 120 kind material – usually about 400 MPa. The obtained resistance was slightly lower than that of the weaker C 130 type porcelain (about 580 MPa). The relative dispersion of compressive strength was low and equalled 31.7%. Besides the damaged samples, a group of specimens was selected for the microscopic investigation. The compression process of these samples was stopped at different levels of stresses: 100, 250, 460, 521 and 541 MPa. Greater pieces of destroyed samples were also subjected to microscopic study. The applied procedure enabled a detailed study of degradation progress in the porcelain material, subjected to increasing load. The obtained mechanoacoustic characteristics of the particular samples showed considerable differentiation. Figure 2 presents course of the rate of AE events versus the increase of compressive stress for the sample, which loading was stopped at 541 MPa, just before the destruction. Figure 3 presents the energy of events in the interval of one second versus stress for the strongest specimen damaged at 608 MPa.

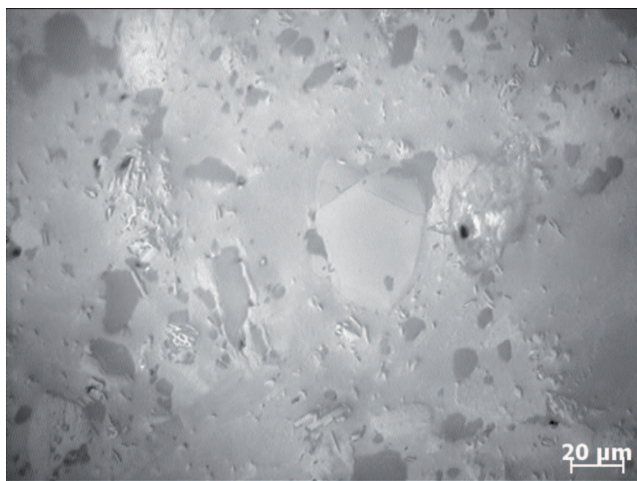
Fig. 4. Representative structure of the sample loaded up to the early subcritical stage of degradation, magnification 500x. Dark areas remaining after crushed out particles of cullet and quartz grains constitute about 4% of the surface. Fine bright grains of corundum and grey mullite precipitates are not affected by degradation

In Figure 4 there is presented material of the sample loaded up to 250 MPa. There are visible almost only effects of the preliminary stage.

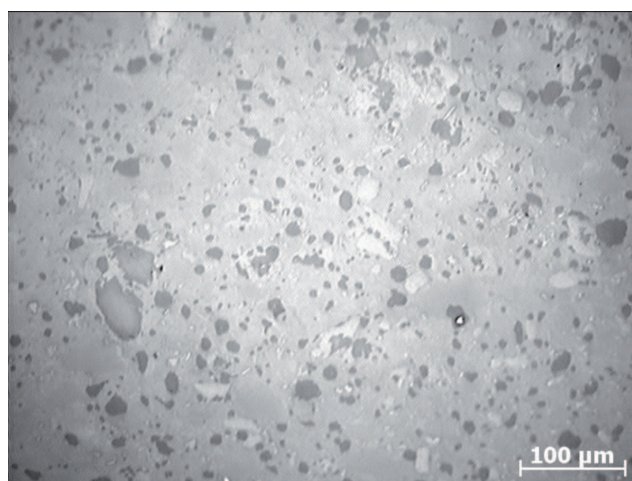
Fig. 5. Image of the structure at the boundary part of the sample stressed up to 460 MPa, magnification 200x. Dark areas remaining after crushed out particles of cullet and quartz grains of different size constitute about 7.5% of surface. Almost all bigger quartz grains contain internal cracks. Damage of mullite and corundum phases are only incidental

The second – subcritical stage of structure degradation is closely connected with the homogeneity of the sample structure in micro and semi-macro scales. The subcritical stage follows the preliminary stage and lasts to the beginning of the critical stage. This phase of destruction is considerably varied for particular samples and shows single or series of acoustic signals of low or moderate intensity of AE activity. Intervals of longer AE activity occurred rarely. The strongest signals follow the fracture and splitting off the walls and corners from the sample. During this period further damage of particles of cullet (without acoustic effects) and quartz grains (weak AE signals) takes place. There are created peripheral and internal cracks in grains. A slow degradation of mullite phase was registered too. The stresses of advanced subcritical stage, especially in the central section of the samples, caused initiation of internal cracks and sometimes crushing out parts of precipitates. They were strongly bounded with the glassy matrix and peripheral cracks occurred very rarely. In the case of the samples, which were stressed up to the end of subcritical stage (460 and 521 MPa), the area of damaged, separated and crushed out elements of structure comprised about 8% of surface. This value included almost the whole cullet (below 5%), a part of quartz grains (especially of small size) and less than 1% of mullite phase. Figure 5 presents the structure of the sample containing moderate effects of subcritical degradation. In Figure 6 strongly advanced subcritical effects, in the central part of the sample compressed up to 521 MPa, are visible.

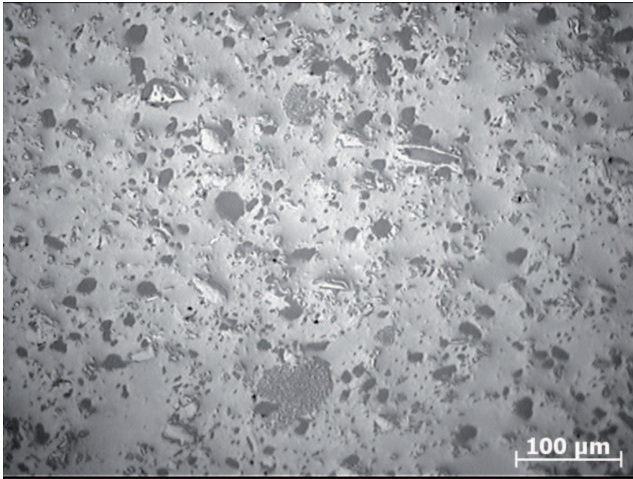
Fig. 6. Image of the structure at central part of the sample stressed up to 521 MPa, magnification 200x. Black areas remaining after crushed out particles of cullet and quartz grains constitute above 8% of surface. Strongly cracked, great and dark precipitates of mullite are visible. Quartz grain contains peripheral and internal cracks. Damages of corundum phase are rare

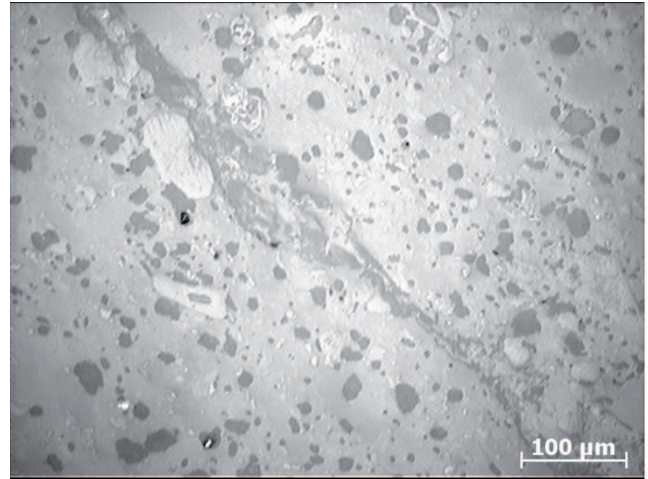
Fig. 7. Image of the structure of the piece of destroyed sample, magnification 200x. Large crack and bright fractured grains of quartz are visible. Damages of mullite phase are small and negligible in case of corundum. Dark areas remaining after crushed out elements of structure exceed 13% of the surface
