# **TRANSACTIONS OF THE INSTITUTE OF AVIATION**

Scientific Quarterly  
1/2009 (196)

**REVIEW OF AERONAUTICAL FATIGUE INVESTIGATIONS  
IN POLAND DURING THE PERIOD MAY 2007 TO APRIL 2009**

Antoni Niepokólczycki, DSc, Editor

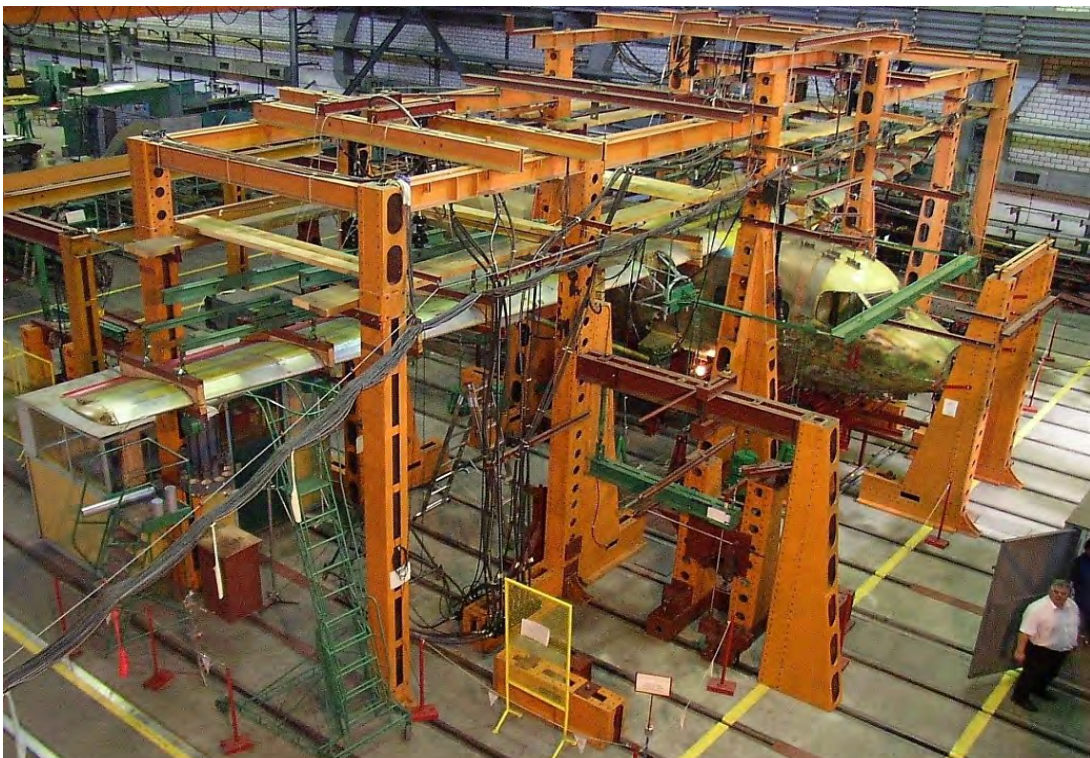
*Fig. 2. Wing and wing loads-carry-through test rig. The test is conducted with MTS Aero 90-LT system.*

- 1) wing and wing carry-through structure fatigue tests (fig. 2);
- 2) empennage and attached structure fatigue tests (fig. 3).

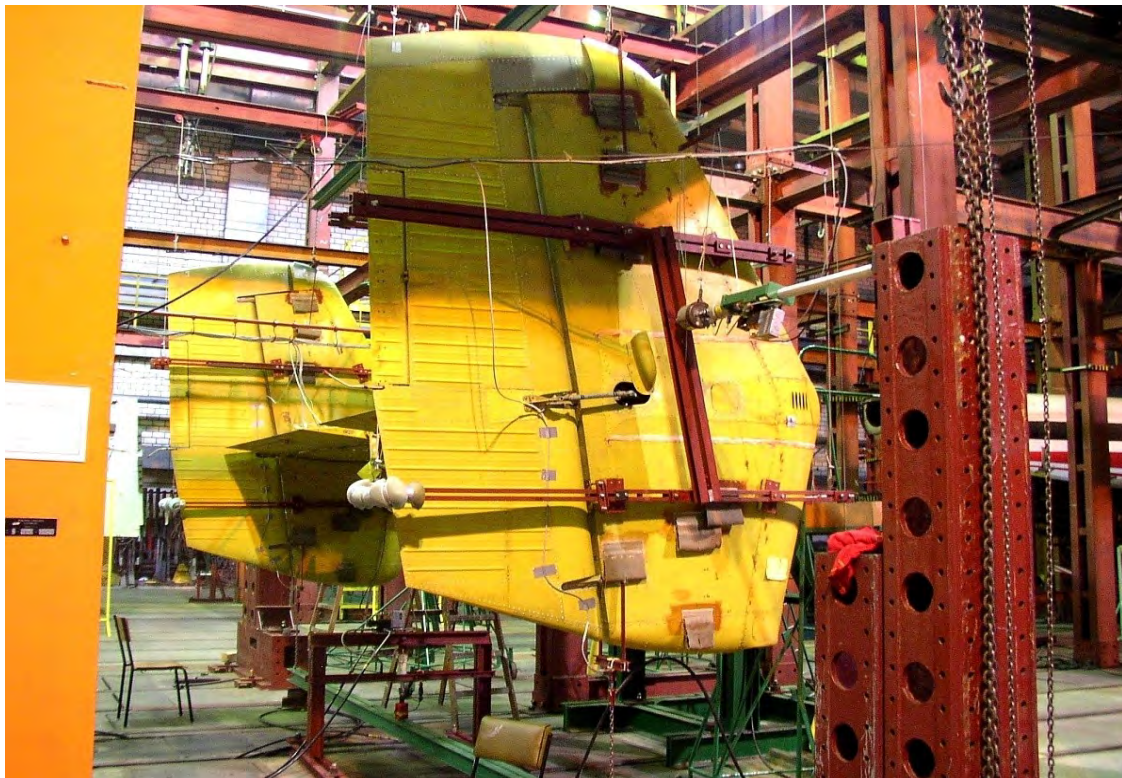
**Fig. 3. Empennage test rig in Polskie Zaklady Lotnicze. The test program was prepared by the Institute of Aviation in Warsaw. The loading system was developed at PZL Mielec.**

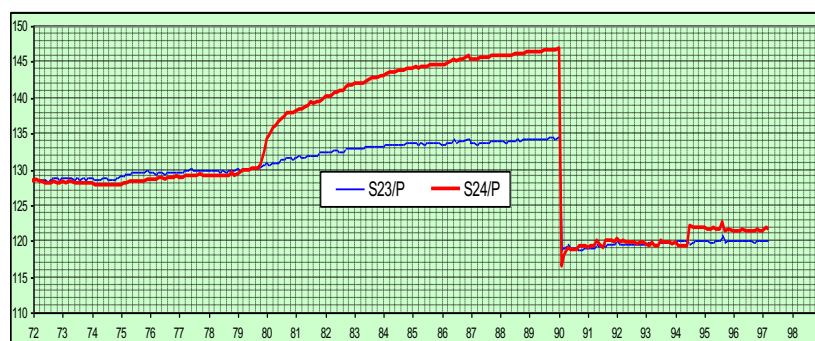
**Fig. 5. Strain gauges no S23/P and S24/P maximum indications changes during the test. Indications are scaled in MPa (megapascals). Prior to 80000 simulated flight hours maximum indication of S24/P began to change as a result of the wing skin crack propagation. After 90000 simulated flight hours this area was repaired.**

The strain gauges measurement during tests is a very popular method of airframe strain analysis validation and fatigue damage detection. On the wing structure more than 100 strain gauges were applied. Some of them were added during the test, in order to better observe the area of interest. On the empennage structure about 20 strain gauges were applied (fig. 4). The analysis of the strain gauges measurements leads to fatigue crack detection (fig. 5).

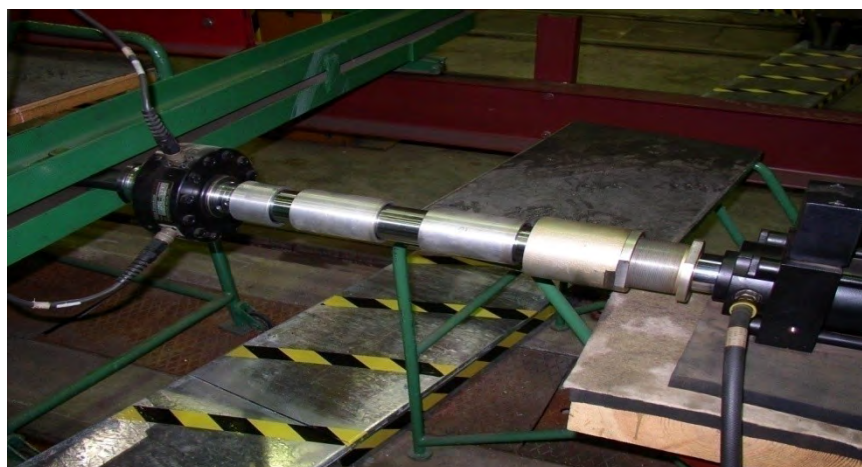
*Fig. 6. MTS Aero 90-LT hydraulic actuator with stroke limiter, used in order to prevent extensive damage of tested airframe in case of the loss of its rigidity.*

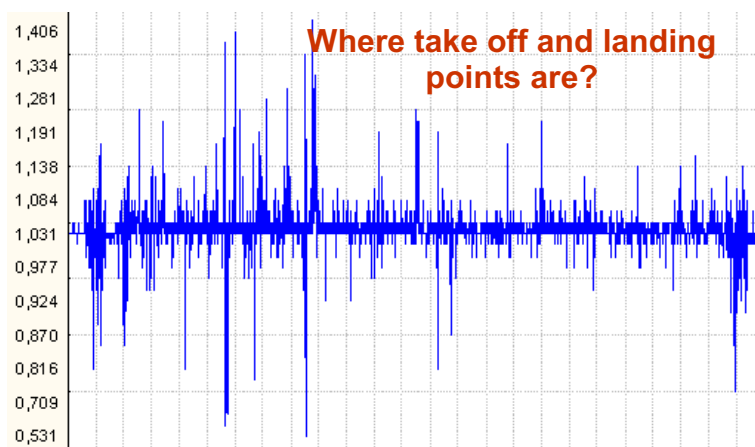
**Fig. 1. The  $n_z$  signal for one flight**

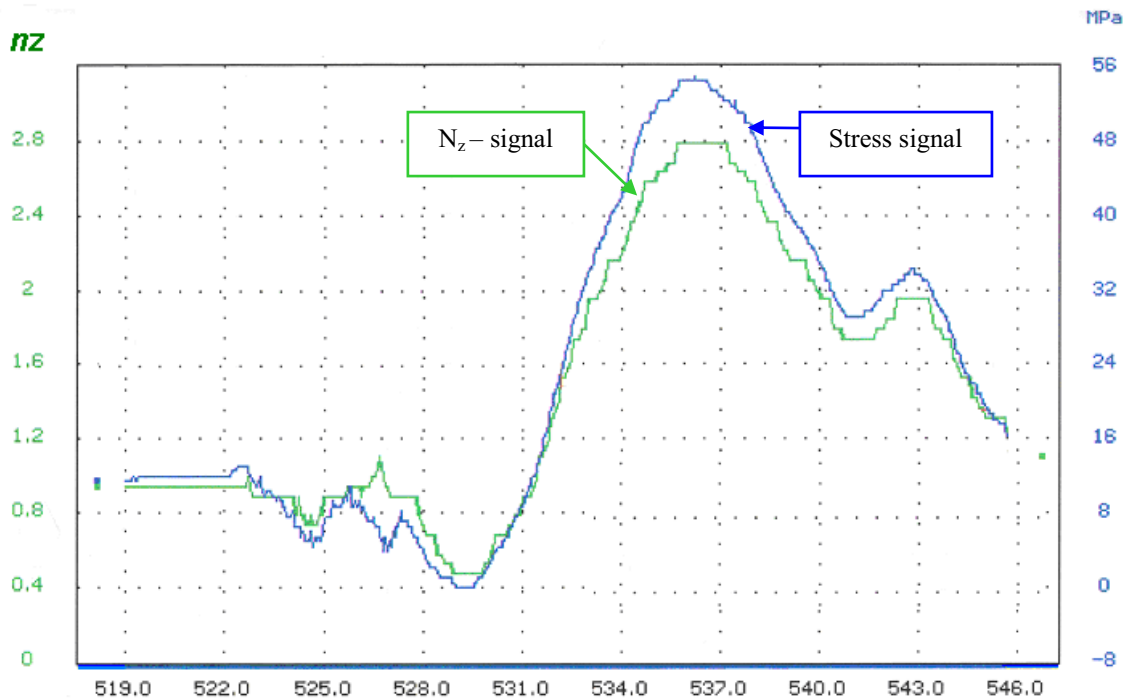
**Fig. 3. Changes in the courses of signals – an original drawing**

The recorded parameters are presented in fig. 3.

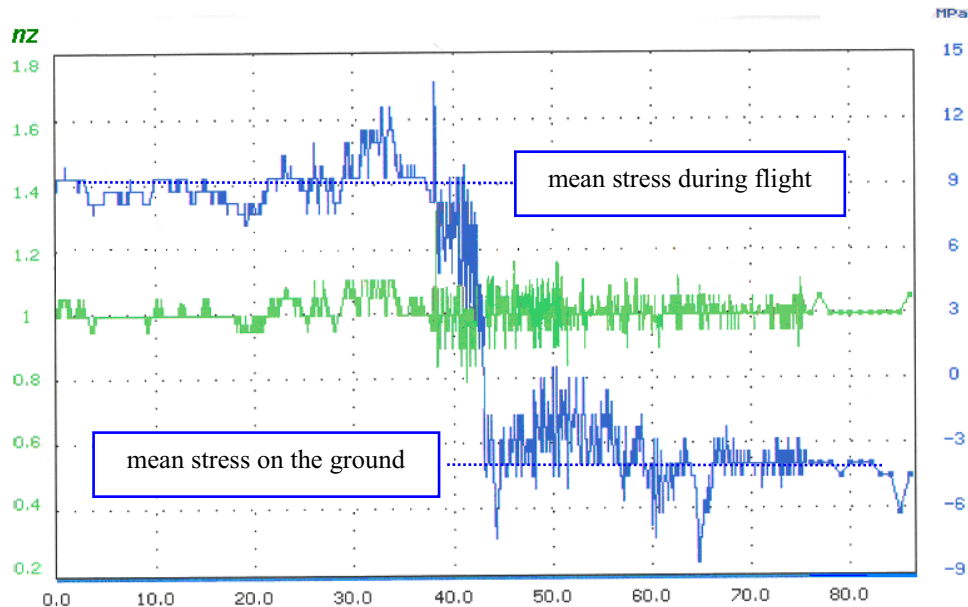
In Figure 6 a part of data recorded during flight tests and illustrating the very moment of landing has been presented. The blue line corresponds to the change in stress in the lower wing skin. This localization is very close to the area for which fatigue analysis is carried out. The figure 6 shows changes in stress during the landing that allow us to conclude that the change in load configuration during the landing results in the reduction of mean stress by approximately 12.5 MPa.

**Fig. 6. The courses of signals during the landing**

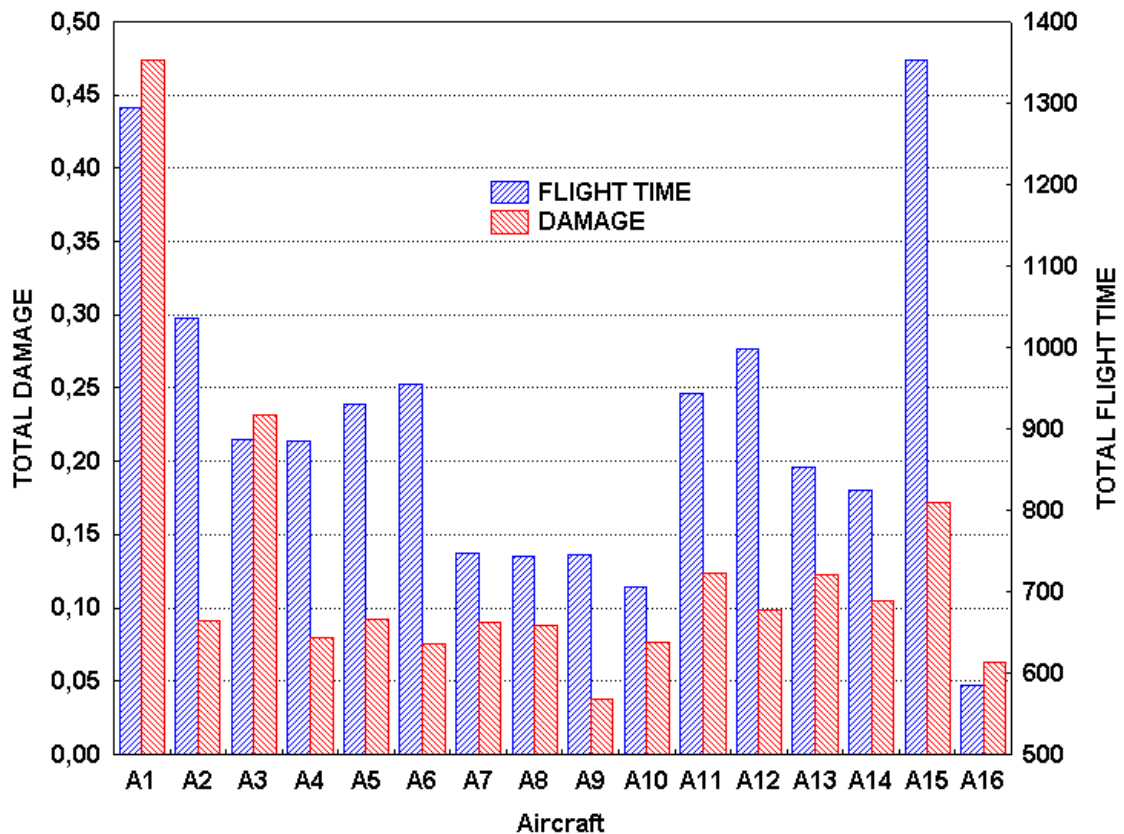
The calculations made on the basis of the algorithm presented above allowed fatigue damage determining of the whole population of in-service airplanes. The data from years 1996÷2007 have been used for the calculations. Figure 7 presents fatigue damage for the chosen group of 15 airplanes. Simultaneously, the same figure presents the flying time of these planes. The intensity of particular plane usage can be estimated from the comparison of fatigue wear and flying time.

**Fig. 7. Results of calculations of fatigue wear**

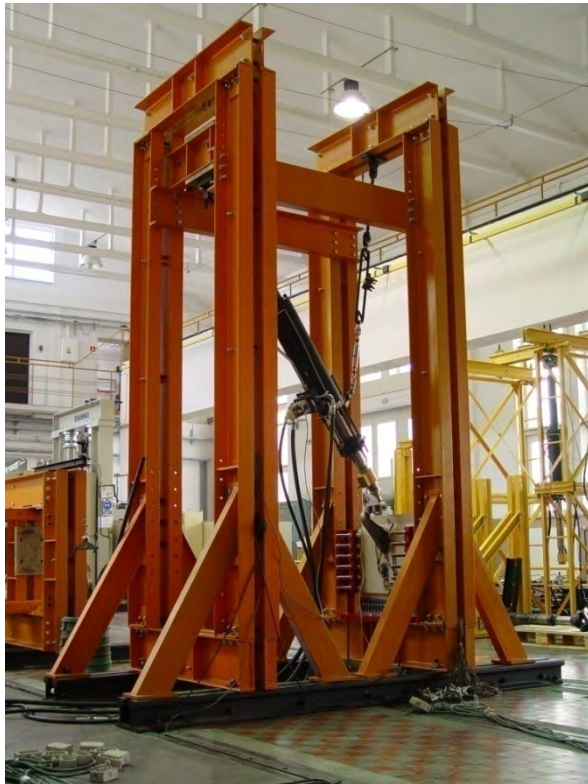
*Fig. 1. Test set-up with the A400M engine cowl door hinge fitting specimen.*

Figure 1 shows the test set-up with hinge fitting specimen (one of the configurations) and figure 2 shows the test set-up with latch housing specimen. Tens of channels for the strain gauges and 3 displacement transducers for each specimen were required to measure behavior of the specimen structures during the static and fatigue tests.

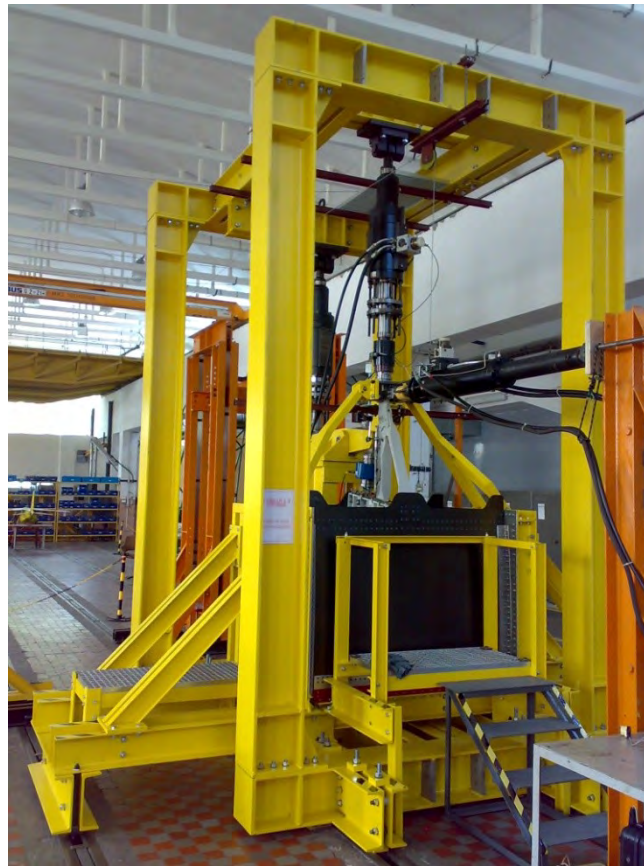
At present, certification tests of actuator hinge fitting of A400M vertical tail plane (VTP) is carried out at the Institute of Aviation. One specimen is tested both under static and fatigue loads. Specimen consists of the hinge fitting and representative part of the VTP carbon fiber composite box. Figure 3 shows the test set-up with the specimen.

*Fig. 3. Test set-up with the A400M VTP actuator hinge fitting specimen.*

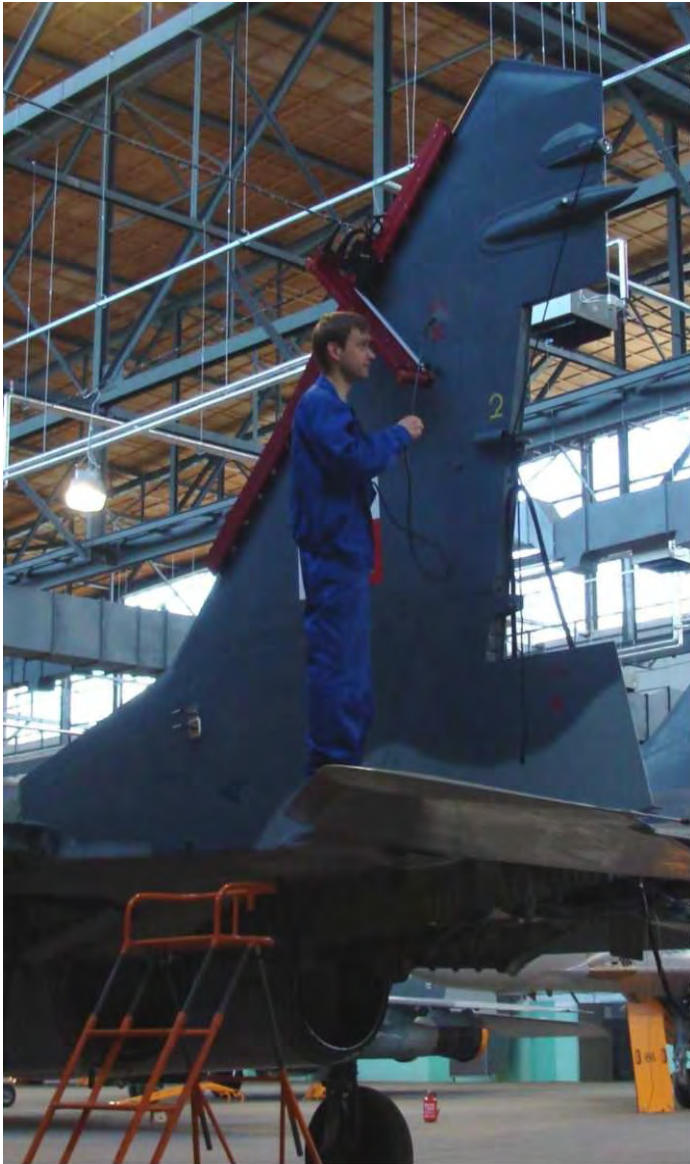
*Pic. 1. Composite vertical stabilizer inspection.*

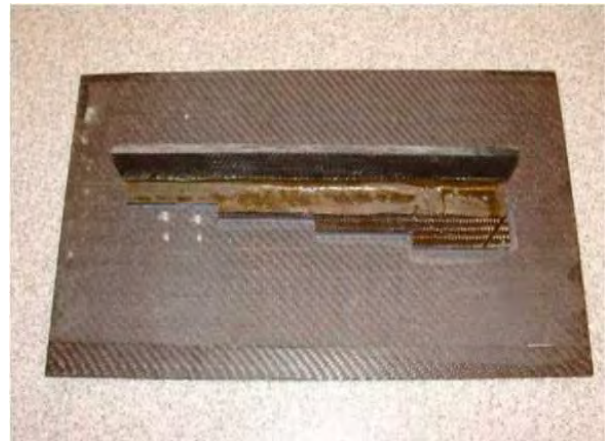
**Pic. 6 Test specimen**

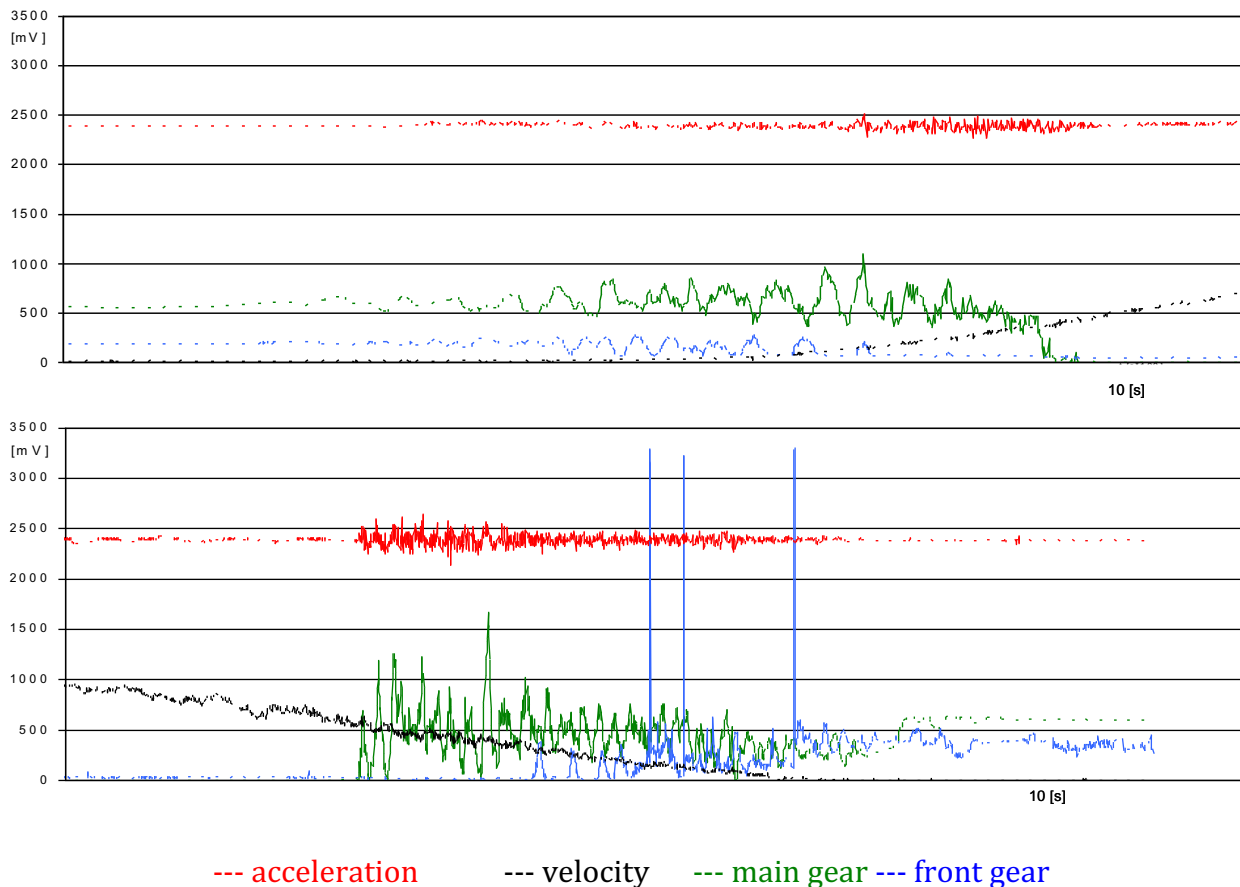
An example of recorded signals is shown below. The graphs show the voltage values (in mV) of signals of main gear load, front gear load, acceleration and velocity (based on pressure measurements).

**Fig. 5. Sample of registered signals**

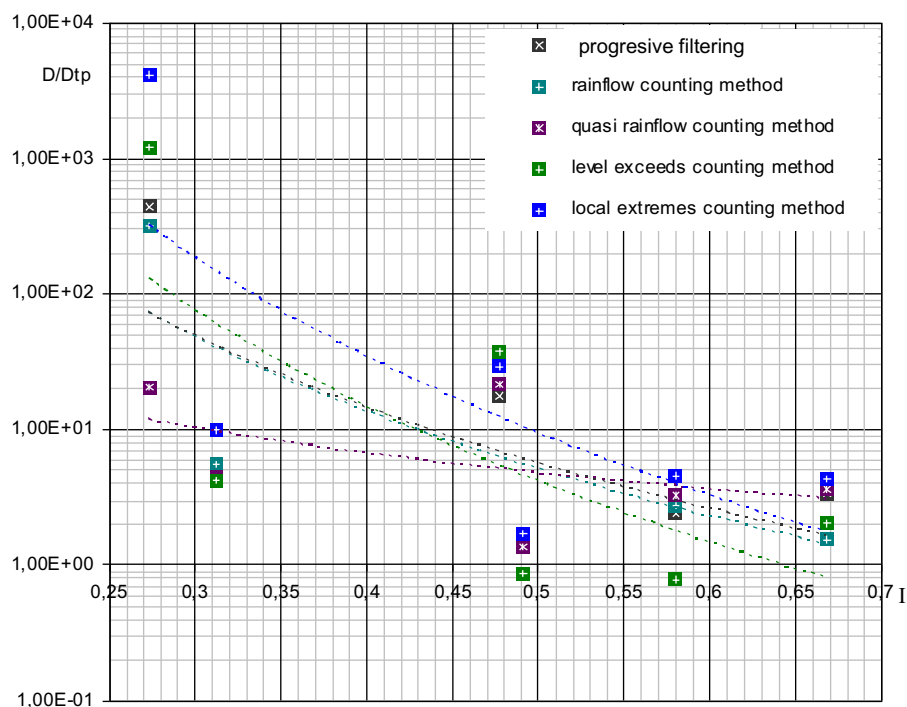
Based on the records transfer matrices were generated. Next, a cumulated damage  $D$  value was calculated according to Palmgren-Miner hypothesis. Fig. 6 shows the ratio of  $D$  (separate for each investigated method) to the value of  $D$  taken from the transfer matrix (treated as the reference) in function of  $I$  coefficient (where  $I$  is the ratio of the number of local extremes over the number of mean value exceeds in time)

**Fig. 6. Comparison of FCC methods**

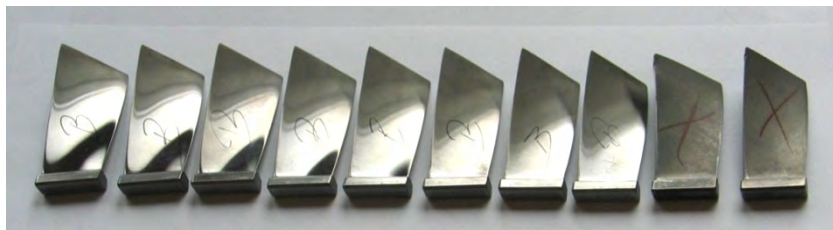
*Fig. 1. Blades of the 1-st stage compressor*

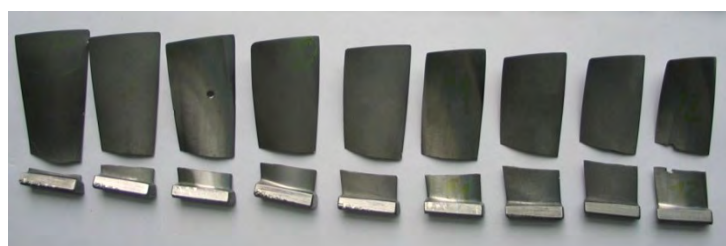
**Fig. 8. Ruptured blades of the 1-st stage of the compressor after investigations.**

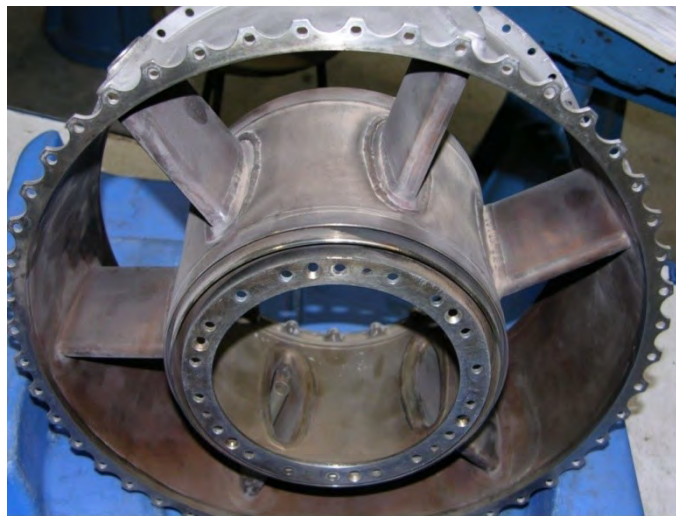
*Fig 1. View of a turbine casing for the small helicopter turbo-engine.*
