# REVIEW OF AERONAUTICAL FATIGUE INVESTIGATIONS IN POLAND DURING THE PERIOD MAY 2009 TO MARCH 2011

By Antoni Niepokólczycki

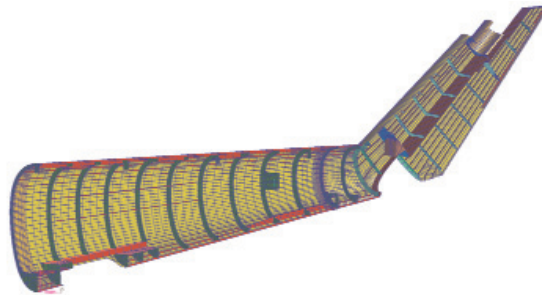
*View of the right hand side half of the numerical model*

The majority of the elements used in the model were thin walled quad elements with six degrees of freedom in a node in order to consider the effect of bending. The strength elements such as ribs or transmission boxes were represented by brick elements. Bar and beam elements were introduced for slender structure elements, such as stringers reinforcements, or when the geometry of an element was not relevant but its mass was significant, like in the case of the horizontal stabilizer.

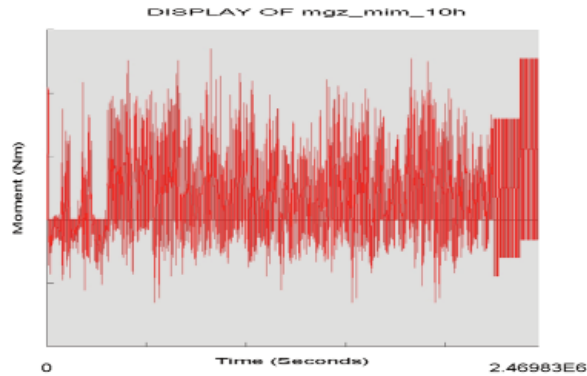
**Example load spectrum for the bending moment in horizontal plane**

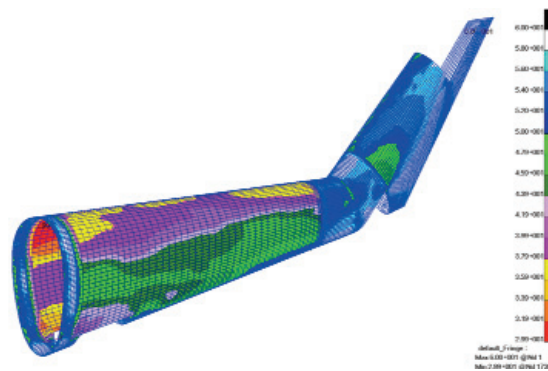
**Total fatigue life, logarithmic scale**

The analysis determined the critical locations where fatigue damage may occur. Damaged regions were located in the vertical stabilizer, where the horizontal part meets the skew one and on the circumference of the tail boom near the collar connecting it to the rest of the fuselage. The presented estimation allowed predicting fatigue life of the sheathing to be 6200 flight hours. The load that had most influence on the airframe fatigue life was the bending moment in the horizontal plane caused by the rear rotor thrust.

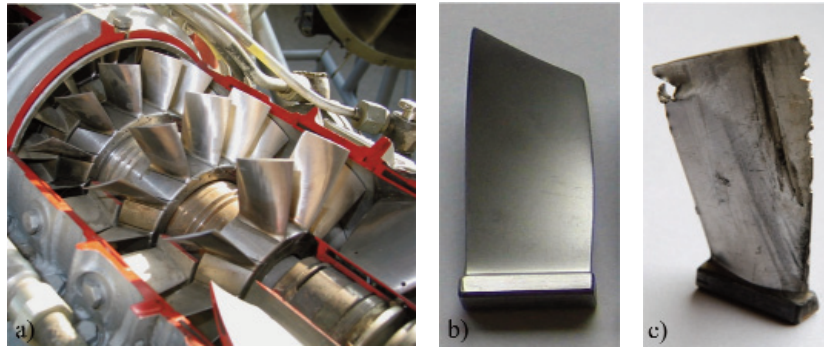
*View of the first stages of aeroengine axial compressor (a), separated blade without mechanical defects (b) and the blade damaged by a foreign object (c)*

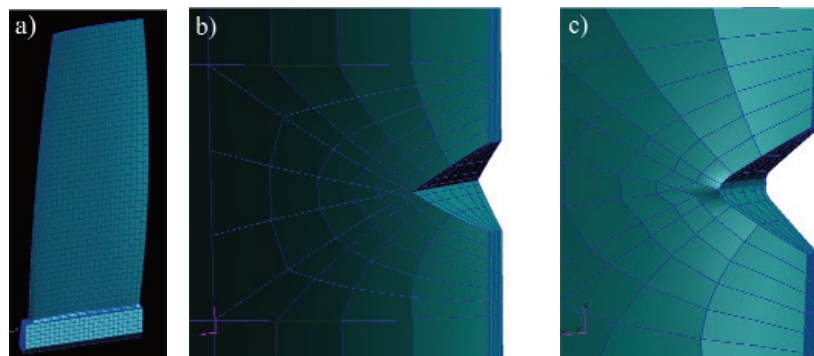
A nonlinear finite element method was utilized to determine the stress state of the blade during the first mode of transverse vibration. In this analysis, the numerical models without defects as well as those with V-notches were defined.

*Numerical model of the non-defected blade (a) and magnified view of model with infinite (b) and finite notch radius (c)*

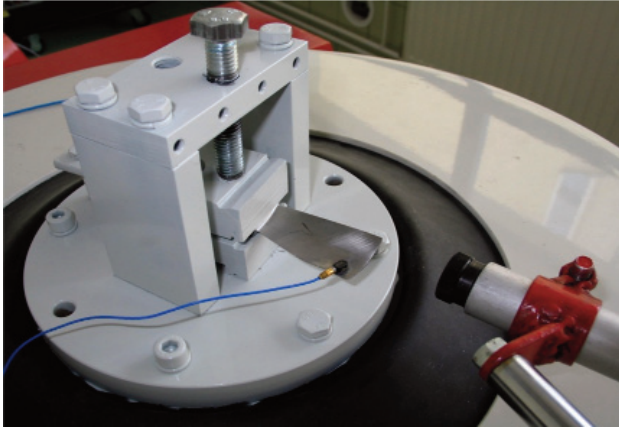
*Compressor blade fixed to the shaker during the fatigue test*

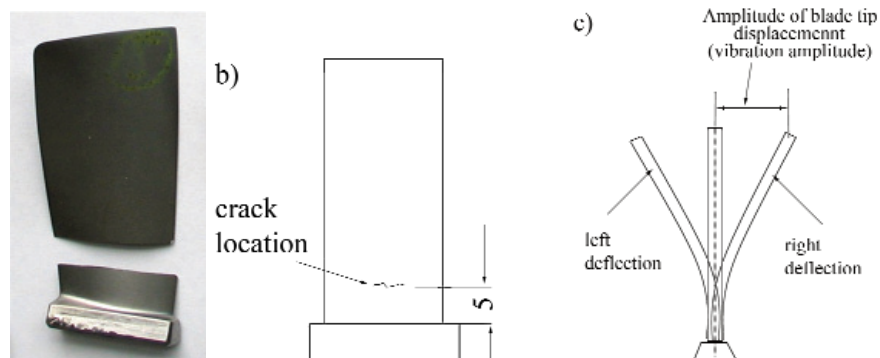
**First stage compressor blade after fatigue test (a), the most frequent crack location in the blade without preliminary defects (b) and the 1st mode of transverse vibrations shape (c)**

The location of this crack and the crack front shape were defined based on the experimental results obtained for the blade tested in resonance conditions. The K-factor values were computed only at one point of the crack front, where the crack tip touches the free surface as the crack length was measured just in this direction ( $\phi = 0$ ) during experimental investigations. In order to determine the stress intensity factors for different crack sizes, ten diverse flaws in the blade were defined.

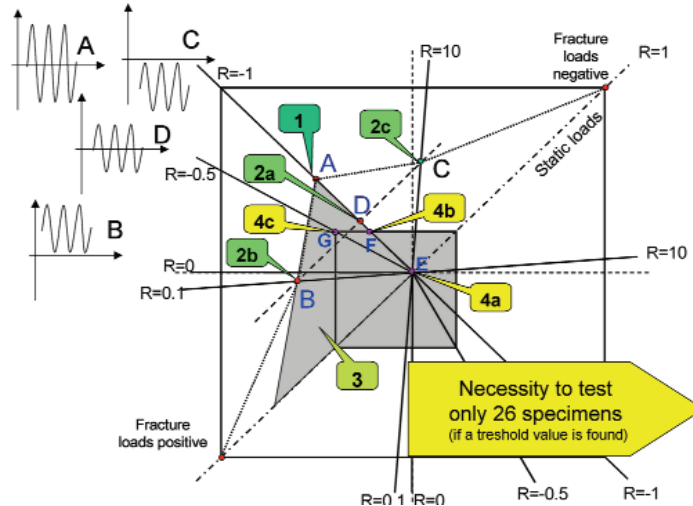
represented by point A in the figure below, and it could be interpreted as the loads that cause a noticeable drop in the residual strength after  $10^4$  cycles.

**Key points for simplified method of fatigue properties estimation for composite structures**

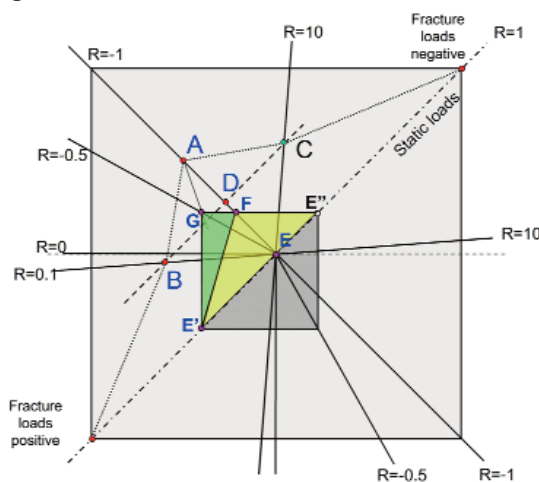
In the last (i.e. 5<sup>th</sup>) step of the procedure, two virtual planes  $E'GF$  and  $E'FE''$  are created, which make up the surface representing the number of cycles to failure in the zone of operational loads (see figure below).

**Virtual surface approximating fatigue properties of composite structures**

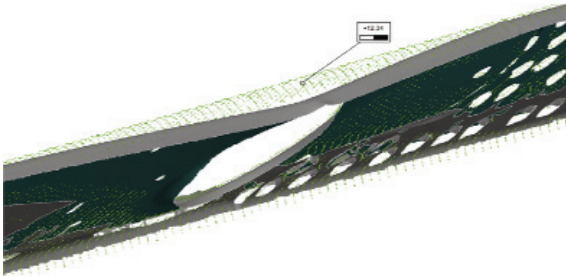
**Deformation of the longeron caused by the heat treatment**

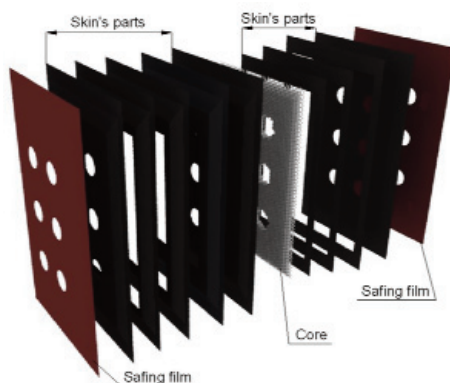
#### **Panel's structure**

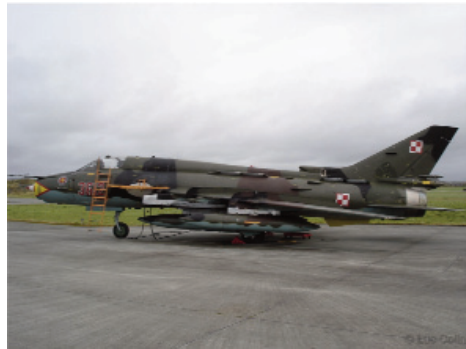
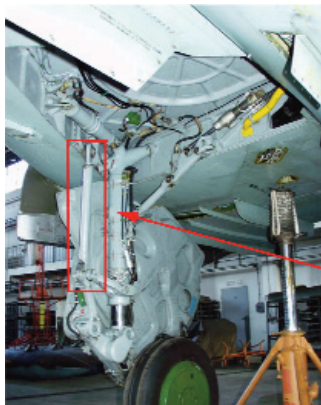
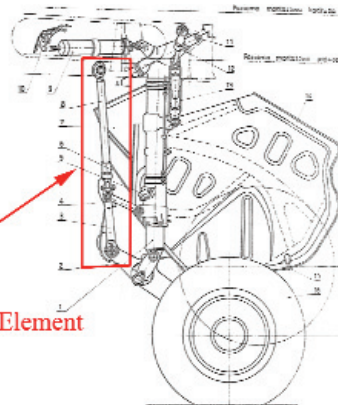
pull rod  
Critical Structural Element

**Main landing gear scheme**

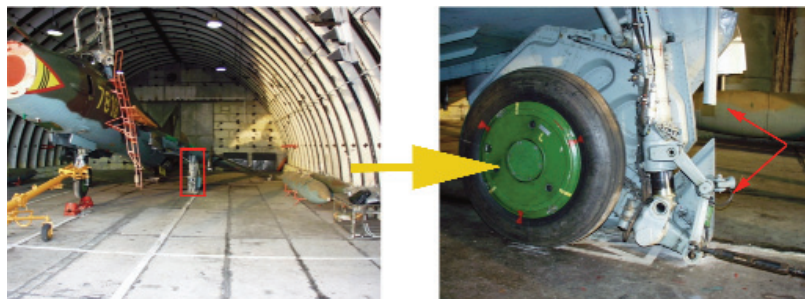
**Failure of the main landing gear**

The material tests and other engineering analyses pointed to the fatigue fracture as the cause of damage. The cracking process originated in the area of a structural notch on the boundary of the pull-rod base material and one of the three spot welds. The calculated crack propagation time (number of cycles) for the case was determined to be considerable. The corrosion of the inner surface of the cylinder was the factor that accelerated the crack growth.

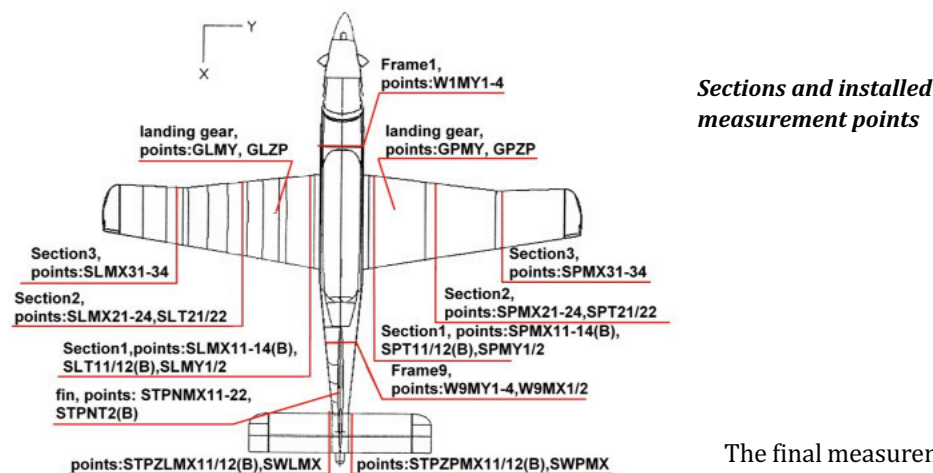
**Sections and installed measurement points**

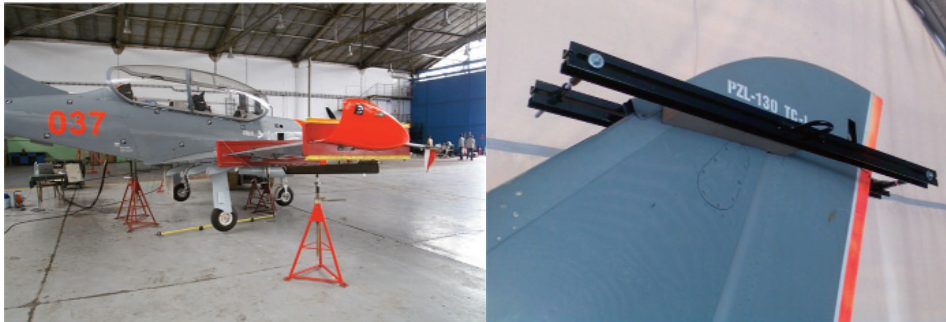
***Wing sensors calibration and clamps used for wing and fin loading***

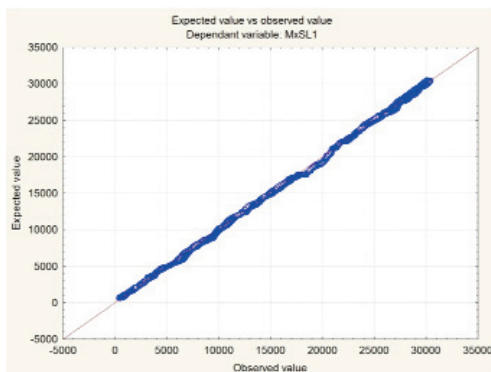
***Calculated value of  $M_{xSL1}$  (bending moment in root rib of the left wing) vs. real value measured with dynamometer***

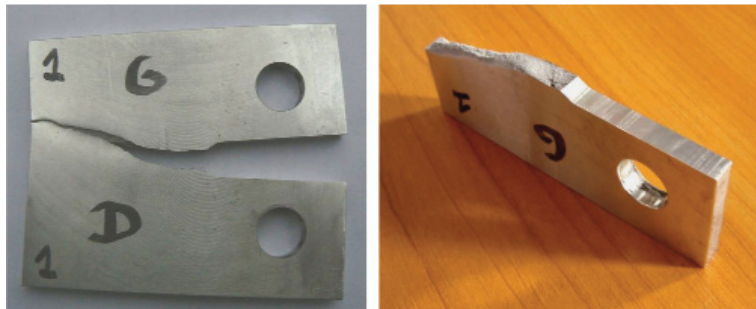
*WOL (Wedge Opening Load) specimen after test*

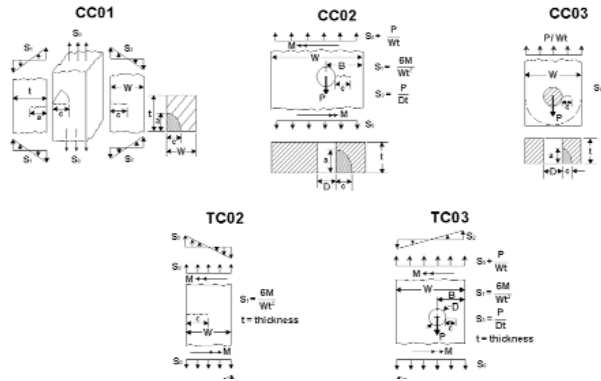
**Crack cases selected for calculations**

The figure shows crack cases selected for the purposes of the analysis. Following the recommendations of the research methodologies and the NASGRO software instructions, crack models were selected according to the geometry of the critical element. The initial crack length applied in the calculations was 1.27 mm. Other dimensions were selected according to the measurements.

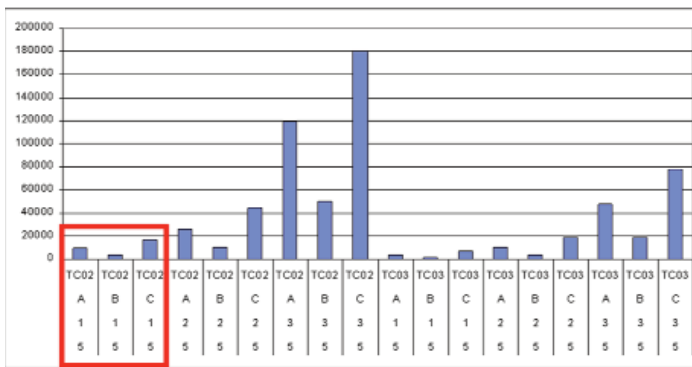
**Graphical representation of durability for the selected critical elements**

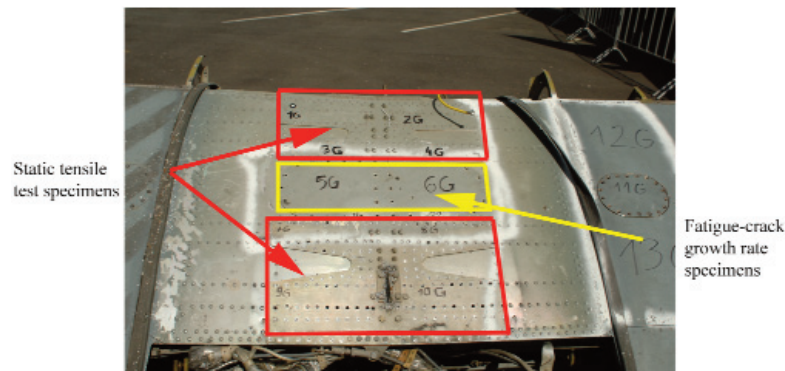
*The wing of the PZL-130 ORLIK - place of collecting material for specimens*

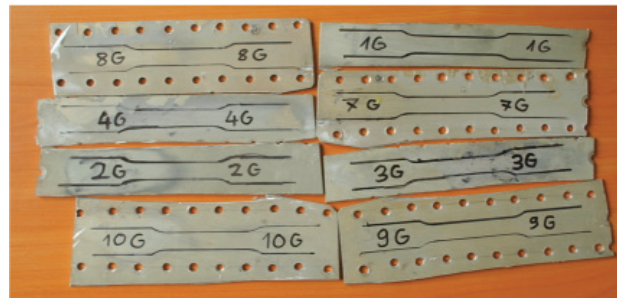
*Location of collecting static test specimens*

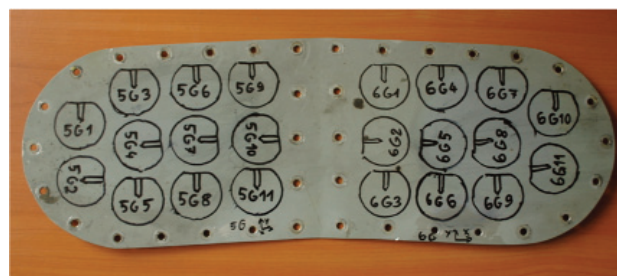
*Distribution of fatigue-crack growth rate specimens*

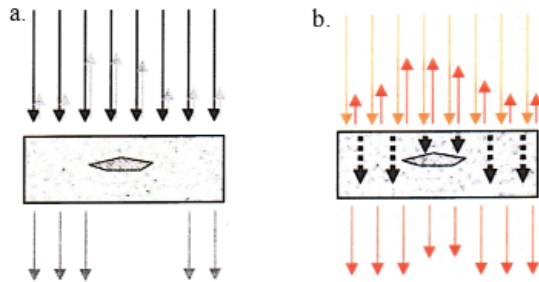
**Presentation of physical phenomena similarities in the examined material:**  
*a) dispersion of ultrasound waves*  
*b) dispersion of thermal wave*

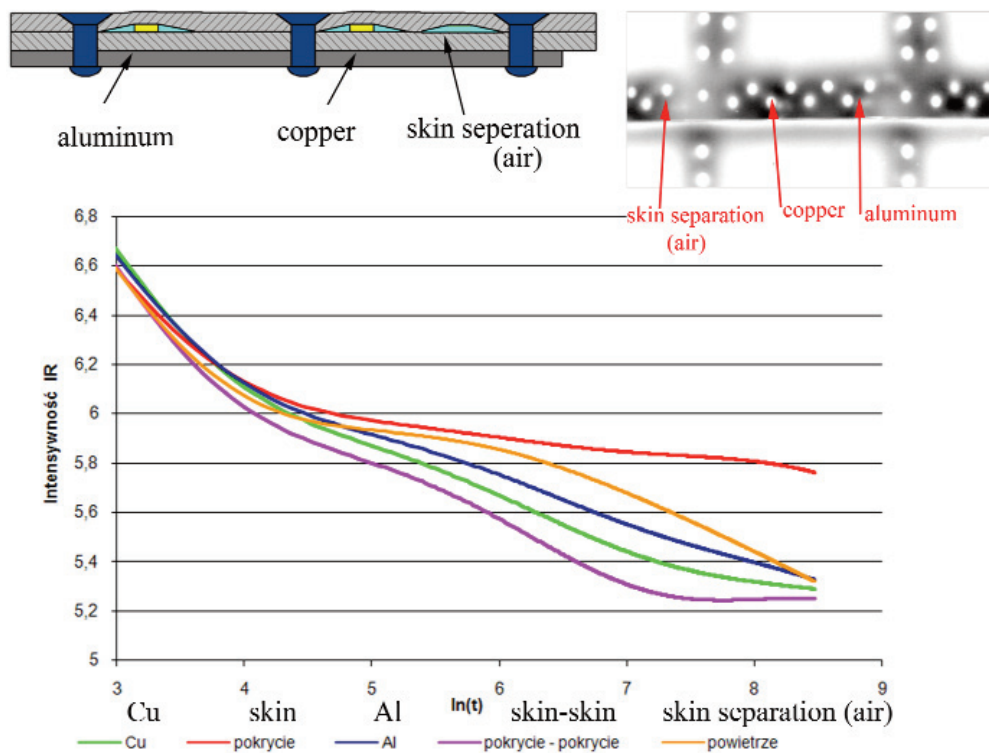
**Thermograph of the sample tested and a diagram illustrating the surface intensity**

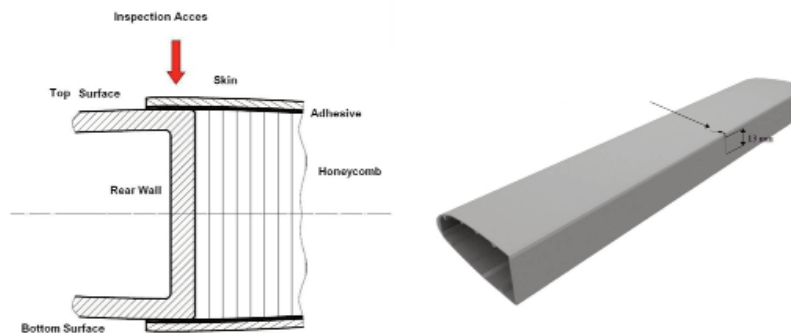
**Geometry for inspection**

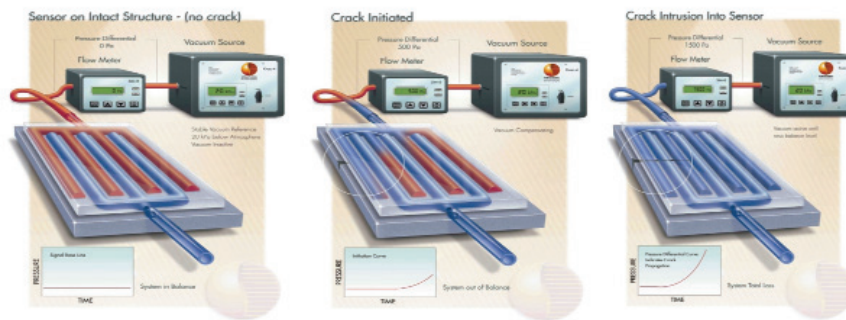
The technique called CVM™ is connected with the crack monitoring. This technique is simpler than wave generation. Monitoring is based on local crack detection. Sensors consist of multiple measurement galleries. There are two channels in each sensor (connected to the vacuum generator and ambient pressure). Damage localization is connected with the vacuum generation in the measurement galleries. The principle of work is presented in the figure below. Depending on the crack length, crack orientation and sensor shape, pressure variations indicate crack propagation under the sensor, which means there is a possibility for crack length estimation.

***Principle of work of the CVM™ system***

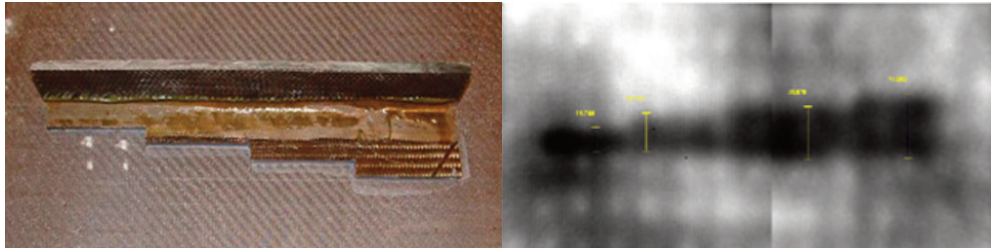
*Specimen of the wing skin (left) and thermography results (right)*

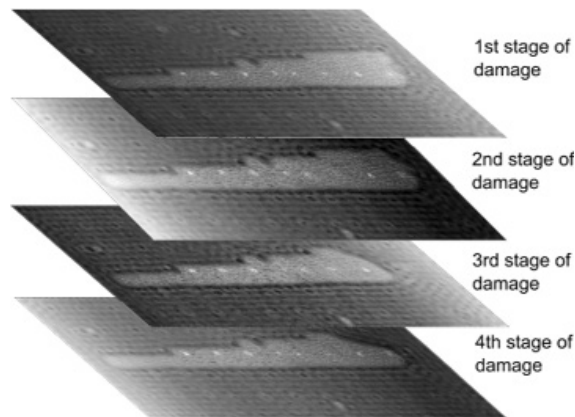
The propagation of damage is illustrated below in the form of C-scan:

*Propagation of disbond*

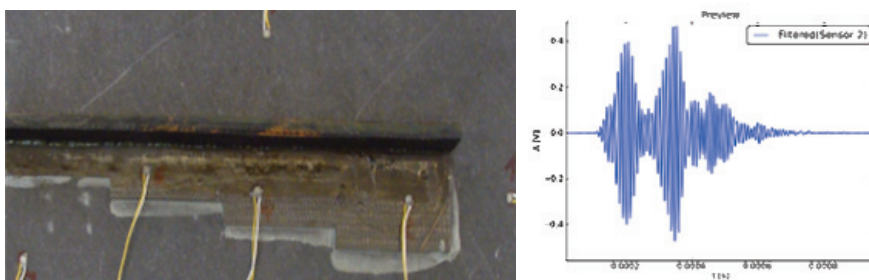
*PZT sensors layout and example of generated signals*

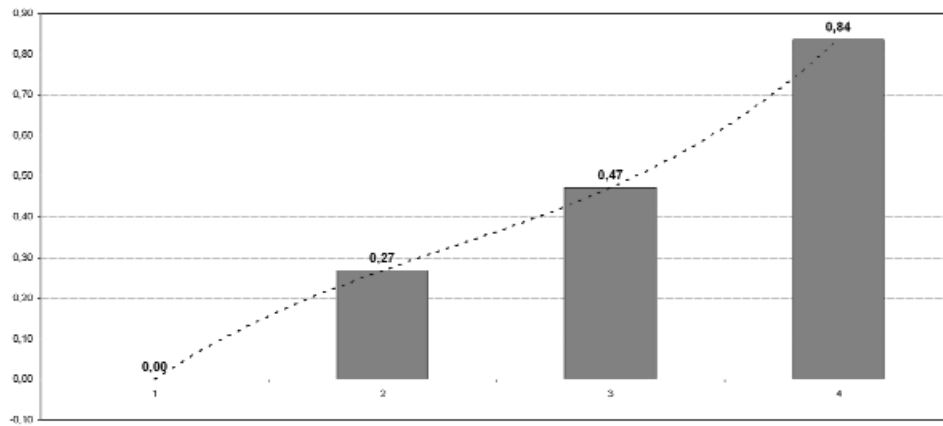
If there is a non damage condition, the index is equal to 0. If the damage develops, the Damage Index is equal to a value higher than 0 but never reaches a value greater than 1.

**Results of the damage index development for the experiment**
