Influence of field and road pattern change on gully development in the Bug River valley side (E Poland)

Abstract: Causes of dynamic development of a permanent gully dissected in sandy river valley side were presented in this paper. Road and field pattern change conditioned the gully forming during one downpour. A new pattern and crop structure caused fast surface flow on the side. Flow concentration along the road and balks causes dissections of gully escarpments and development of the gully branches.

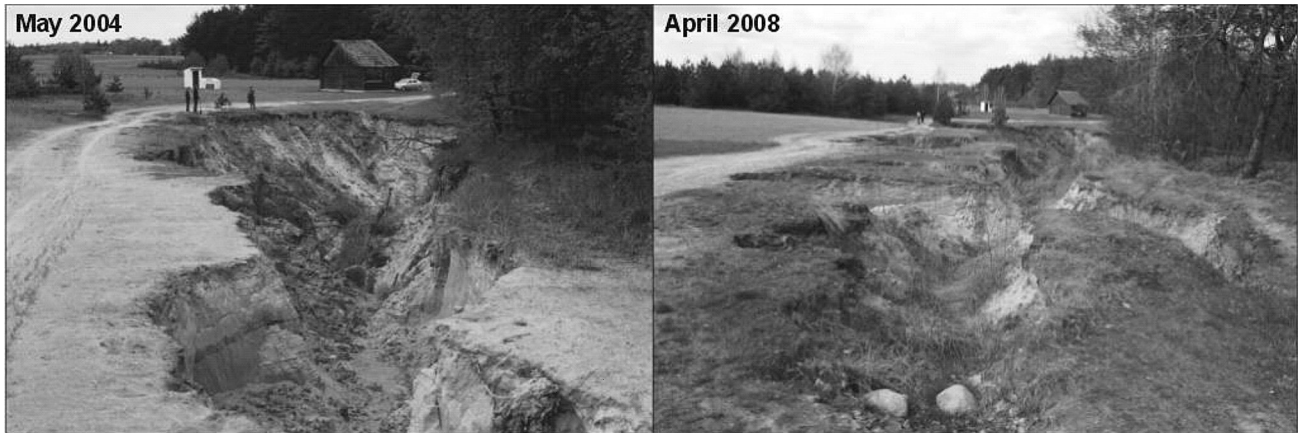
Fig. 3. Upper segment of the new gully in: May 2004 and April 2008

orological station, 15 km from the gully – size of downpour amounted 43 mm), this gully developed rapidly. It cut a track running along the Bug River valley edge to a depth of 10 m, on the length over 50 metres and width about 10–15 metres. On March 2004, the gully has elongated due to head-cut erosion by relatively small dissection of 20-m length and 3–4 m width (Fig. 3). A volume of the gully, calculated on the basis of tachymeter measurements, amounted $3.1 \cdot 10^3 \text{ m}^3$.

Lithological and geomorphological conditions on the Bug river valley edge are favourable to gully erosion. However, the main reason of new gullies development is the field and road pattern change, because an ancient pattern dispersed overland flow on the slope. Its unintentional alteration hasn't caused an instant erosion for an ancient system of overland flow has functioned for 30 years yet. Its part conformity to the new field pattern happened during the downpour on 28th May 2002, what resulted in strong gully erosion. An entire adaptation of the flow is able to occur after filling of the former road depression on successive field. It will cause further increase of the catchment and gully erosion along roads and furrows (Fig. 2), begun in 2004–2009 period (Fig. 3, 4).

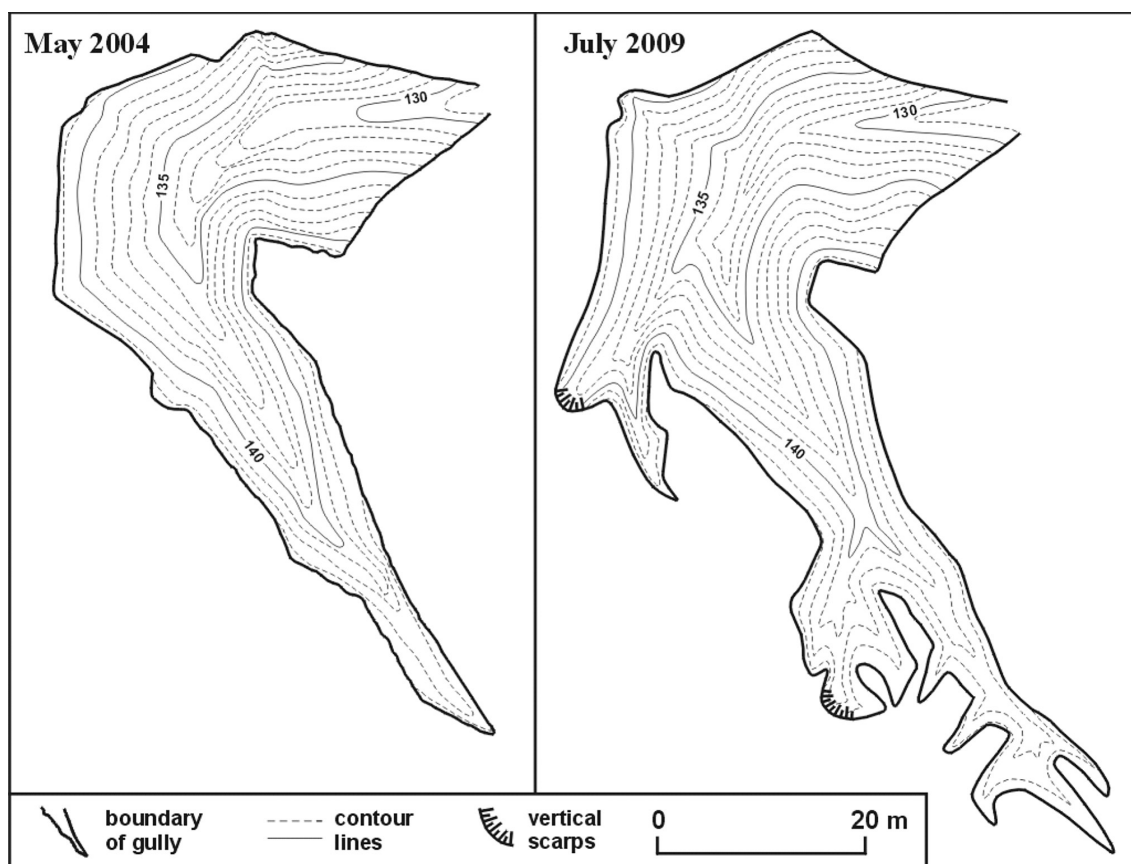
Fig. 4. Development of new gully in the 2004–2009 period on the basis of tachymeter measurements

Next significant gully development took place in June 2009. During torrential, short-lasted rainfalls, side branches developed by head-cut erosion in lower and medium parts of the gully (Fig. 4). It was the result of the field flow along furrows and baulks. After this episode, the main form is 100 metres long and total length of all dissections amounts to 150 metres. A gully volume increased to $4.0 \cdot 10^3 \text{ m}^3$, i.e. by 29% during 5 years.

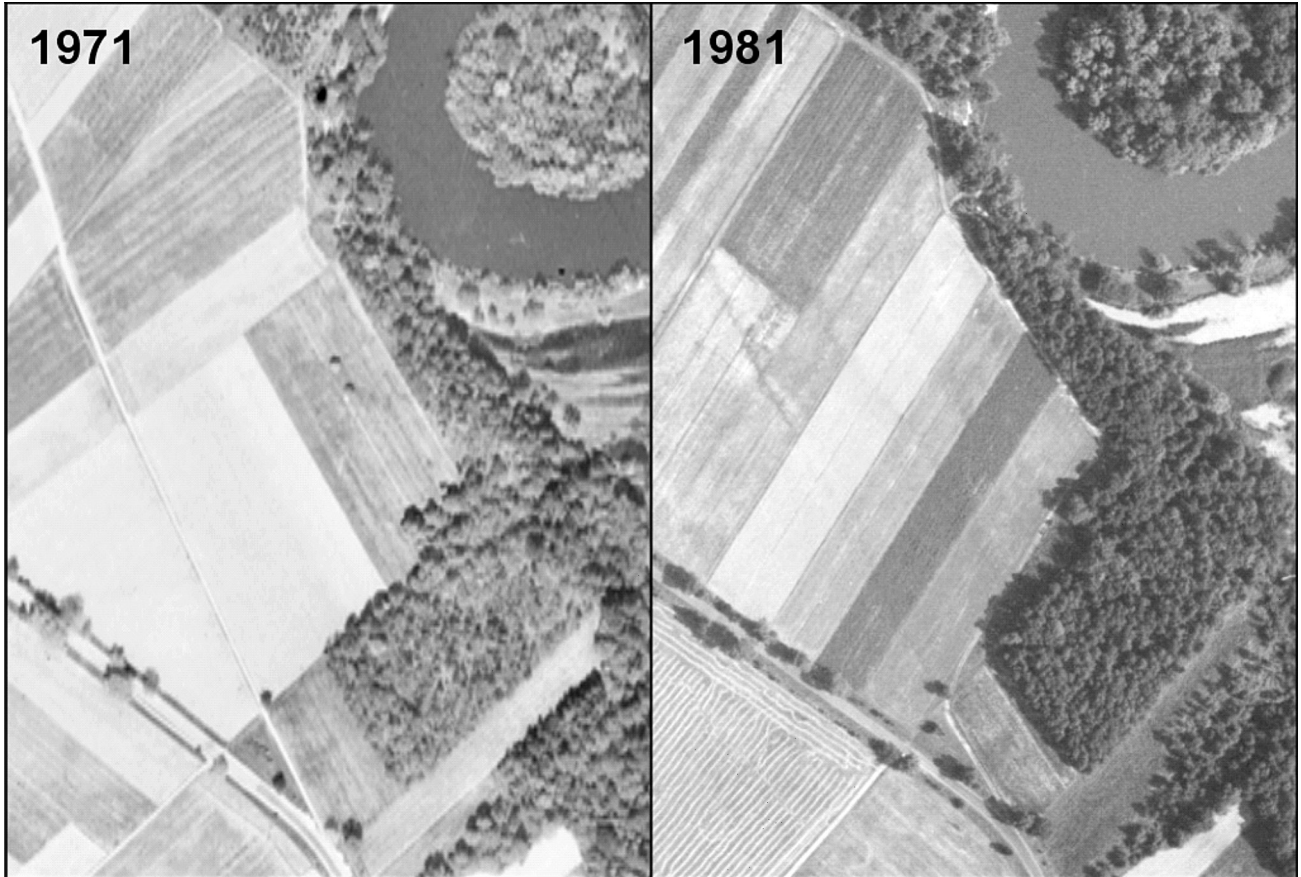
Fig. 5. Field and road pattern change as a result of a field arrangement carried in 1972, aerial photo from 1971 and 1981

A current field and road pattern developed as effect of field arrangement, carried out in order to have easier access to parcels (Fig. 5). On adjacent to the Reserve, agriculturally used side, direction of cultivation was changed that time from across to down-slope one. An old road, collecting a surface flow previously, was ploughed but a shallow depression crossing new fields, remained. It collected and dispersed flow from upper sections of fields till 2002 year. However, during 30 years, it became filled with colluvia layer with 50 cm thick. In turn, the new road, running along the Nature Reserve boundary, has deepened a little (< 30 cm) during this time, It was the result of washing during intensive using by visiting the Reserve school children, tourists, also anglers and farmers.
