SURFACE MODIFICATION OF POLYPROPYLENE NONWOVEN WITH COMPOSITE METALLIC LAYERS

Kazimierz Reszka, Ewa Dobruchowska

Joanna Koprowska, Błażej Wiśniewski

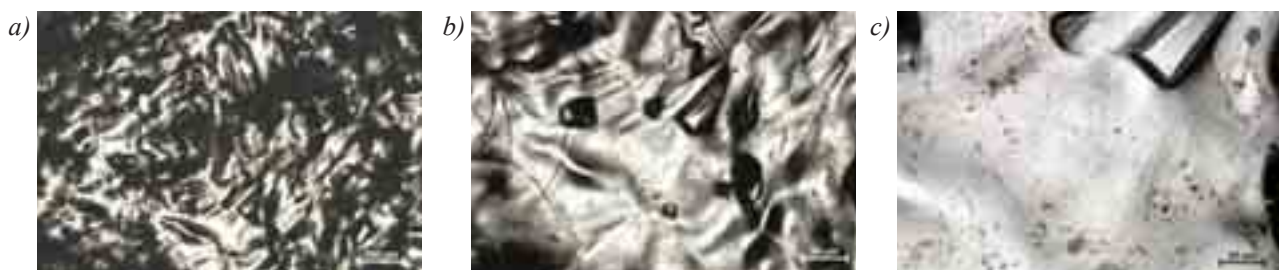
Images obtained by metallographic microscopy (Fig. 2) provide a monolithic surface of the nonwoven fabric, melted under the influence of temperature, and a few holes that are residues of free spaces characteristic of the design of non-deformed “weave”. A metal layer covering the molten substrate is continuous, marked by a few cracks, visible clearly in all sampling areas.

Fig. 2. MM images of 1 (CuZnNi) sample surface: a) the scale of 100μm, b) the scale of 50μm, c) the scale of 20μm

“Over-pressed” spots show a similar structure in all areas of the surface sampling. There are no visible signs of “flow” of substrate material. The deposited layer is uniform and smooth, and the visible points of discoloration may be a sign of initial chemical changes, possibly corrosive destroying of the layer.

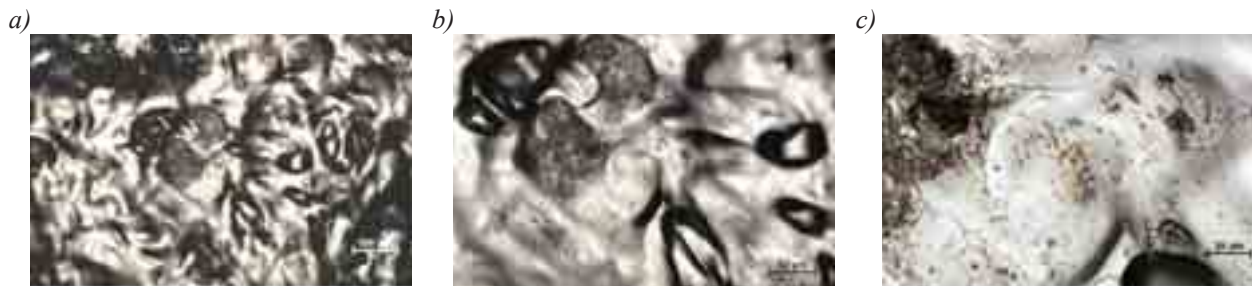
Images obtained by metallographic microscopy (Fig 3) illustrate the “weaves” i.e. areas of unwoven fabric between “over-pressed” spots. The fibres of this zone are highly molten and form a compact structure. One can only see a few pores, which are residua of the free spaces of nonwoven fabric produced prior to deposition of metal layers. The fibres are outlined with cracks on a metal layer, running across the fibres and extensive staining accumulated at elevations. This is probably an image of places where the metal layer was subjected to peeling or chipping.

Fig. 3. MM images of 2 (NiCuFe) sample surface a) the scale of 100 μ m, b) the scale of 50 μ m, c) the scale of 20 μ m

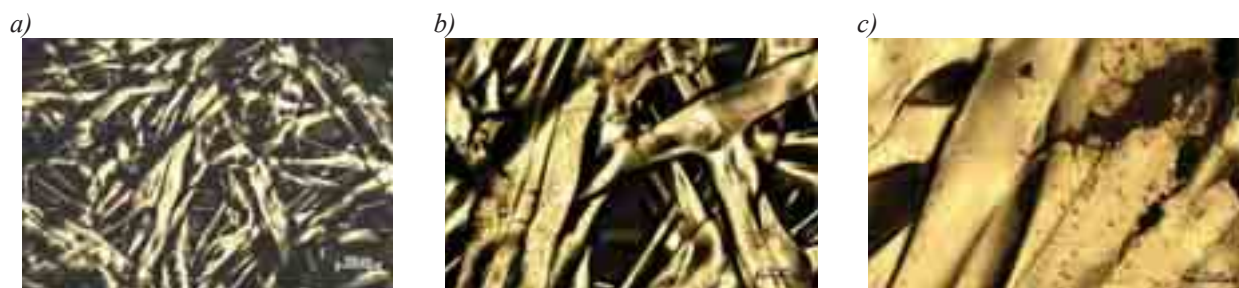
Images obtained by metallographic microscopy (Fig. 4 a, b, c) of the areas of unwoven fabric between locations of "overpresses" and "weaves" provide a confirmation of previous observations. They show that the dominant role in evolution of unwoven fabric morphology in the deposition process, in relation to the uncoated unwoven fabric, play two effects: partial melting and binding of the surface fibres forming "threads" and scaling leading to disruption of a deposited metal layer. Compared to the previously described layers, the temperature accompanying the Cu /Sn layer deposition process resulted in less deformation of their shape.

Fig. 4. MM images of 3 (CuSn) sample surface a) the scale of 100 μ m, b) the scale of 50 μ m, c) the scale of 20 μ m

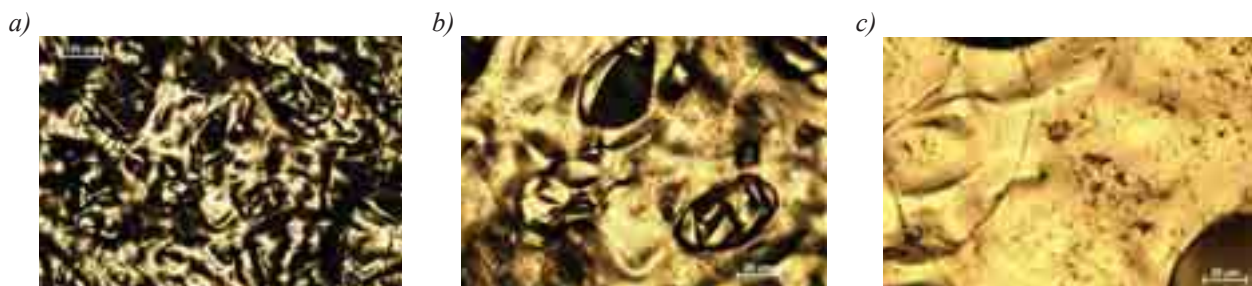
Images obtained by metallographic microscopy (Fig. 5 a, b, c) of the areas of unwoven fabric between locations of “overpresses” and “weaves” show that there was a total deformation of the fibres under the influence of temperature. The metal layer revealed cracks that run across the entire width of the fibres. There occurs local extensive scaling that exposed low-lying fibre fragments of fibres of lower deformation.

Fig. 5. MM images of 4 (three-layer system: CuZnNi / NiCuFe / CuSn) sample surface a) the scale of 100 μ m, b) the scale of 50 μ m, c) the scale of 20 μ m

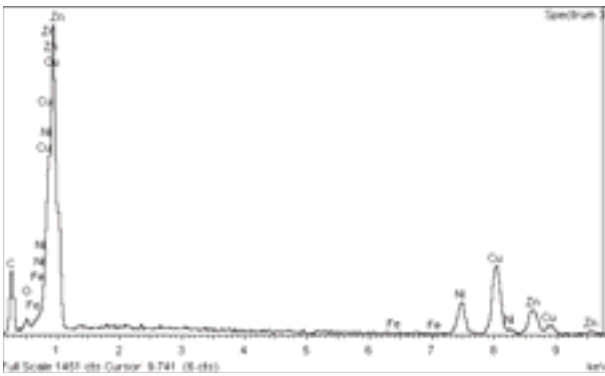
Type of target/ layer	Target composition (wt%)	Layer composition (wt%)	Spectrogram
CuZnNi	Cu (53.5-56.5) Zn (25-30) Ni (17-19)	C(6) O(4.02) Cu(49.23) Zn(25.57) Ni(15.08) Fe(0.1)

Table 3 presents the fraction of elements constituting the composition of the metal targets used for the layer deposition and elements forming the deposited layers. Fractions of elements forming the layers are the average selected from three arbitrarily selected points of measurement. Next to each set, there is a spectrogram from one of the measurement points.

It follows from these sets that the chemical composition of the analyzed area is composed mostly of carbon. It is identified for the most part, as a component of polymer substrate from which the unwoven fabric is made. There was also found the presence of small amounts of oxygen in all the analyzed layers. There was no presence of zinc in the three-layer system.

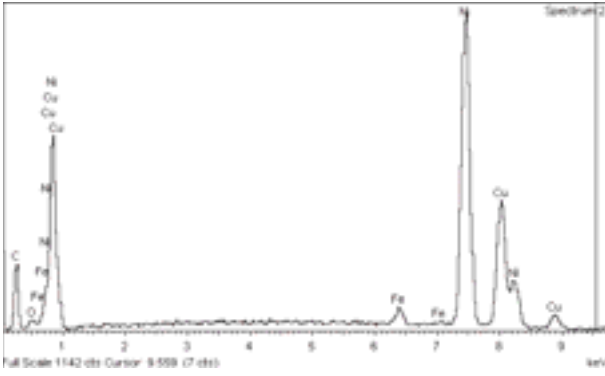
NiCuFe	Ni (65) Cu (33) Fe (2)	C(6) O(3.8) Ni(61.6) Cu(28.0) Fe(1.32)

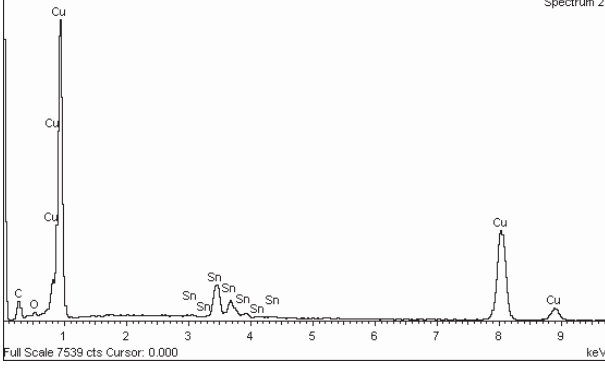
CuSn	Cu (80) Sn (20)	C(6) O(2.51) Cu(75.82) Sn(15.67)

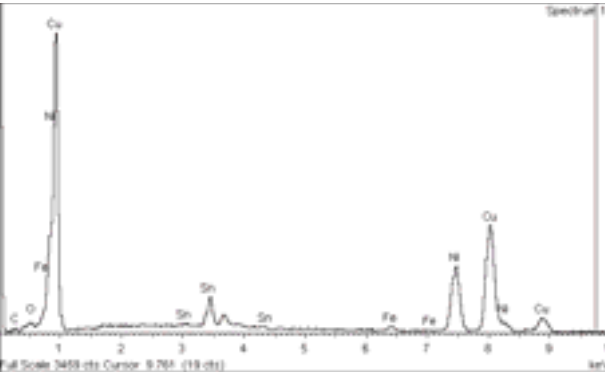
CuZnNi/ NiCuFe/ CuSn	(compositions as mentioned above)	C(6) O(1.7) Cu(56.0) Ni(28.0) Sn(7.6) Fe(0.7)
