REPLACEMENT OF A FAILED SHOTCRETE FACING BY A FLEXIBLE SLOPE STABILISATION SYSTEM

Abstract. The alignment of a new highway from Igoumenitsa to Evros in the north of Greece required several massive cuts in soil slopes. Mainly due to erosion and creep movements within the superficial layer of a cut soil slope, the shotcrete facing failed. The friction forces as a result of interaction between shotcrete facing and soil surface caused an overstraining of the stiff facing, and finally its collapse. The shotcrete was removed and replaced by a flexible slope stabilisation system consisting of a high-tensile steel wire mesh cover in combination with an adequate nailing. Flexible slope stabilisation systems are widely used to stabilize soil and rock slopes. They are economical and a good alternative solution to stiff measures with shotcrete or massive structures with the possibility of reintroducing vegetation. Special concepts have been developed for the dimensioning of flexible slope stabilisation systems considering superficial instabilities. Numerous implemented cases in soil as well as in rock with and without vegetated faces confirmed that these measures were suitable for practical a

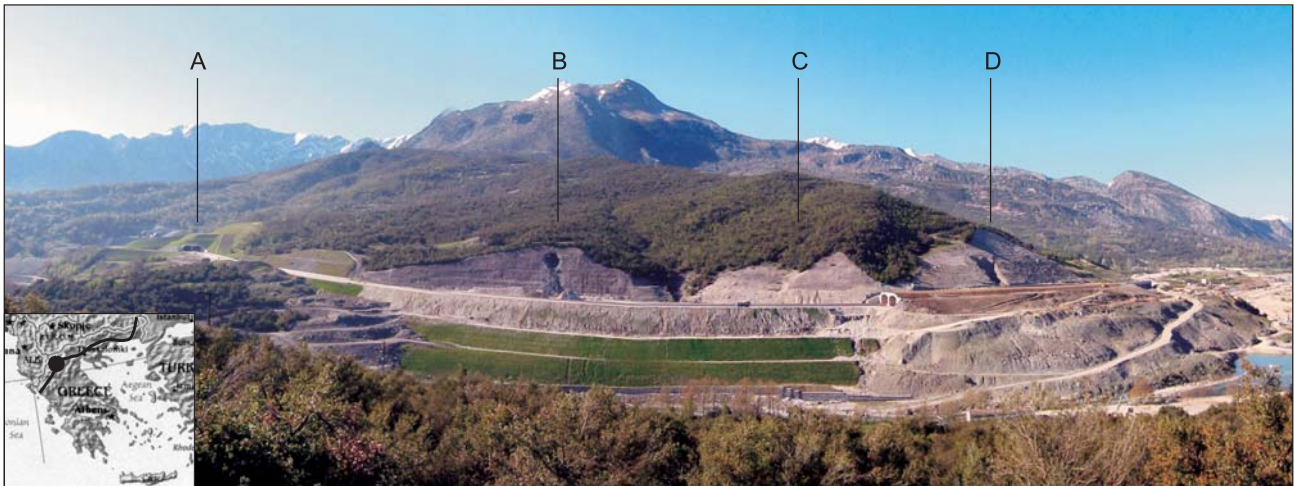
Fig. 1. Project overview looking south of Egnatia

The recultivated slope cutting is situated near Peristeri, Greece, above a tunnel open pit constructed at an altitude of about 720 m a.s.l. (location A, Fig. 1). The inclination of the stabilised 420 m long slope, 40 m high at the entrance area as well as 18 m above the covered tunnel, amounts to 40–60°.

The area of interest is the location A (Fig. 1) (ch. 4+511–ch. 4+616) where sandstones are prevalent. Geologically, the area is structured by flysch of Pindos zone. Tectonically, the flysch is intensely folded and sheared. On the surface, the flysch is weathered and shattered down to a 6 to 7 m depth. Seasonal perched water tables are developed in the surface of the loose and shattered flysch zone. The erosion caused by Metso-

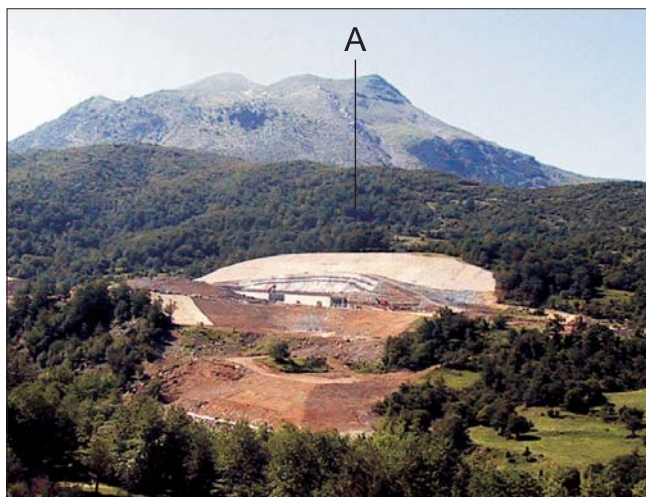
Fig. 2. Slope after TECCO installation

Failures were observed in the embankment fill, the weathered part of the flysch, and the deeper layers of the flysch. The failures can be separated into creeps and landslides. The largest part of the A area is an active deep landslide with a local creep. Creep causes instability at shallow depth (Figs. 2–4).

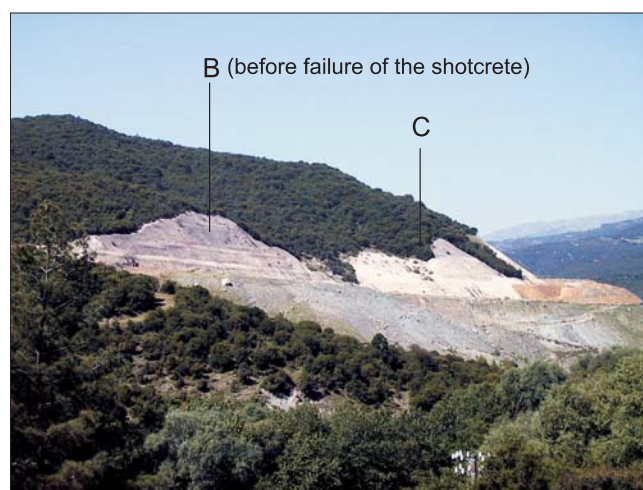
Fig. 3. Neighbouring shotcrete slopes

In general, the applied shotcrete was of poor quality. Evidently, the added fraction of cement was partially too poorly visible because of the darker shotcrete colour. In those areas, up to 20–25 mm of the top layer of the shotcrete facing is strongly weathered and mellowed with the resulted cracks. The appearing lighter areas were of better quality, less weathered and in better condition. Next to the bad quality of the shotcrete facing, the main problem was the erosion of the subsoil just beneath the shotcrete, due to insufficient or not adequate drainage measures. Locally, there were no more contacts between the subsoil surface and the shotcrete facing.

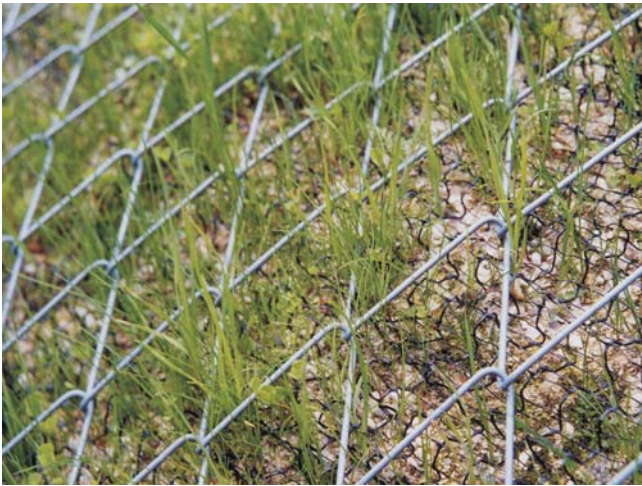
Fig. 5. TECCO system spike plate

Special diamond-shaped system spike plates matching the TECCO mesh serve to fix the mesh to soil or rock nails. By tightly pressing and if possible slightly impressing the spike plates in the stabilised ground, the mesh is tensioned in the best possible manner.

As the first step, the shotcrete facing was completely removed. Instead of a stiff impermeable cover layer, a flexible slope stabilisation system was installed consisting of the high-tensile steel wire mesh TECCO in combination with special system spike plates (Fig. 5) adapted to the high-performance steel wire mesh (Fig. 6). Its size and bending resistance have been based on numerous puncturing and bending tests. The GEWI D = 28 mm, with a length of 8 m and in a 3.0×3.0 m pattern, were used for the slope nailing, whereas the mesh was connected to each nail head by special spike plates (Fig. 7). The forces were then transferred from the mesh, over the plates into the anchors (Rorem, Flum, 2003; Rügger, Flum, 2001).

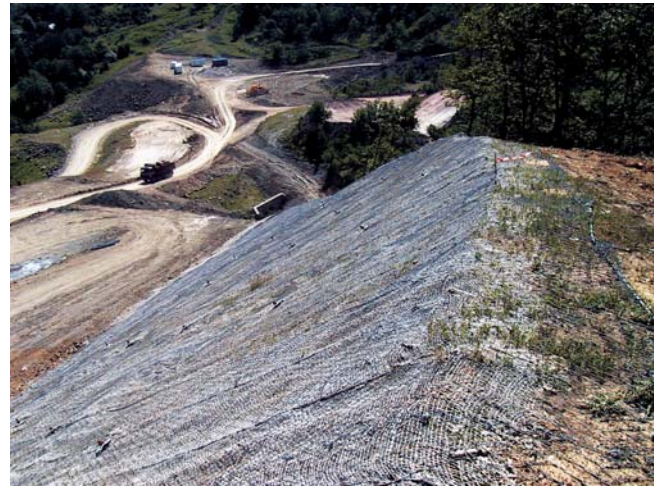
Fig. 8. After the mesh installation

erosion caused by heavy rainfalls, snow, water outflows or even wind (Figs. 8–10).

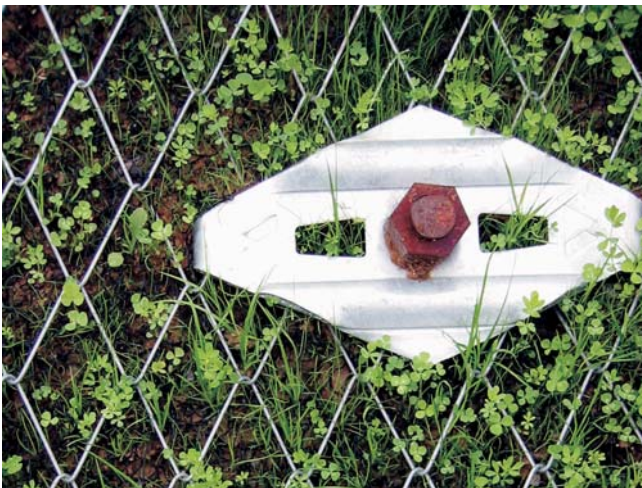
Fig. 6. High-tensile steel wire mesh TECCO

In a standard layout, the high-tensile steel wire mesh TECCO for surface stabilisation is made of a high-tensile steel wire, with the individual wire tensile strength of at least $1,770 \text{ N/mm}^2$. The wire is of 3 mm diameter, and has an aluminium-zinc coating (so-called GEOBRUGG SUPERCOATING) for protection against corrosion. The diamond-shaped meshes measuring $83 \times 143 \text{ mm}$ are produced by single twisting. The TECCO steel

wire mesh provides a tensile strength of 150 kN/m . Thanks to its three-dimensional structure; the mesh clings to the soil in an ideal manner and, additionally, serves to optimally secure subsequent sprayed-on greening.

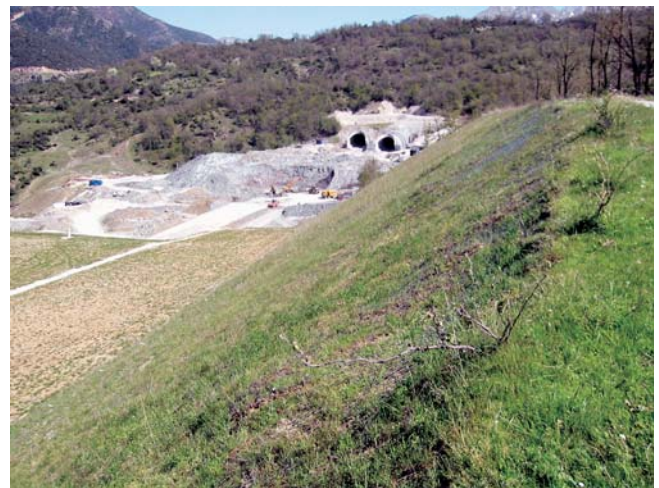
Fig. 9. After the mesh installation (one year later)

Two years from the installation during dry and hot summers and cold, wet winter weather, the slope is establishing a continuous vegetation cover by itself, even that it is built into the flysch consisting mainly of sand and siltstones. After an initial grass greening, the local vegetation was slowly creeping back onto the stabilised cut slope, with bushes and shrubs. No additional irrigation or reintroducing vegetation has been carried out during this period. The visual impact of the slope as described above is much more appealing com-

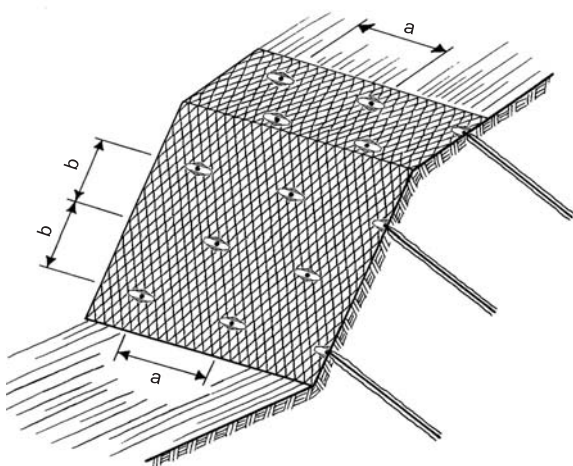
Fig. 7. General nail arrangement

The nailing was adapted to the static requirements based on the overall stability investigation considering sliding mechanisms with deeper-seated sliding surfaces. In addition, it is supposed to be checked if the flexible slope stabilisation system, consisting of the mesh cover and corresponding system spike plates in combination with the existing nailing, could withstand all stresses of the superficial instabilities. Based on the world-wide published and accepted RUVOLUM dimensioning concept, local instabilities between the single nails as well as superficial slope-parallel instabilities as shown on Figures 11 and 12 had to be investigated. Thereby, all proofs of bearing safety could be fulfilled.
