# Water-lubricated bearings of ship propeller shafts - problems, experimental tests and theoretical investigations

Wojciech Litwin, Ph. D.  
Gdansk University of Technology

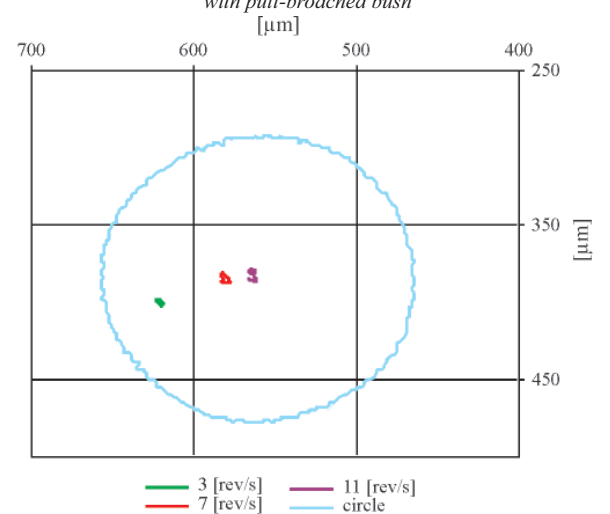
Fig. 18. Bearing fitted with composite bush of 0.0017 relative clearance value; up – the bearing with turned bush; down – the bearing with pull-broached bush

The performed tests showed that roughness topography, i. e. its arrangement has not any significant impact on bearing qualities [7]. Below, an example comparison of the experimentally recorded shaft axis trajectories, is shown. The observed very small differences in the journal's position demonstrate that the state of surface has negligible effect on hydrodynamic bearing qualities. Worth adding that the tests were performed just after mounting the bearing and before bush material running-in.

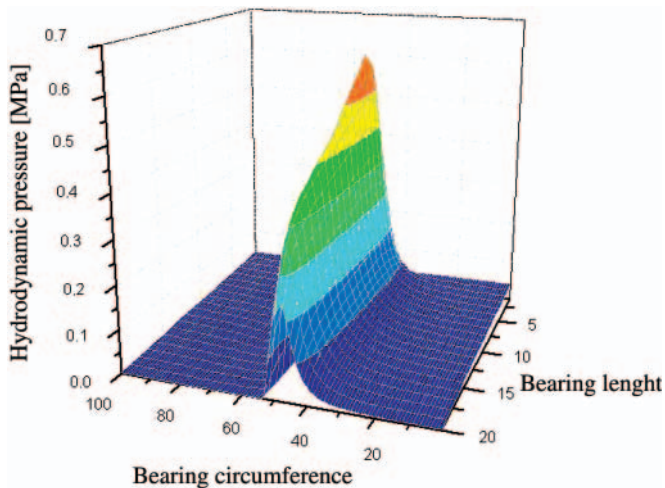
Fig. 20. Calculated pressure field in a bearing fitted with elastic bush of the material rigidity modulus  $E=800$  MPa, and shaft axis skewed against bush

In the below attached diagrams is presented a change of form of calculated pressure field, which results from the skewing of shaft axis. In the analyzed case the theoretically maximum value of hydrodynamic load-carrying capacity of the bearing decreased by 25% as a result of the shaft axis skewing.
