An analysis of cause and effect relations in diagnostic relations of marine Diesel engine turbochargers

Abstract

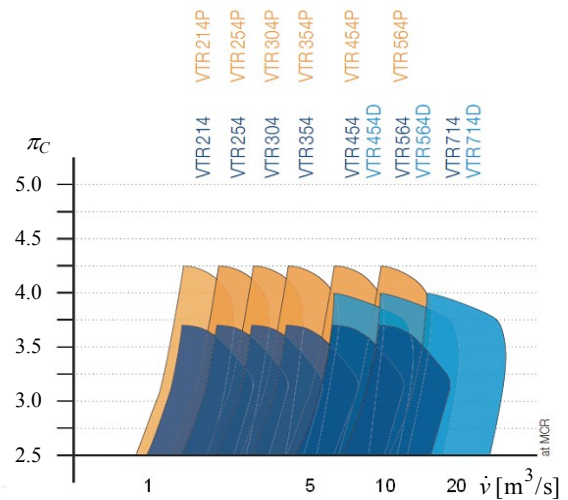
Fig. 2. Normal characteristics of the compressors of the VTR type [7, 10]

Constant pressure turbochargers of the TPL and VTR types are also produced by ABB. Decomposition of the popular VTR model is presented in figure 1, whereas normal characteristics of the VTR type in the co-ordinate system compression – flux of charging air volume for the contractual engine operation point, identifying operational parameters of compressors are shown in figure 2 [7, 10].

VTR turbochargers in the working medium exchange system of Diesel engines deliver air fluxes of compression up to 3.3 (the basic compressors) and up to 4.25 (P type) with the volume fluxes up to approximately 15 m³/s and the compression up to 4.0 and mass flux up to 20 m³/s (D type).

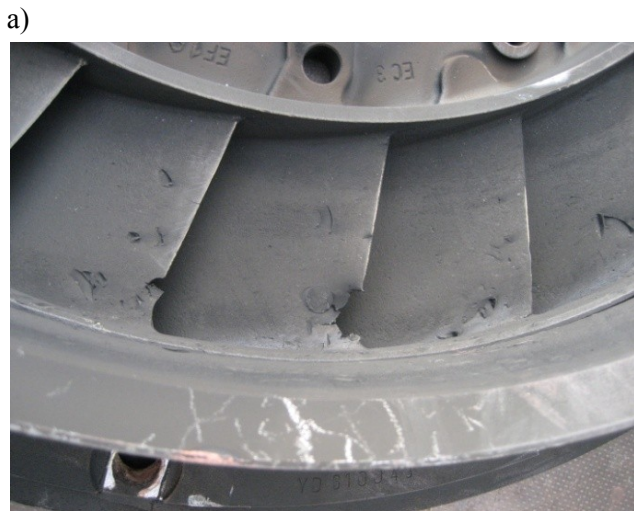
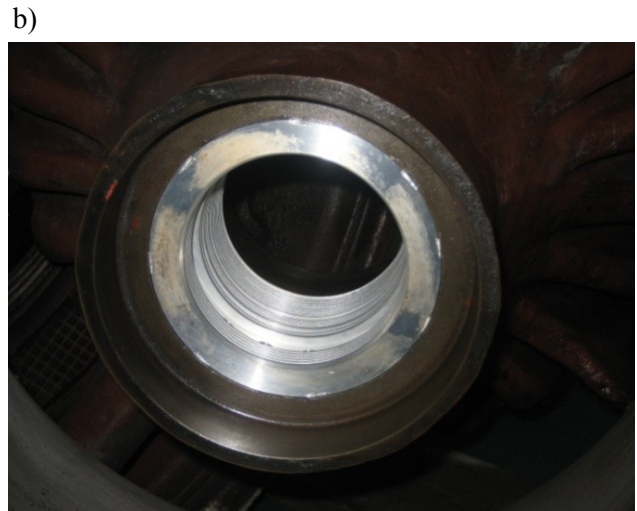
Fig. 10. Results of the random damage to the VTR-454-11 turbocharger; a) damage to turbine guide vane / stator blades due to a broken or torn injector pin, b) the damaged labyrinth sealing due to the shortage of an air barrier

- the own oil system or the engine oil installation of.
- 2) Damage resulting from the natural ageing / wear processes, related to the turbocharger active service time (Fig. 9).
 - 3) Damage resulting from external chance causes (Figs 10 and 11).

These can be regarded as the random events, related to faulty functioning of an antropo-technical couple: human – engine (a nut left in the turbine, not renewed oil). The most frequently encountered damage of this type results from non-compliance with the assembly technology, e.g.: positioning of bearings incompatible with manufacturer's recommendations, application of the substitute sealings etc.

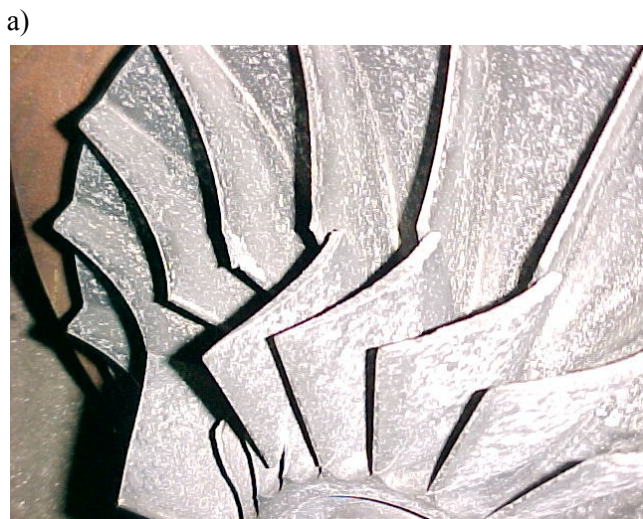
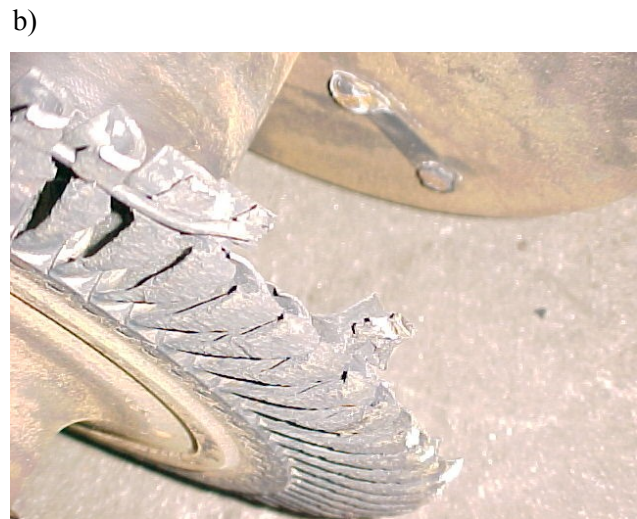
Fig. 11. Results of the random damage to the ABB VTR-250 turbocharger [13]; a) damage to the compressor rotor caused by the seizure of the bearings of the VTR-250 turbocharger, b) damage to the turbine rotor by a foreign body – the ABB VTR – 250 type turbocharger
