EFFECTS OF LASER RADIATION ON THE CEMENTITIOUS MATERIALS – THREE CASE STUDIES

Agnieszka J KLEMM*, Kazimierz ROŻNIAKOWSKI**

Summary: Laser processing is unarguably associated with some alterations of cementitious materials' geometrical microstructure and chemical composition. Since high temperature is involved in the laser cleaning process, the chemical composition of surfaces may change, followed by crack development and subsequent changes of roughness. The relationship between laser treatment and substrate parameters is a two-way relationship. The great variation in absorptivity of highly developed surfaces of cementitious materials results in substantial differences in their responses to laser irradiation. Paper presents selected results of three investigations on the effect of laser radiation on characteristics of porous cementitious materials.

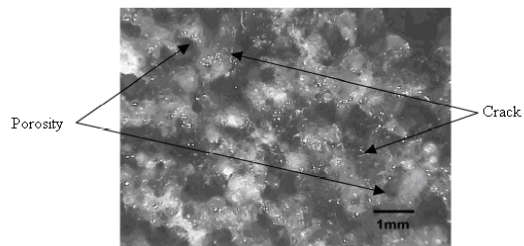
According to research by Lawrence [7], pore formation is one of the features in the laser-glazed surface. Fig. 1 shows the pores formed and cracking when a CO₂ laser (power densities: 2.25 kW/cm², traverse speeds: 240 mm/min and laser spot diameters: 10 mm) was applied to a concrete surface. The mechanism behind the pore formation is mainly attributed to gas escaping from the melting concrete. At a given laser power density, porosity decreases with the increase of the scan speed. Different lasers affect the concrete in different ways despite the similar power densities.

Fig. 1. Typical optical surface morphology of the OPC surface glaze generated with the CO₂ laser (Lawrence, 2004).

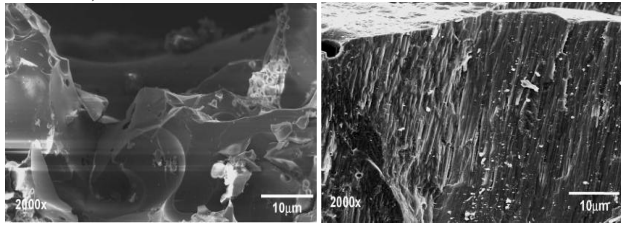
Fig. 2 shows an OPC surface glaze generated by a high power diode laser (HPDL). The glaze is of a fully amorphous nature (no discernible structure) while the glaze generated by the CO₂ laser is of a semi-amorphous nature (randomly located regular columnar structure). In contrast, the untreated OPC comprises of a porous polycrystalline structure.

Fig. 2. Typical SEM micrograph of the fracture section of the OPC surface glaze generated by the HPDL (left) and the CO_2 laser (right) (Lawrence, 2004).

Investigation confirmed that in the close neighbourhood of craters only a slight damage of external layer of material took place with no evidence of material cracking. It may suggest that this process can only be relevant in the initial phase of heating and only in the central part of crater. Spalling of material from crater seems to be intensified by this process. A small crack of the material can be seen in the left bottom part of the crater on Fig.2 above.

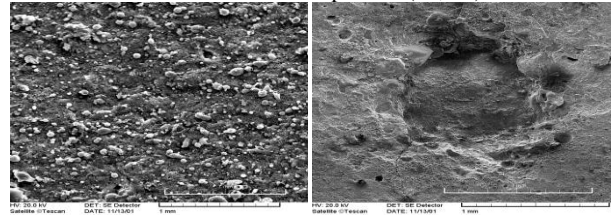
The SEM photographs (Fig. 4) of the surfaces before and after laser treatment show clear differences in surface microstructure. Some compounds from the affected areas have been removed due to evaporation or high gas pressure. It is possible to distinguish fragments of material with an oval, unordered shape which could be created as a result of melting and recrystallising.

Fig. 4. SEM image of non-exposed (left) and exposed sample (right)

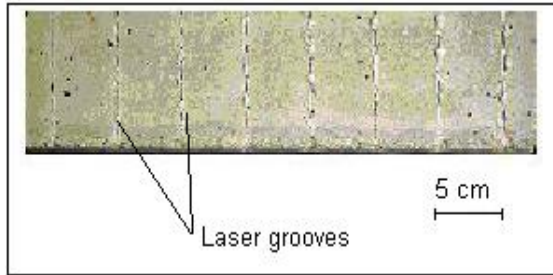
Figure 5 shows the photograph of the sample (C30) with clearly visible laser grooves consisting of centrally placed area from which material has been removed and the surrounding area of relatively small damage. Maximum depth of penetration was between 1.0 – 4.8 mm depending on the laser power.

Fig. 5. Sample after exposure to laser irradiation (C30)

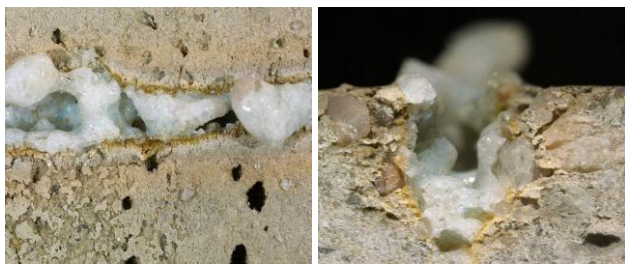
Similarly to the previously presented investigation fragments of amorphous material of irregular shape were created as a result of melting and re-crystallising. Figures 6-7 show the effect of high power laser on cementitious surfaces.

Fig. 6. Concrete sample C30 exposed to 1.6 kW

Experiment proved that the relatively low power of laser radiation (below 1.0 kW) does not have any significant effect on concrete performance regardless its composition and variation in microstructure. However further increase in energy results in more pronounced changes in concrete of lower strength. High power exposure has resulted in some decolourisation of material near laser groove as well as creation of micro-cracks due to temperature gradients.

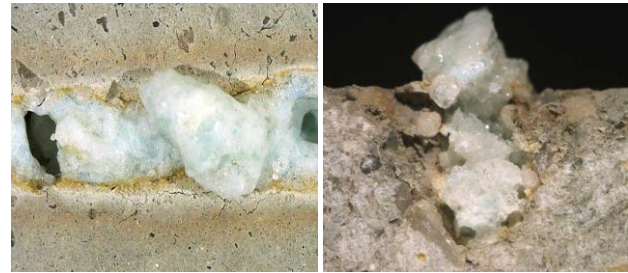
Fig. 7. Concrete sample C50 exposed to 1.6 kW

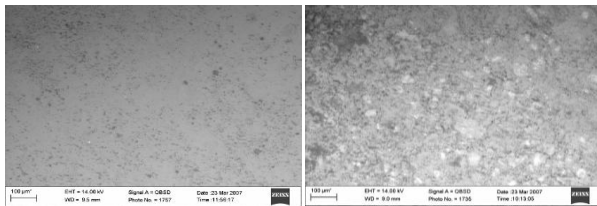
Heat produced by laser cleaning on mortar surfaces dissipates through formations of cracks, glazing, removal of paint or mortar and other losses. The amount of energy dissipated through the crack development or mortar removal depends on the properties of mortar. In weaker surfaces, it was shown that there is a great potential to dissipate the energy through the removal of mortar rather than through the development of cracks. The mortar surface exposed to freezing and thawing cycles was found to be weaker than that of the laboratory-cured sample, and consequently no cracks were observed here (Fig.9).

Fig. 9. BSE images (150x) of mortars subjected to F/T cycles before and after the application of 31 laser pulses.

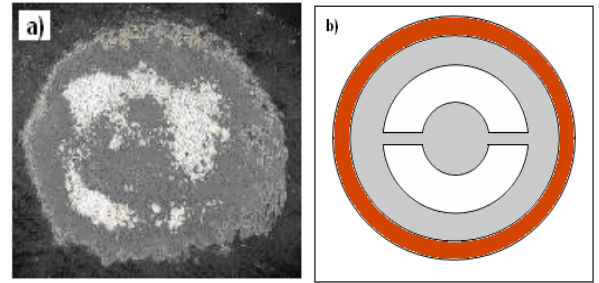
Near-surface porosity of laser-cleaned areas was assessed qualitatively by the analyses of BSE images. Two different zones within laser craters were identified and analysed: Undamaged Zone and Damaged Zone. The damaged zone was found to be denser and more consolidated than either the undamaged zone or the reference surface, due to vitrification of some parts of mortar surface following the laser cleaning process. Furthermore, near surface porosity of reference surface seemed to be higher than the undamaged laser cleaned area (Fig. 10 (a) and (b)).

In the damaged zone, glassy patches were observed where cracks and pores formed during vitrification. Pore formation results here mainly from gas escaping from melted cement paste. Despite the formation of pores, the near-surface porosity of glassy patches seems to be lower than in the remaining mortar surface.

Fig. 10. Laser crater: (a) Optical micrographs of LP-A(DRY) after 6 pulses (80x); (b) Different zones within the laser crater.

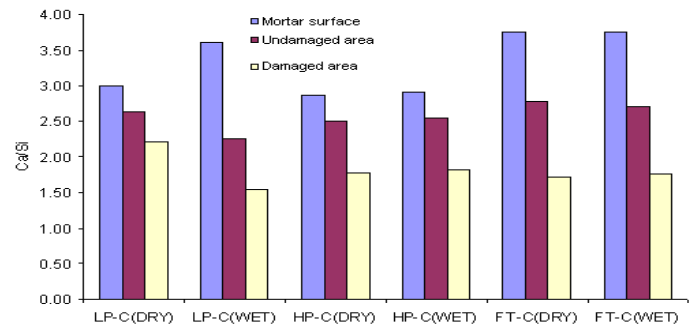
Fig.11. The value of Ca/Si ratio on surfaces of mortar samples

Chemical analyses of surfaces focused on two different zones. The EDX analysis of laser-affected areas showed that the ratio of Ca/Si obtained from damaged zone was higher than for the undamaged zone or the reference surface. Moreover, the value of Ca/Si in the undamaged zone was higher than for the reference surface (Fig. 11). The average value of Ca/Si on the laser-cleaned area was found to be 47% lower than on the reference mortar surface. Hence laser-cleaned mortar surface was found to be high in Si element and/or low in Ca element when compared with the original mortar surface.

Increment of Si content with respect to Ca on mortar surfaces could be attributed to the removal of CaCO_3 or movement of SiO_2 to mortar surfaces. Another possible reason could be associated with changes in the relative distribution of melted cement paste and aggregate and therefore relative elemental abundance in the near-surface layer.
