**ANNUAL REPORT CERGOP-2/ENVIRONMENT WP2  
STATION QUALITY ASSESSMENT AND UPGRADE  
PERIOD: APRIL 2005 – MARCH 2006**

**Gábor Virág  
FÖMI Satellite Geodetic Observatory, Penc, Hungary**

## SITE INSPECTIONS

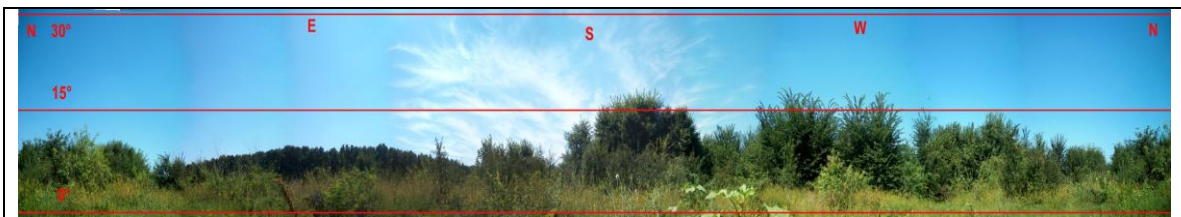
Figure 3. Horizon photography of BUCA

The site selection in Romania was very good. The epoch stations except Bucharest-Magurele are placed in bedrock, without any significant obscuration above 15° (e.g. see Figure 2., 3.). But unfortunately at Vrancea epoch station near to the point marker a new fence was created last year, which causes significant obscuration. In the Figure 4. can be seen the horizon photography at the level of the adapter and in the Figure 5. at the level of tripod head. Due to the significant obscuration at CEGRN'05 GPS campaign, the Romanian colleges performed GPS measurement at the top of a tripod instead of adapter. They also performed 5-day measurements at a new marker near to the old poin in the same time.

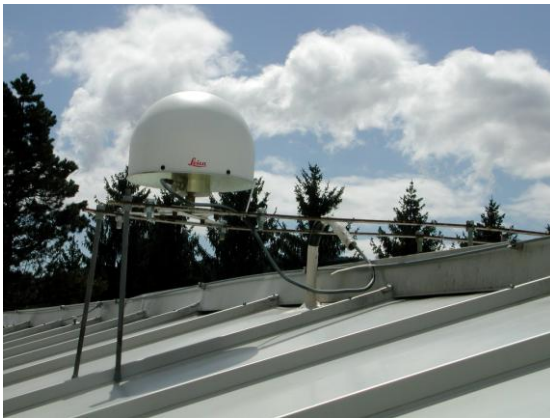
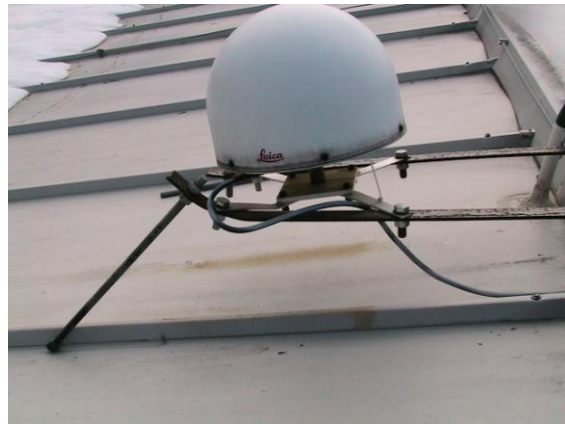
The site selection of the inspected Romanian, Bosnian and Italian permanent stations are typical. Antenna placed on the top of building anchored to the roof with steel construction. The antenna holder of ASIA seemed the weakest construction among the inspected CEGRN sites, unacceptable by any standards. In March 2006 it was damaged probably due to weather conditions (Figure 6.).

**Figure 6. Antenna holder of ASIA originally (left) and after damage (right)**

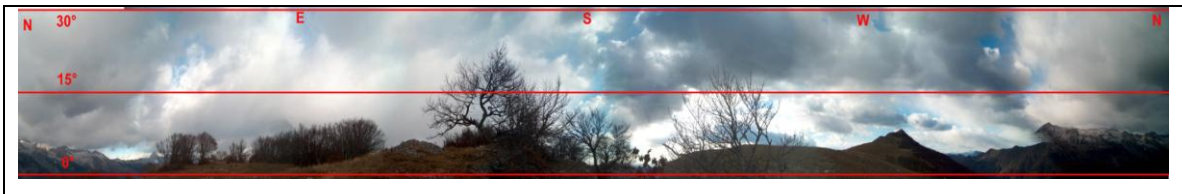
The two Slovenian inspected epoch sites are placed in bedrock, without any significant obscuration (e.g. Figure 7.).

**Figure 7. Horizon photography of BOZI**

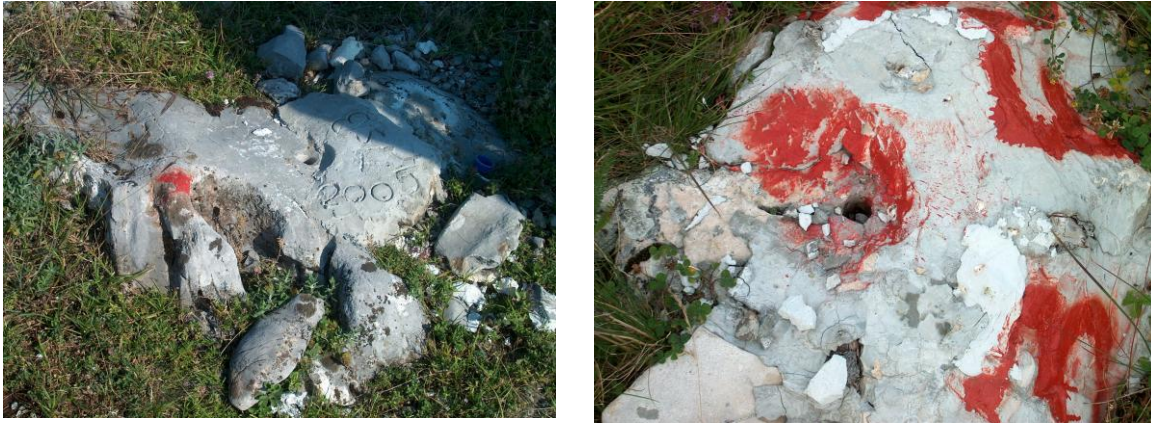
The monumentations of Slovenian epoch sites are good. Metal marker is placed in bedrock in Bozica and placed into rockbase pillar in Malija. Antenna setting up can be performed by rigid metal adapter. At Romanian epoch sites the marker only a small bored hole in the bedrock (see Figure 8) which is not satisfactory. This way the antenna height can not be measured so precisely.

Figure 8. Marker of TIS3 and FUN3.
