# **INTRODUCING PRECISE LEVELLING FOR STABILITY RESEARCHES IN BUILDINGS SITUATED IN THE NEIGHBOURHOOD OF AREAS OF INTENSIVE BUILDING WORKS**

**Krzysztof Mąkowski, Janusz Kuchmister**

**Geodesy and Geoinformatic Institute  
University of Environmental and Life Sciences, Wrocław  
e-meil: [makolski@kgf.ar.wroc.pl](mailto:makolski@kgf.ar.wroc.pl), [kuchmister@kgf.ar.wroc.pl](mailto:kuchmister@kgf.ar.wroc.pl)**

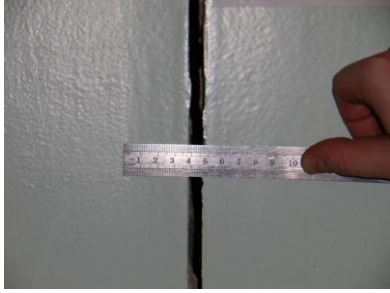
**Fig. 1. Cracking of a wall: Engineers of Shaping an Environment building.**

Measurements of precise levelling included not only buildings, where the signs of construction damage were visible (fig. 1) but also other objects of the University of Environmental and Life Sciences. The first ones were the Didactic Centre building, University Library, the Engineering of Shaping the Environment building, student houses Talisman and Labyrinth. The others were: The Main Building, building of Veterinary Medicine, building of Geodesy and student houses Centaur and Zodiac. The reasons for the damage are certainly complex and different for separate buildings. Numerous cracks in the walls of student house Labyrinth result mainly from its close situation directly on the bank of the Old Odra River and were noticed at the beginning of 1960s, but they intensified after the flood in 1997. Damage to the University Library was noticed at the turn of the century (first signals occurred in 1997). Therefore their source may be the difference in water level during the flood, and the fact that there is a layer of earthwork ground under the building foundation. (Krzyśków, Sowa, 2001; Rybak, 2002). The cracks in the walls of part of the Student House Talisman, occurred because of moving heavy circular traffic from the modernized part of Grunwaldzki Square into Grunwaldzka Street which was unprepared for receiving such traffic where the road surface was very damaged anyway. A crack in the construction of the building of Engineering of Shaping the Environment (fig. 1) probably resulted from excavating a trench for a new building of the Didactic centre. The reason for the cracks in the Centre are not yet known, but their occurrence can be connected with the building of two new, huge service objects “Grunwaldzka Gallery” and “Grunwaldzki Center”, where the depth of trenches was about 5-7 meters, which was connected with sufficient lowering of ground water.

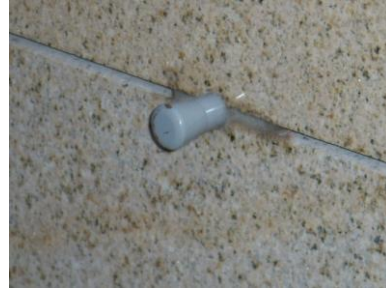
**Fig. 2. Controlled bench mark on the Didactic Centre building.**

110 stabilized controlled bench –marks (fig. 2) and 23 national bench-marks which create the reference network were included into measurements. Totally 246 levelling sections which included from 1 do 8 stations were measured (fig. 3).

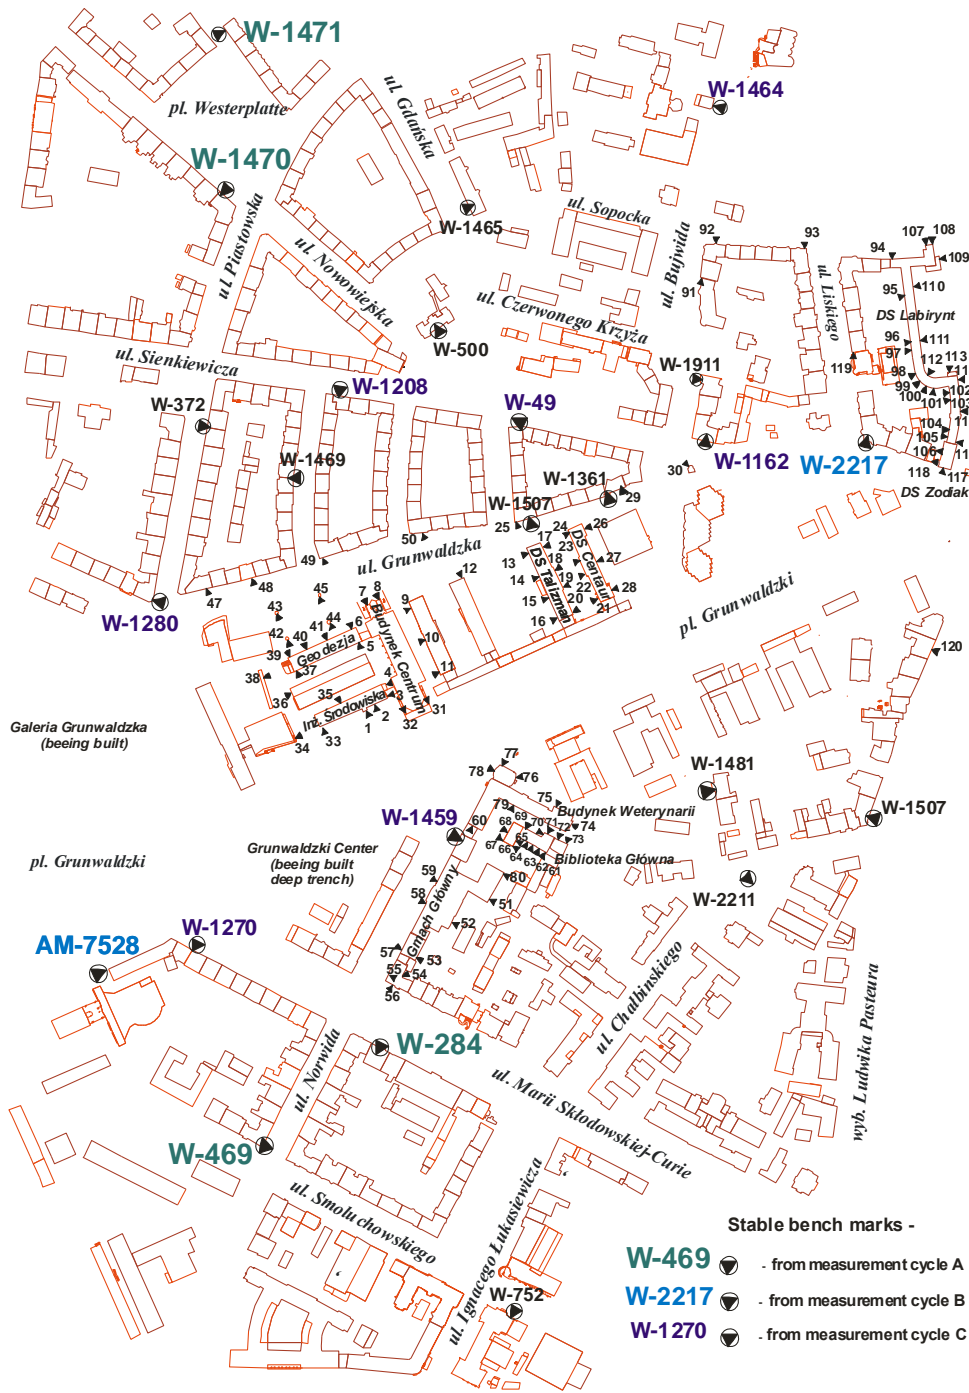
**Fig. 3. Sketch of a control-measurement network.**

The received results of measurements of vertical shifts of the building of the Didactic Centre confirmed the validity of the decision to carry out the researches on settlement of most buildings of the University of Environmental and Life Sciences. They have also shown the necessity for stabilization of a higher number of control points (Wolski, 2001) for achieving wider information about the character of object deformation in the way it was carried out for other objects (fig. 3).

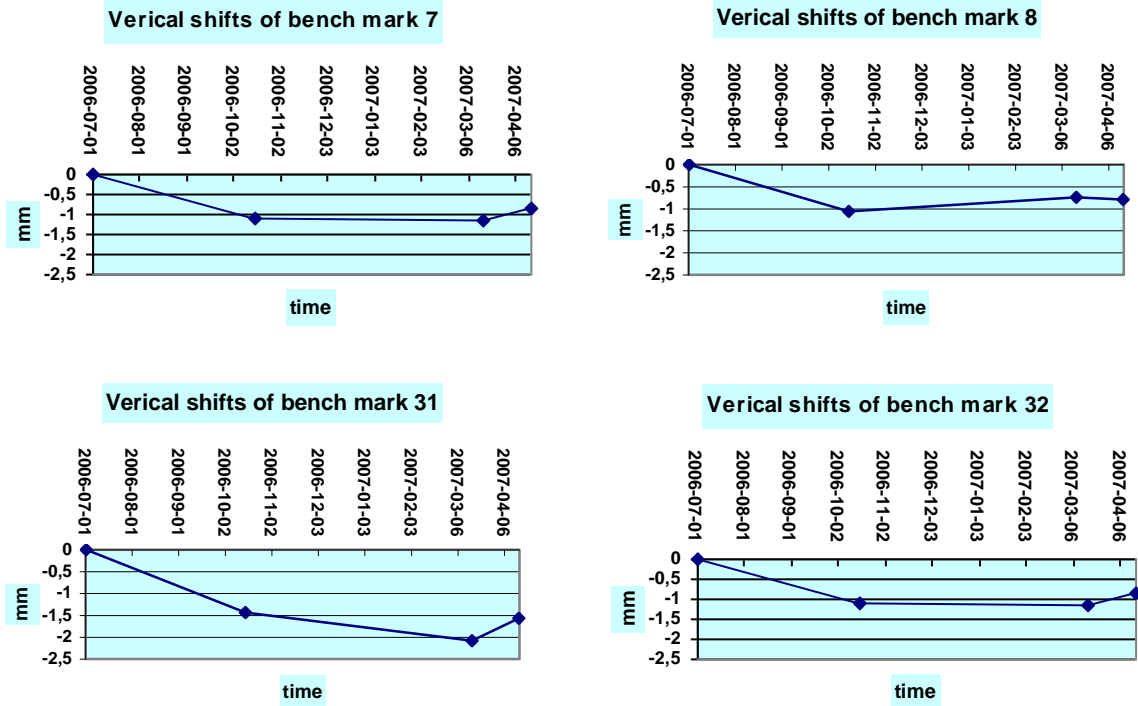
Fig. 5. Vertical shifts of bench marks situated on the Didactic Centre building.

precision from Leica Company. The measurements were connected to the closest, currently stable reference bench marks W-384, W-1469. Values of vertical shifts and errors of those shifts for bench marks situated on the building in the Didactic Centre were presented in table 1. Shifts in the time frame are presented in fig. 5.

Defined vertical shifts have a settlement character and their values although not huge are, in most cases, important taking into consideration the criteria of precision of their definition. A question arises in such a situation whether those small settlements could cause wall cracking of the Didactic Centre. A partial answer to that question can be given by performing analytic - graphic analyses of settlement interpretation (Czaja, 1983; Wolski, 2001). The Didactic Centre building was built on a concrete block that is why it is important if the size and location of defined vertical shifts of measured bench marks does not disturb the rigidity of mass of the object. The results of the performed calculation of rigidity parameters of the building are presented in table 2.
