# DEFORMATION MEASUREMENT OF THE ROOF CONSTRUCTION OF PAVILION „Z“ AT BRNO TRADE FAIR GROUNDS

Josef Weigel, Otakar Švábenský, František Soukup

Institute of Geodesy, Brno University of Technology  
weigel.j@fce.vutbr.cz, svabensky.o@fce.vutbr.cz, soukup.f@fce.vutbr.cz

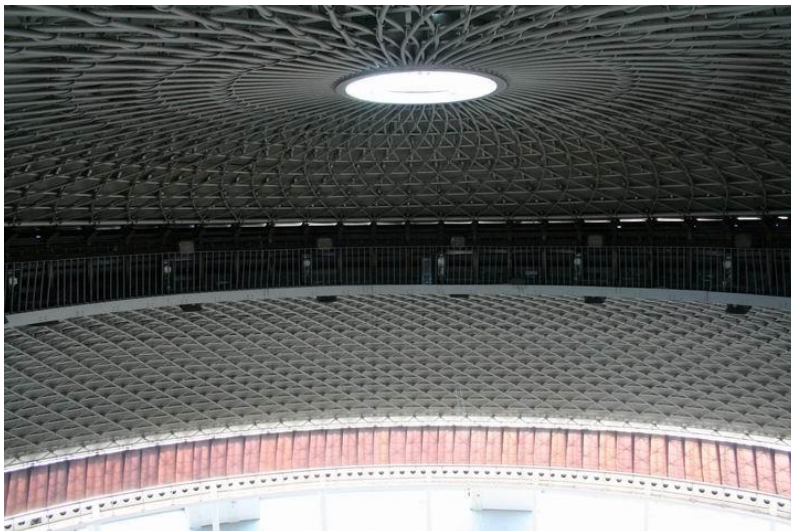
Fig. 3. View of the roof construction.

The Pavilion „Z“ is a building of circular shape with 122 m diameter and 43 m height. Steel roof carrying construction is built as a unique circular dome-like construction with 93,5 m diameter of foot ring and 22,3 m camber (Fig. 3). Dimensions of steel tubes (continuously conducted in three vertical layers connected in knots by screwed yokes) are changing from 102/6 mm in bottom to 60/4 mm in top part (Fig. 4). Foot ring diameter is 330/17 mm. Average steel consumption on the roof construction was 33 kg m<sup>-2</sup>.

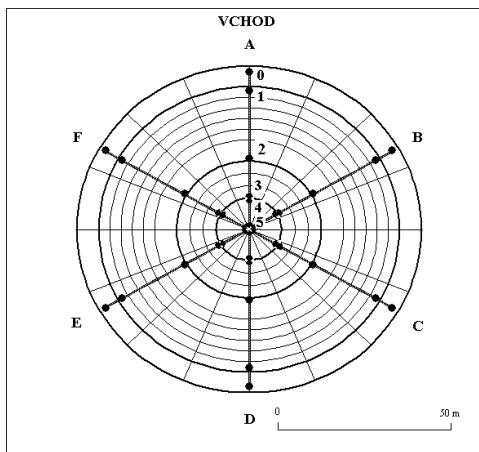
Fig. 5. Profiles and points measured.

The Pavilion „Z“ roof carrying construction had been represented by measured points (places) which were spread regularly in six vertical profiles and six elevation levels. The profiles are named A to F, and the points in single profiles are numbered 0 to 5, while the point 0 is at the lowest elevation level, and the point 5 is at the highest (central) level – see Fig. 5. Points of the lowest level 0 were marked at the level of foot ring on the horizontal face ring. Points of the level 1 correspond to the sixth horizontal ring (counted from below), points of level 2 correspond to the fifteenth ring. Points of level 3 correspond to the third horizontal ring counted from the central ring carrying the inner foot bridge, points of level 4 are at the edge of this central ring. Finally points of level 5 correspond to interior edge of the roof cap (Fig. 6).

Main result of the deformation measurements is the determination of vertical and radial displacements at 36 selected places (points) of the roof construction, see Fig. 5 and Fig. 6. All the displacements were related to the initial (first) measuring epoch. The results were documented in tabular and graphical outputs. Graphs of displacements were drawn for each single construction profile. Denomination of the profiles and profile points is clear from Fig. 5 and Fig. 6, where profile D is opposite to profile A, profile E is opposite to profile B, and profile F is opposite to profile C.
