# LONG-TERM DEFORMATION MEASUREMENTS OF LARGE SPAN TIMBER STRUCTURES

Jiří Bureš, Marek Kalina

Institute of Geodesy  
Brno University of Technology, Faculty of Civil Engineering,  
Veveří 95, 602 00 Brno, Czech Republic  
e-mail: bureš.j@fce.vutbr.cz, kalina.m@fce.vutbr.cz

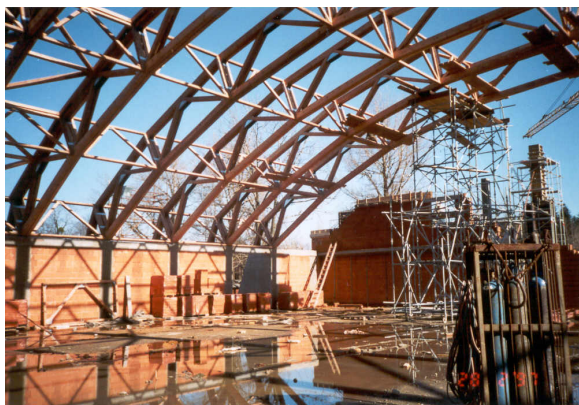
Fig. 1. - tennis hall in Frýdlant nad Ostravicí, 1997, span 40,4 m.

In Fig. 1 is a sample of the roof structure in the tennis hall of Frýdlant nad Ostravicí, made from solid wood and put into operation in 1997 (span 40,4 m). In Fig. 2 is a sample of the roof structure of swimming pool in Brno, made of glued solid beams with span of 35 m, placed in service in 2010 (Pexová et. al., 2009). Usage of new technologies raises the need for the design feedback in the form of monitoring during construction and after commissioning to verify their actual behavior in given conditions, while this informations are used to refine the static models and to optimize the material design of new structures of a similar nature. To monitor effectively the actual performance of roof structures the geodetic measuring methods are used (Bureš, Sláma, 2002), (Bureš, Straka, 2004). Technical regulations for construction and operation of buildings require partially the systematic measurement of displacements and deformations. Due to the influence of environment leads to gradual changes in the mutual spatial relationship of different parts of structures (sinking and creep), which is reflected in measurable distortions of geometric parameters. It is purposeful to measure regularly these deformation phenomena in appropriate intervals (measurement epochs).

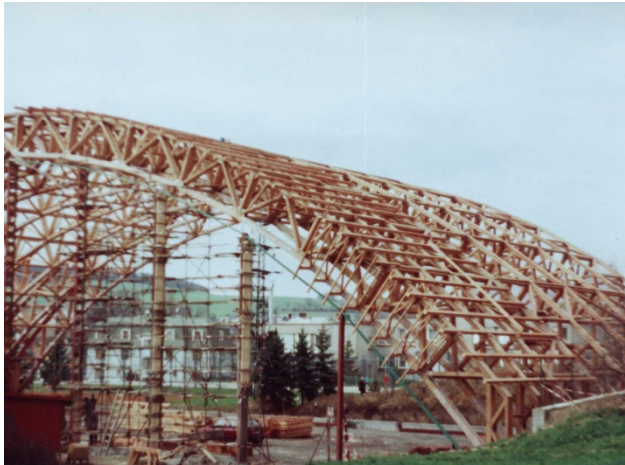
Fig. 3. – hall roof structure in construction phase.

Sporty multi-purpose hall in Bilovec was implemented in 2001. An example of the structure during construction is shown in Fig. 3, Fig. 4 is a view of the completed structure inside the hall.

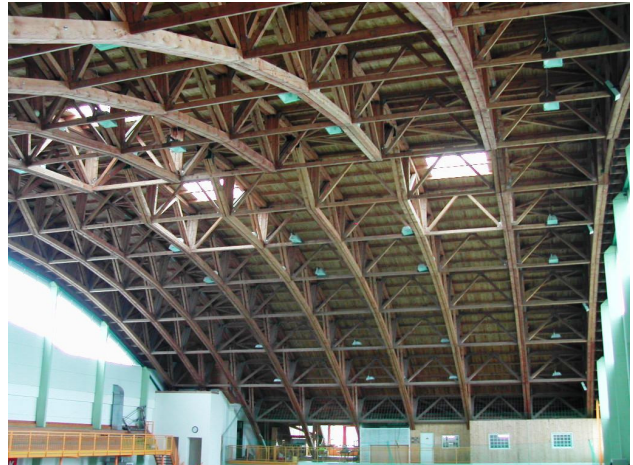
Fig. 4. – roof after its completion.

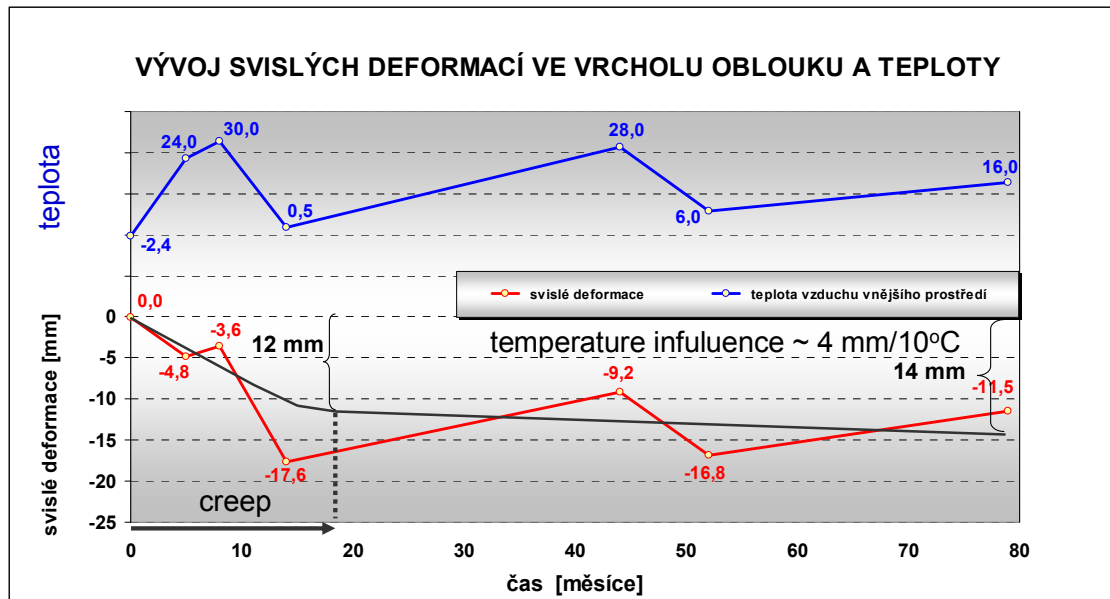
Fig. 12. - deformations and temperature.

Fig. 12 shows the evolution of the vertical deformation at the top of the arc in time given in calendar months from the beginning of the surveying, and the temperature in intermediate epochs of measurement. It is evident from the development of vertical deformation that during approximately the first 15 months after the commissioning proceeded the gradual fitting together with the creeping yield of the construction joints. During that time, while construction went through all the seasons of the year, the vertical permanent deformation at the top of the arc has reached about 12 mm. Then the behavior of the structure is stabilized and the structure is mainly influenced by exposure to ambient temperature. At higher temperatures in summer there is an uplift in the top of the arc, and vice versa at low temperatures in winter is the top to decrease. The effect of temperature shows in the vertical change of about 4 mm over 10°C temperature changes.

After the construction fitting and creep during the first two years, in the next six years there was only a slight increase in permanent deformation of about 2 mm, which is in correspondence with the expected evolution of the structure.
