THE EFFECT OF DIFFERENT DELIVERY CONDITIONS ON THE ACCELERATED DEGRADATION OF STRUCTURAL STEEL IN THE COAL MINE ENVIRONMENT

The main objective of this work was to determine the effect of different delivery conditions on the accelerated degradation of structural steels used for lifting beams (rails) of the monorail transport systems. Some of these rails, made of the same steel grade as others, undergoes accelerated corrosion in the coal mine environment. Corrosion degradation occurs much faster (more than two times faster), comparing to the same steel grade rails operated under the same conditions but with different microstructures. However, all the provided rails meet the requirements of appropriate standards for steel on the lifting beams of the monorail transport systems.

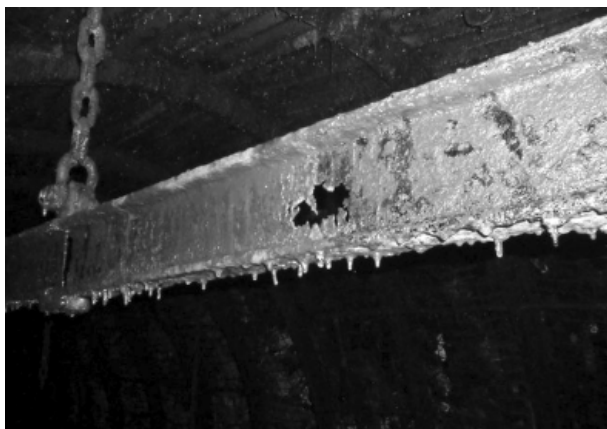
Fig. 1. Accelerated degradation of the lifting beam in coal mine environment (steel 3)

For economy reasons and because of good machinability, mild and low alloy steels are the preferred materials for underground coal mine structures. However, the corrosivity of coal mine water, containing usually high concentration of such aggressive components as sulphate and chloride ions vary from mildly to highly corrosive (Ruhi et al., 2009; Singh, 2006). The lifting beams of the monorail transport systems are made of S355 grade structural steel and meet the requirements of relevant standards of chemical composition and mechanical properties. The rails was delivered to coal mine with three different microstructures. Unfortunately, in one case, rails made of the same steel grade, undergoes accelerated corrosion in the coal mine environment (corrosion degradation occurs more than two times faster although rails was operated in the same conditions than other rails. The longest operating lifetime was for rails made of steel 1, than for steel 2 and shortest for steel 3. An example of such accelerated degradation of the lifting beam (rail made of steel 3) is shown in Figure 1.

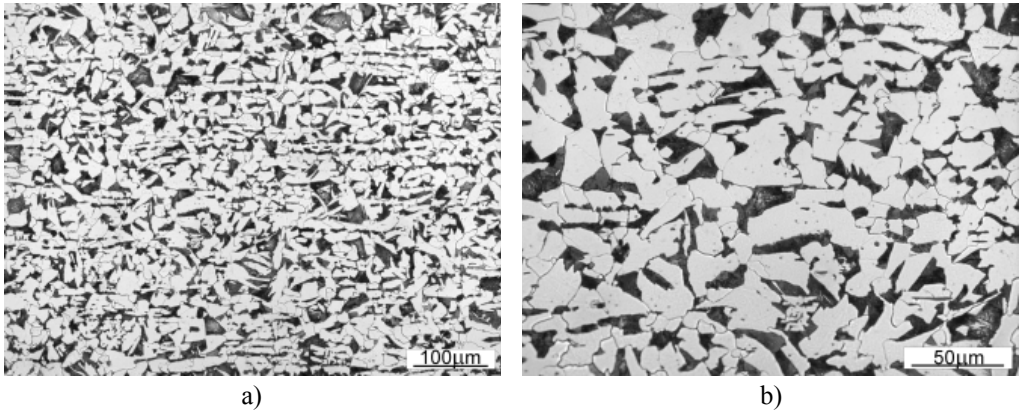
The microstructure shown in Figure 2 is almost free of banding and is characterized by a uniform distribution of ferrite and pearlite grains. The trace of banding is present, but this microstructure can be described as not banded. This steel is in normalized or normalizing rolling state. The microstructure of steel 2 (Figure 3) is still homogeneous (probably due to the high rolling reduction ratio) but showing ferrite-pearlite banding. Steel 3 has severe banded microstructure with wide-banded ferrite (Figure 4). Probably, this is the reason of accelerated corrosion in the coal mine environment of “I” beam rails made of this steel, although the mechanical properties and chemical composition complies with the standards and are close to the steels 1 and 2.

Fig. 2. Microstructure of the investigated steel 1. Etched with 2% Nital

As it is seen in Figure 2, the microstructure of the steel 1 is more homogeneous than microstructures shown in Figure 3 and 4 (least homogeneous). The same sequence has a corrosion resistance of the steels (from lowest to highest susceptibility to corrosion).

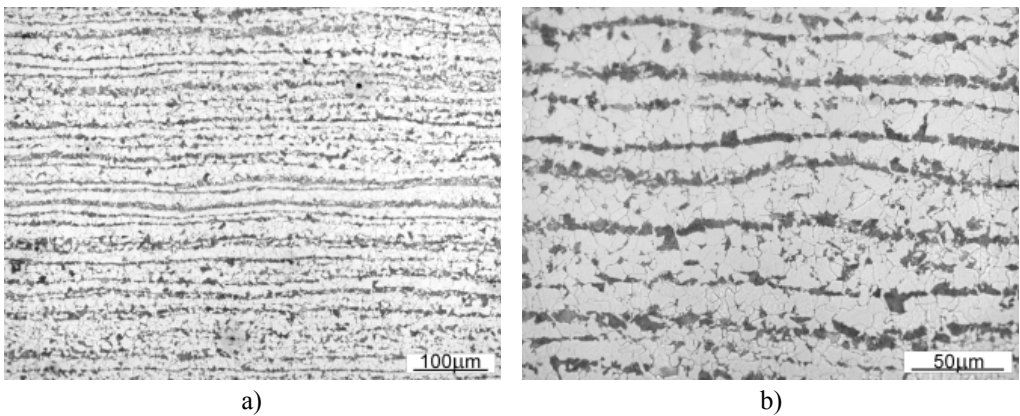
Fig. 4. Microstructure of the investigated steel 3. Etched with 2% Nital

- There is a significant difference in the corrosion susceptibility in coal mine environment of rails made of the same steel grade but in different delivery conditions.
- The highest corrosion resistance was observed for steel with homogenous microstructure obtained by the normalizing or normalizing rolling.
- Steel of the most heterogeneous and severe banded microstructure with wide-banded ferrite has the worst corrosion resistance in coal mine environment.
- To avoid accelerated corrosion of „I” beam rails in the coal mine environment in the future, steels should be ordered in the normalized or normalizing rolling state (+N).
