EXAMINATION OF DETERIOGENIC BIOFILMS ON BUILDING FACADES WITH SCANNING ELECTRON MICROSCOPY

Abstract

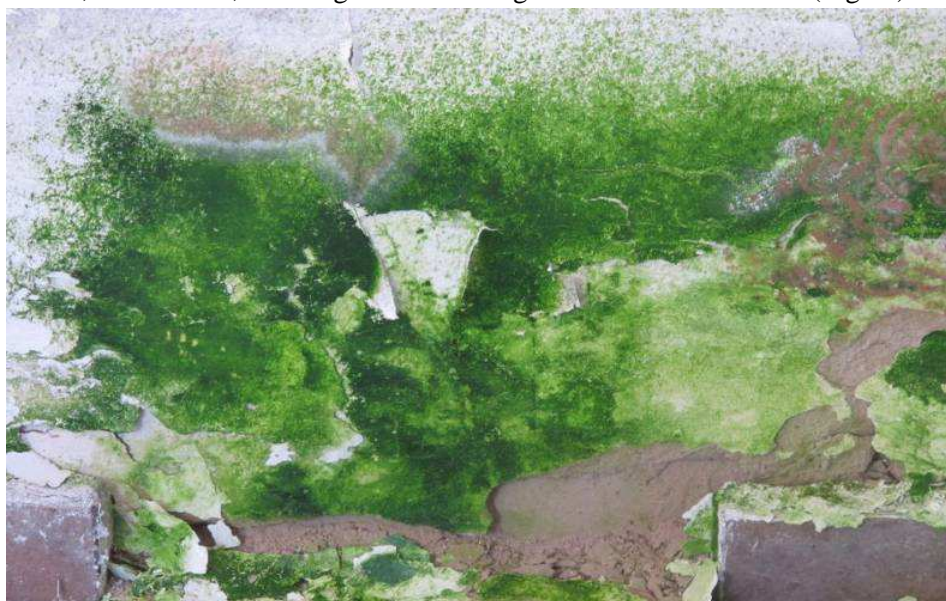
Fig. 1. Detail of the facade of the building with clearly visible biocorrosion

The term - deterioration involves a wide spectrum of phenomena causing weakening, loss of quality and destruction. All technical materials used on facades, are exposed to depositing of biological agents, and consequently susceptible to the development of biological corrosion. The technical state of a facade, its material properties and the environmental conditions are of great importance in the progression of the destruction [3, 5, 7, 8, 12, 16]. Biocorrosion refers to facades of both old and new buildings, facades with insulation and the ones with thin-layer plasters. This phenomenon leads to a weakening of the functional characteristics of the technical material such as: cracks, detachment, crushing and worsening of the visual aesthetics (Fig. 1).

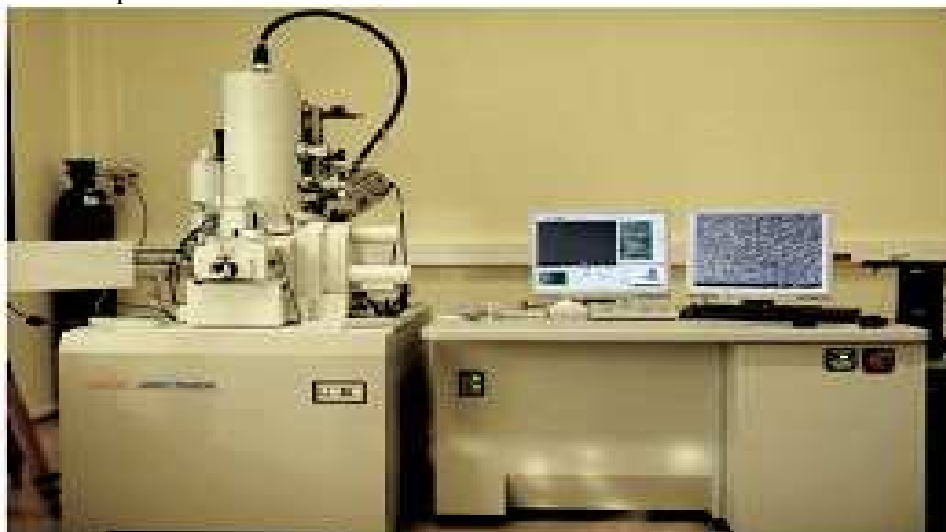
Fig. 2 . Scanning electron microscope JEOL JSM SEM-7600F at the Faculty of Mechanical Engineering, University of Zielona Góra

and identification of any defects or chemical composition. The essence of the scanning electron microscope is the use of the electron optical microscope for scanning of the tested sample with an electron beam formed by a system of magnetic lenses. The basis of the electromagnetic lens design is the solenoid which produces an electromagnetic field after electric current has flown through it. Electrons are very sensitive to magnetic fields, and thus can be controlled by changing the current flowing through the lens. An electron beam of high energy is concentrated in the area of the influence of electromagnetic lenses and reaches the sample, thereby generating signals on its surface. This results in the transmission of, inter alia, backscattered electrons, Auger electrons, secondary electrons, characteristic X-rays, cathodoluminescence and other photons of different energies. They are received by a detector, consisting of a photomultiplier and a scintillator. The main task of the scintillator is to transform signals emitted from the sample into electrical pulses which are next amplified by the photomultiplier. The signal from the detector reaches the electronic circuits that control the image on the computer screen [4, 9, 10].

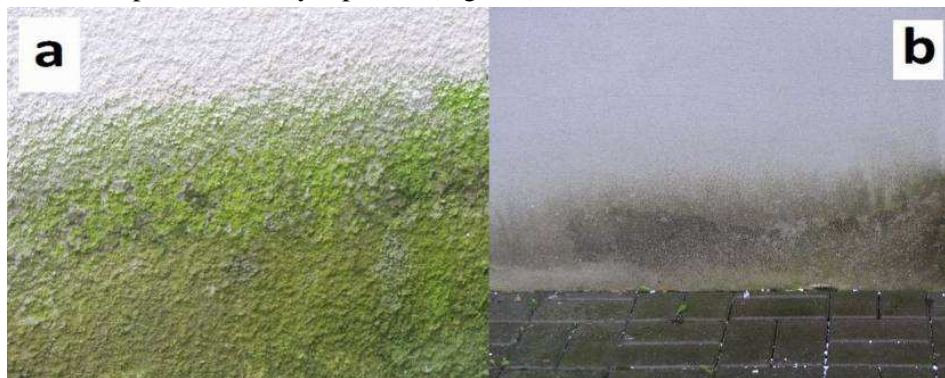
Fig. 3. Parts of the facade adjacent to the ground which the biological film for SEM observation was derived from, a - 30-year-old, non-insulated facade, very porous, b- 14-year-old facade insulated with styrofoam, covered with a thin-layer plaster

1. from an approx. 30-year-old, non-insulated building covered with a rough cement-lime plaster (Fig. 3a.)
2. from an approx. 14-year-old building insulated with styrofoam, covered with a porous thin-layer plaster (Fig. 3b.).
