## **Problems of protection and restoration of historical monuments of L'viv built using Roman cement**

**Mykola Bevz**

**Abstract:** In article are shown examples allow confirming that Roman cement was widely used in Lviv in the second part of the 19<sup>th</sup> century while erecting the public and residential buildings. The creating and develop a program on research, preservation and restoration of historical and architectural monuments, on which the architectural and ornamental finishing of facades was carried out with application of Roman cement is proposed.

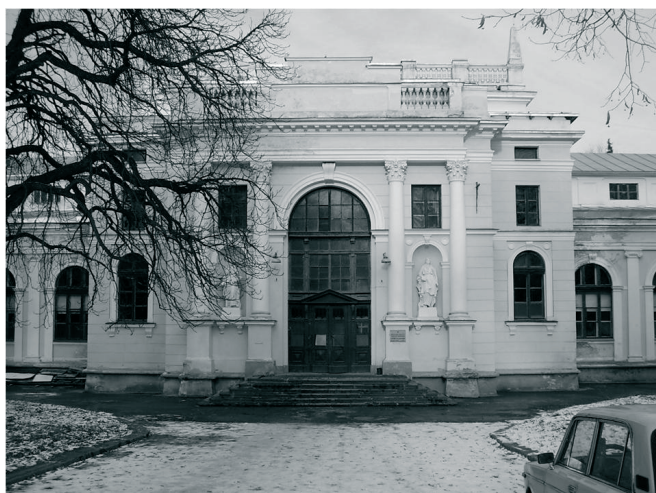
Fig. 1. The elevation of former Palace of Arts. Foto: M.Bevz, 2009.

The first object we would like to present is the building of the former *Palace of Arts* erected by the architect Fr. Skowron in collaboration with Gr. Peżański and M. Luzecki (sculptures by J. Markowski and A. Popel) at the upper terrace of Strytskyi Park [12, s. 112]. The building was projected as one of the objects of immense exhibit complex, so called Common Regional Exhibit, which was open in fall in 1894. It is a local architectural monument (fig. 1). After the World War II (when the Exhibit was liquidated and almost all pavilions were gradually dissembled) the inside of building was fully rebuilt to perform the sports function for L'viv Polytechnic University. In one wing there were gymnasiums arranged and in the other - a swimming pool. At present the technical state of the building is extremely poor. Our researches pursued in June 2009 determined that this building was erected with application of Roman cement (probing taken by M. Bevz, K. Prysiashnyi). On our side we have suggested the Rector of Polytechnics not to commence the repair works and perform diligent examination of the object in order to elaborate the correct method of repair and restoration works. Considering these data, previously developed design documentation of building repair is being revised (the project was performed by the planning and design office of Polytechnics). In our judgment, the project did not meet the restoration requirements and needed further elaboration.

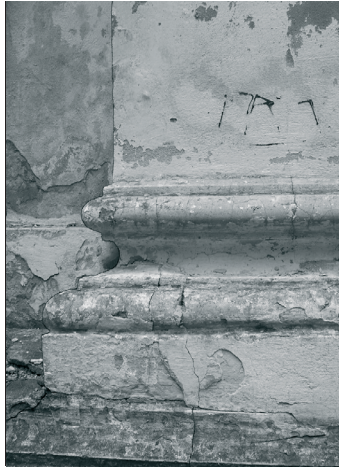
Fig. 2. The basis of pilaster made with using Roman cement. Foto: M.Bevz.

Roman cement was used by architect Franz Skowron while erecting the Palace of Arts to produce picturesque elements of facades (bases for pilasters and capitals, locking brackets, archivolt, cornices, railing posts, profiled components of window-ledge) and sculpture. Details of Roman cement were combined on facades with traditional limy plastering. We have ascertained two methods of producing the details from Roman cement at this object: a) use of Roman cement to produce compacted components at the very site; pulling method (cornice, bases of pilasters); this method is evidenced by the illustrating the transition of layer of roman cement from basis of pilasters over to level vertical surface of its body (fig. 2; b) mounting of prefabricated elements on façades (capitals, key brackets). Main reason for poor technical state of building is lack of repair of roofs and enduring blotting of walls and façade décor, inappropriate methods of previous repairs.

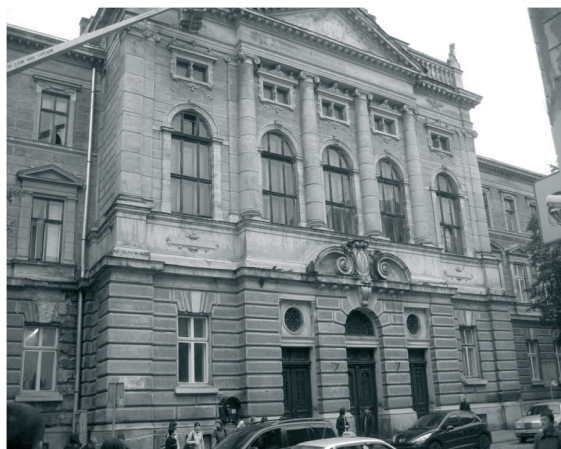
Fig. 3. The elevation of former “Palace of Justice”, built with using Roman cement. The architects: Franz Skowron and Jan Zawieyski, project 1891. Foto M.Bevz, 2011.

Second object is located in the very city centre at the beginning of Kniazia Romana St. (former name of Galytska St., at the end of the 19<sup>th</sup> century S. Batory). Regional Court used to be situated in this building (it was also called “Palace of Justice”). The building was erected in the place of north wing of building of Barefoot Carmelite Monastery. It was built according to the project of architect F. Skowron in collaboration with architect Jan Zawieyski from Krakow [13, p. 275] (fig. 3, 4). L’viv sculptors Anton Popel and Leonard Marconi were also engaged in work on finishing the facades and interiors [12, p. 116]. The construction was commenced in 1891 and lasted till 1895; it is believed that while planning the building Jan Zawieyski was the one to choose the decorating forms of façade, as well as materials and construction techniques. We have not managed yet to find out the very plan of facade finishing by Jan Zawieyski [11, p. 275]. Sculptural group “Justice” above the front of main entrance performed in 1893 by Leonard Marconi. There used to be an opulently decorated courtroom in the building. The stairs in the main lobby were decorated with the sculptures of two lions (made from alabaster by A. Popel). The sculpture of “Justice” in the lobby of the left wing of the building is also his creation.

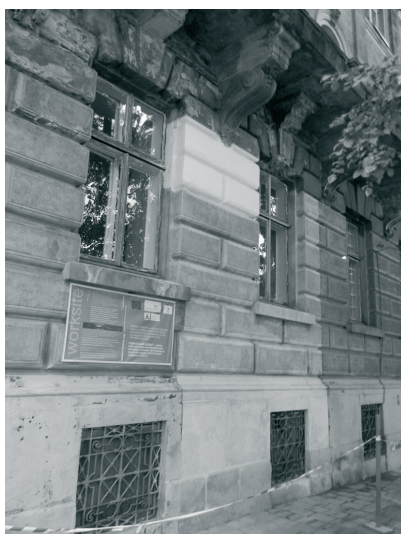
Fig. 4. The fragment of elevation of former “Palace of Justice” after the cleaning, made under promotion prof. J.Weber during the workshop in Lviv as the cooperation between the EU-FP7 project N226898 ROCARE. Aim was to demonstrate the possibility to recover the genuine appearance of the historic elevation by the use of Roman cement as historically authentic and compatible material. Executors were: Atelier Gurtner Wien (Austria) in cooperation with the restoration team of Department of Restoration of architectural Complexes of L'viv Polytechnic. August, 2011.

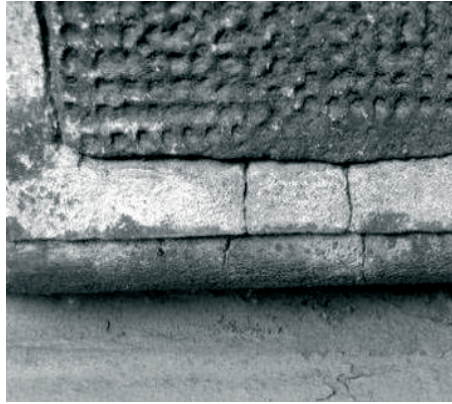
Fig. 5. The profiled pulled frame of every plank of rustication is made from Roman cement and filled inside with a help of lime plaster (on the elevation of former “Palace of Justice”). Foto M.Bevz, 2009.

Krakow (in particular while building the local schools) [14]. Building of the Regional Court in L'viv once again evidences the fact of architect's inclination towards the technologies with Roman cement. In this regard we would like to note that they are used in a very specific way here. Analysis shows that all plastic and sculptural decorations on façades are made from Roman cement, but besides massive rustication on parterre floor is performed in combination technique – profiled pulled frame of every plank of rustication is made from Roman cement and filled inside with a help of lime plaster, which provides the special “pecked” surface finish (fig. 5).

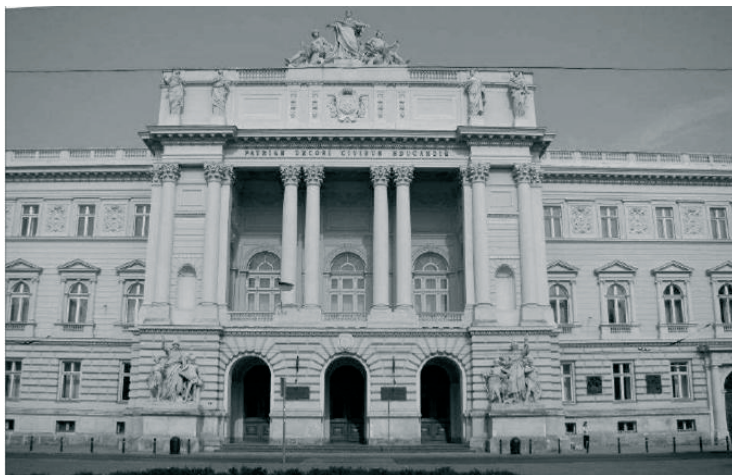
Fig. 6. The building of Galician Parliament (project by architect Juliusz Hohberger, 1877). Foto: M.Bevez, 2009.

Décor and sculpture from Roman cement were used during the erection of one of the most prestigious L'viv buildings of the second part of the 19<sup>th</sup> century – building of Galician Parliament (plan by architect Juliusz Hohberger, 1877). The construction works lasted from 1877 to 1881. Central risalit with portico on the main façade is crowned with allegoric sculptural group “Galicia, Vistula and Dniester” by sculptor T. Riger [5, p. 143-144]. Allegoric sculptures of the upper part of the building are created by Z. Trembetskyi and F. Mykul'skyi. Façade is allied to Vienna Neorenaissance with opulent architectural décor. Self-disclosure of the paint on the sculpture and picturesque elements evidences the use of Roman cement (Fig. 6, 7). In particular, we can see in on the sculpture “Education” in the left wing of the risalit and on the sculpture “Labour” in its right wing. Both compositions are created by T. Riger.

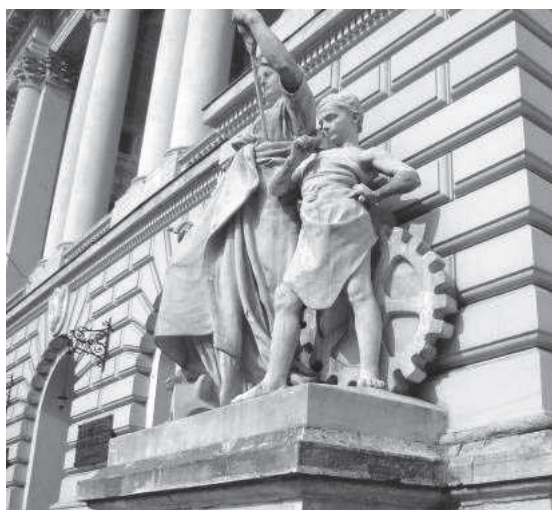
Fig. 7. The sculpture “Labour” in right wing. The composition is created by T. Riger. Foto: M.Bevez, 2009.

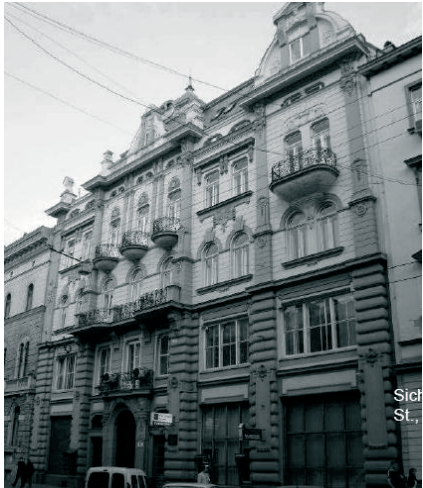
Fig. 8. The neobaroque façade of building on Sichovykh Striltsiv St. 11, architect Karl Boublik. Built 1901. Foto: M.Bevz, 2009.

Neobaroque façade of building No11 by architect Karl Boublik has picturesque elements from Roman cement (fig. 8, 9). The building was raised in 1901.

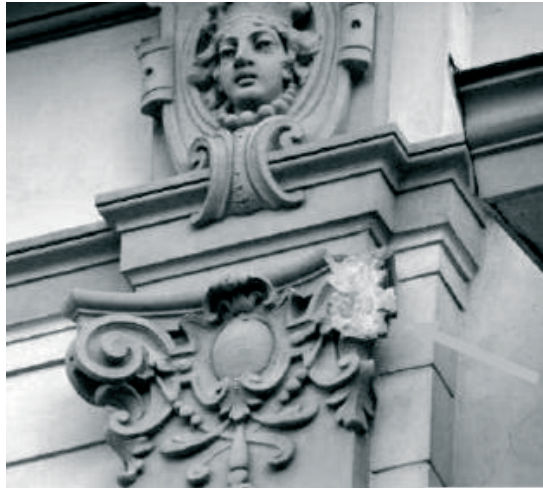
Fig. 9. The picturesque elements from Roman cement on the top part of façade of building. Foto: M.Bevz, 2009.

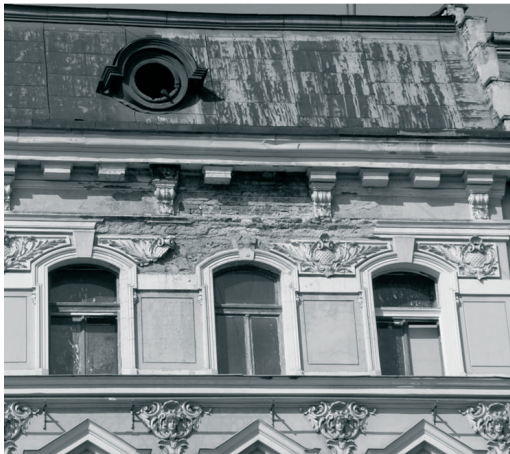
Fig. 10. The fragment of elevation of building on the Shevchenka avenue, 28. Foto: M.Bevz, 2012.

The application of Roman cement can be found also in many other buildings in L'viv, both public and residential. We can see the details from Roman cement on elevations of buildings in Shevchenka avenue (fig. 10-11), Virmenska Street, Kulisha St. (fig. 12-14), Hnatiuka St., Teatralna St., Lystopadovoho Chynu St. Can look for and serve the examples of it on other buildings of central part of L'viv.

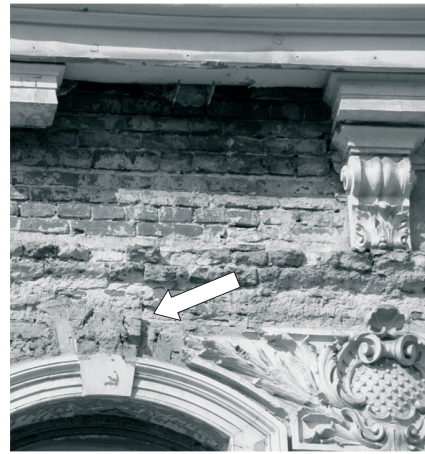
Fig. 11. The detail from Roman cement in destructive form. Foto: M.Bevz, 2012.

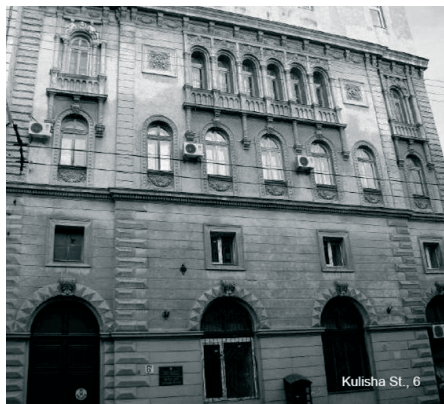
Fig. 12. The main elevation of building on Kulisha St. 6 (the art laboratory of opera). Foto: M.Bevz, 2009.

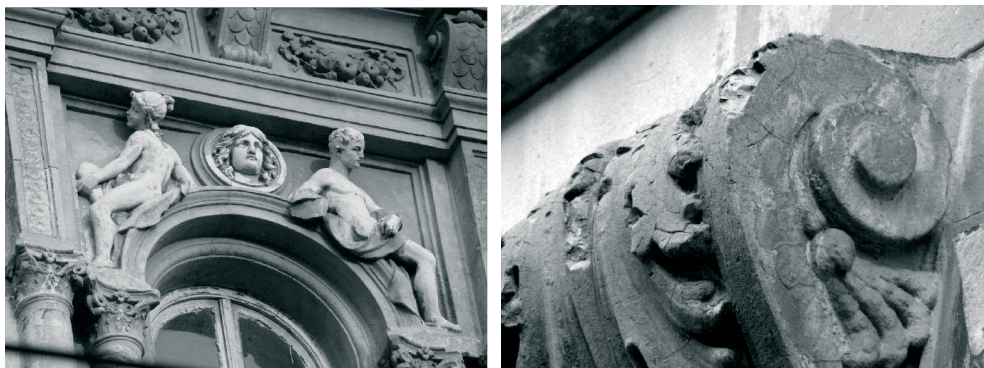
Fig. 13-14. The details from Roman cement on the elevation of the Opera art laboratory. Foto: M.Bevez, 2009.
