FAILURES OF BUILDING CONSTRUCTIONS CAUSED BY DESIGN ERRORS

The work presents basic information regarding failures caused by design errors and discusses examples of this type of failures that occurred particularly due to the lack of recognition of the construction stability, as well as shortcomings in the procedure for checking a project. There is also shown the role of independent verification of major projects.

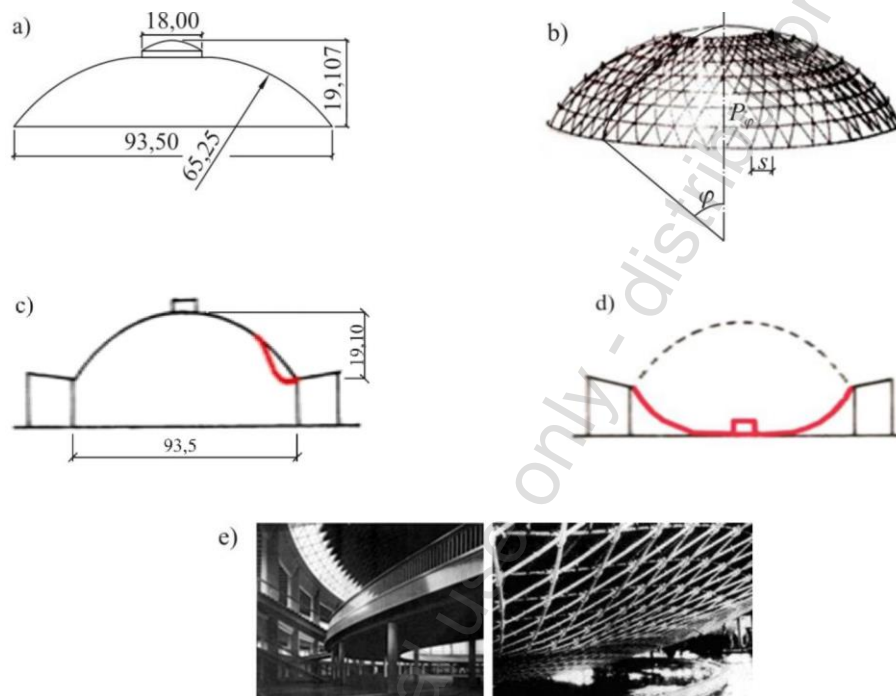
Fig. 1. The collapse of the single-layer lattice dome in Bucharest in 1963 resulting from the development of local deformations [13] during a snowstorm causing asymmetric loading, while moving only 30% of design loads: a) the geometry of the dome b) a view of the lattice dome structure, c) the cross section of the dome during the local deformation occurrence, d) the cross section of the dome after the collapse e) a bottom view of the dome structure before (on the left) and after the collapse (on the right)

Examples of the collapse of structures caused by the lack of recognition regarding their stability include the single-layer braced lattice dome in Bucharest (Figure 1) and the double-layer grate roof covering of Hartford Coliseum in Connecticut, the USA (Figure 3), which collapsed as a result of the loss of stability. Stability, which is the fundamental issue of the solid-state mechanics, should be recognised so as to protect the structure against the collapse [4].

In the light of the considerations, Abedi et al. [2] who investigated the behaviour of such domes found that the domes are susceptible to the progressive collapse due to the buckling dislocation arising when the axial load combines with the torque initiated by the local instability of an element or a node. The instability is produced by inertial forces launching oscillations around the balance state and large local structure defor-

mations that may propagate and as a result lead to the collapse of the structure (Figure 2). The threat of the collapse because of instability in systems of this type increases as the coefficient of the arrow grows in relation to the dome span. Kyriakides identified "the propagation of the local instability" as the new class of structural instability about 50 years ago [28]. When completed in 1961, the dome (Figure 1) constituted a technically approved bold light lattice dome of a diameter of 93.5 m with a top hole of a diameter of 17 m, on the circumference of which there is fastened a rigid steel compression ring having a box section, against which there is leant the 25 tonnes heavy skylight [28]. Its construction is made of steel tubes of a diameter of 102 mm and 6 mm thick walls.

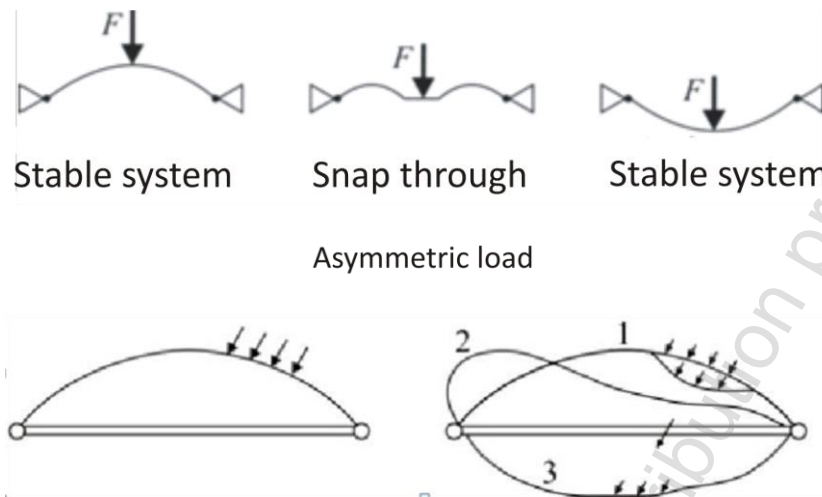
Fig. 2. The local instability of the flat dome occurring with a sudden buckling (snap through) during its transition from one stable system into the second one of the reversed curvature

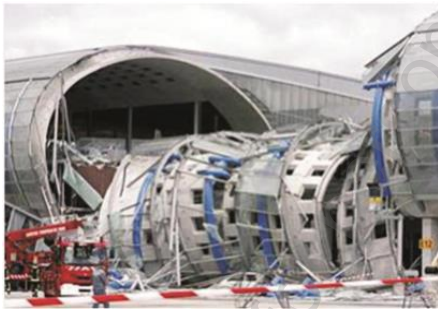
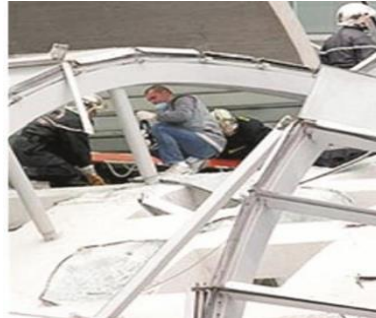
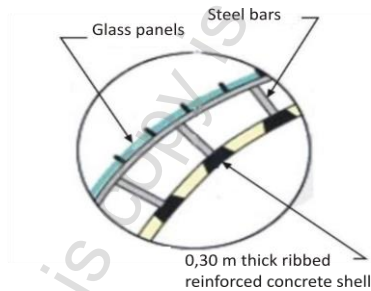
Fig. 4. The partial collapse of the Charles de Gaulle Air Terminal in Paris in 2004: a) a view of the collapsed part of the Terminal, b) a detail of the collapsed roof with a steel rod connecting a steel arch with the ribbed reinforced concrete shell c) a detail of the arc construction, d) the steel and reinforced concrete roof covering during the construction, e) the cross section of the reinforced concrete part of the roof covering [15] f) the cross section of the elliptical shell [15], 1 the ribbed reinforced concrete shell, 2 –the in-situ combination of prefabricated reinforced concrete elements, g) the cross section of the Terminal before the collapse (www.building.co.uk), h) the mechanism of the collapse of the Terminal 2E [5], i) the new solution of the roof covering of the Terminal [22]

The reasons for the collapse of the roof covering:

Construction causes:

- insufficient stiffness of the structure;
- improperly distributed reinforcing steel in concrete elements;
- weak external steel bars (compressed) punching / penetrating in the perforated reinforced concrete shell;
- insufficient concrete support beams.

The most important shortcoming were inaccuracies in the procedure for checking the project. The full independent analysis of the project verification would allowed to determine the shortcomings of the project and avoid the collapse of the Terminal.

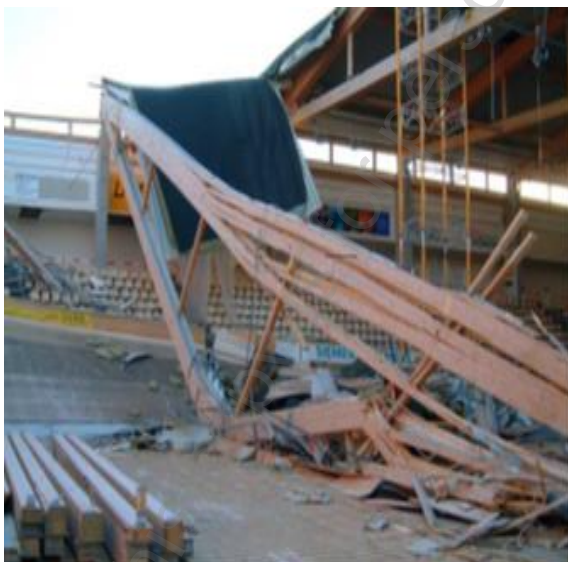
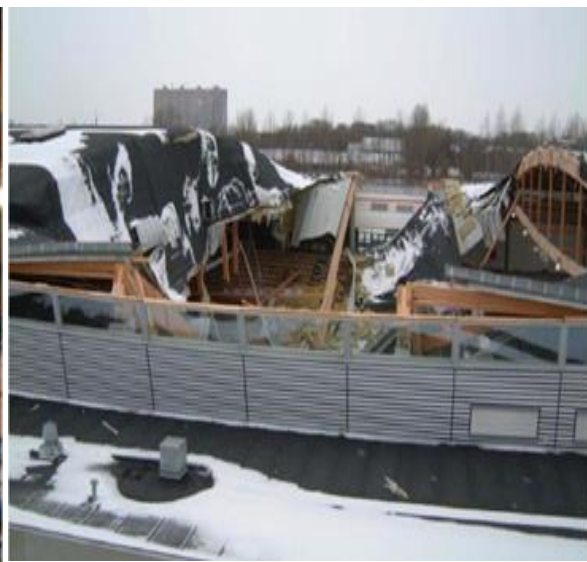
Fig. 5. The partial collapse of the Sports Arena, Ballerup, Denmark (Photo: Munch-Andersen, J.) a) a view of the collapse of two trusses, b) a view of the intact truss, c) the truss of the 72 m span and the maximum height of 5.0 m with the section limited by only 30% of the required load capacity d) the detail of the supporting node of the undervalued strength [30]

The disaster occurred during the heavy snowfall (Figure 5a). The main structure of the roof covering consisted of 12 trusses of the span of 73 metres, each made of two arches of glued laminates connected by vertical connectors. The unaffected truss is shown on the right side of the picture on the right (Figure 5b). Trusses were spaced every 12 m with purlins freely based on them. Two of the trusses collapsed unexpectedly, when there was no wind and only a few millimetres of snow. The incident occurred just a few months after the inauguration of the Arena, when there were no people. Studies have shown that the cause of the failure can be located in one critical cross section in the tension bow in the vicinity of the support (Figure 5c, d), where it was found that the strength was between 25 - 30% of its required value. In addition, the penetration of water was observed as a result of leaks through the membrane of the roof covering and the area of discharging water from the roof surface. However, the concrete structure settlements were not observed, as they could have a significant impact on the roof covering construction. It was agreed that the construction calculations concerning the roof covering were not investigated by a person responsible for checking what is mandatorily required in cases of meeting or sports halls. During the design it was decided not to attach the purlins to the truss too rigidly (?) so that any failure of one of the trusses can initiate the progressive collapse. Owing to this strategy "only" two out of the twelve trusses collapsed.

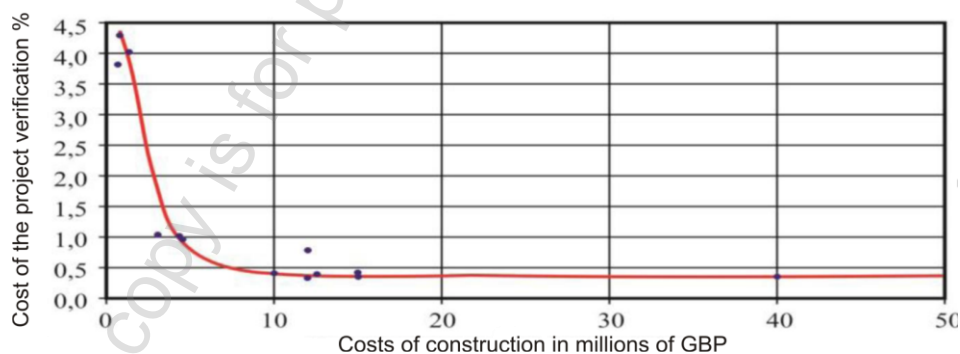
Fig. 6. The diagram of the percentage share of costs of the bridge independent verification and the cost of its construction [11]

Responsible investors and designers should appoint committees to have their projects independently checked, in particular when it is required by the scale or complexity of the project. Based on the experiences gained in England [11] with respect to larger projects, especially bridges, it shows that the cost of such verification is very small compared to that major benefits achieved in terms of increased confidence and reduced risk of the undertaking. Figure 6 presents the diagram of dependency of costs of the project independent verification on construction costs based on data from a number of completed projects.

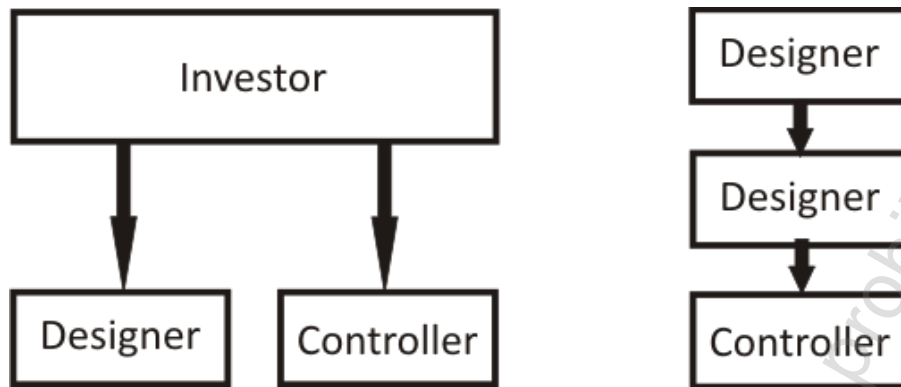
Fig. 7. Possible a designer – a controller arrangements [11].

The following highlights the importance of the independent verification on the basis of the work by Firth [11]. The independence may be technical and financial. Technical independence requires two suitably experienced engineers who have independent approaches to professional opinion through the process of technical analysis or research. A controller must also be free from excessive financial constraints or conflicts of interest. Generally, a checking person should be independent from a designer. This means that he / she should be designated not by a designer but by an investor / a client (Figure 7a) If a designer appoints a controller (Figure 7b) he / she can try to influence the result of the check. A controller may be under pressure, hence in certain circumstances the conclusions reached may be in conflict with his / her professional opinion.
