ARCHIVES
 of
 FOUNDRY ENGINEERING

Properties of the Inconel 713 Alloy Within the High Temperature Brittleness Range

Keywords: Thermal and mechanical tests, Inconel 713C, Gleeble, High temperature brittleness range

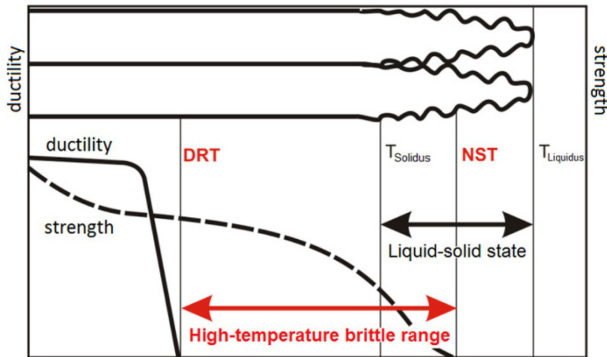
Fig. 1. High temperature brittleness range determining hot cracking in welds [9]

5]. Such cracks result from phenomena occurring in the so-called high temperature brittleness range (HTBR)(Fig. 1)[6-9].

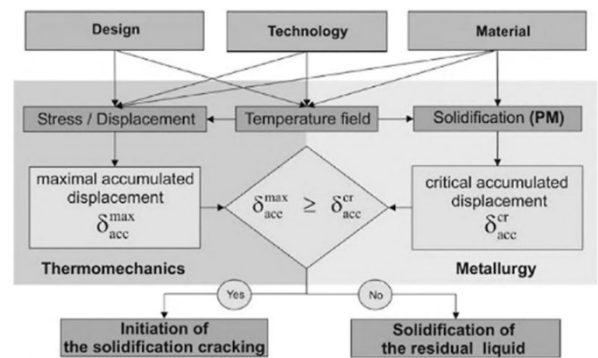
Fig. 4. Phenomenological interrelation between hot cracking criteria and factors affecting susceptibility to cracking [8]

Thus, it can be stated that the weldability of nickel-based casting alloys depends on design, technological, and metallurgical factors that affect the susceptibility of a material to hot cracking in the HTBR (Fig. 4) [8].

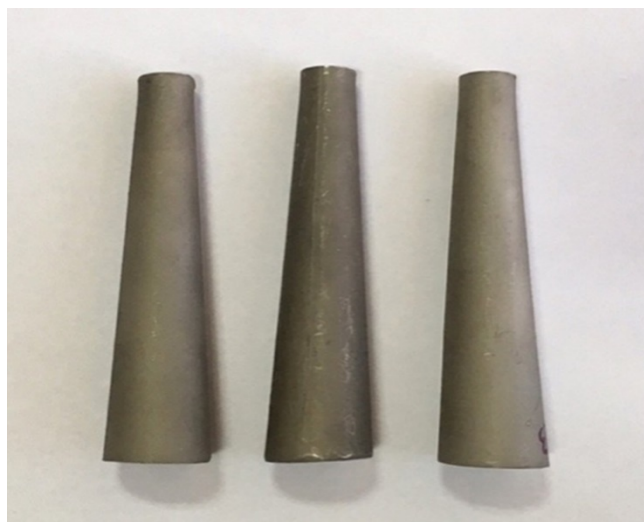
Fig. 5. Test specimens made of Inconel 713C

The material used in the tests was the polycrystalline nickel-based Inconel 713C alloy. The precision castings were made at Consolidated Precision Products Poland Sp. z o.o. The test specimens were provided in the form of truncated cones measuring 95x25x13 mm (Fig. 5). The chemical composition was verified by X-ray diffraction, with the use of an XRF NitonHLT 898W analyser. The results of the analysis are shown in Table 1.

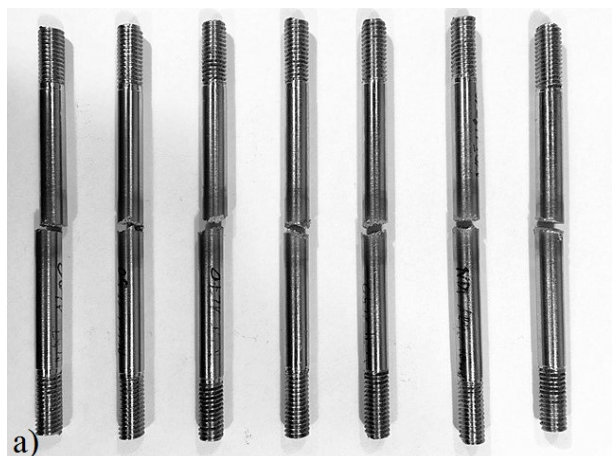
Fig. 6. Determination of the DRT: a) Samples for testing, b) view of the Gleeble 3500 simulator chamber with a specimen fixed in it

The tests were conducted on cylindrical specimens measuring $\varnothing 6 \times 90$ mm (Fig. 6a). A type S thermocouple was used to heat the test material. The specimens were fixed in copper grips (Fig. 6b), heated in vacuum at a rate of 20°C/s up to the solidus temperature, and finally allowed to cool freely. The NST, NDT, and DRT were determined for the material tested. The results obtained enabled the determination of the hot cracking resistance index $R_r = \frac{TL - NDT}{NDT}$ (where TL is the liquidus temperature) and the determination of the high temperature brittleness range, here understood as the difference between the NST and the DRT.

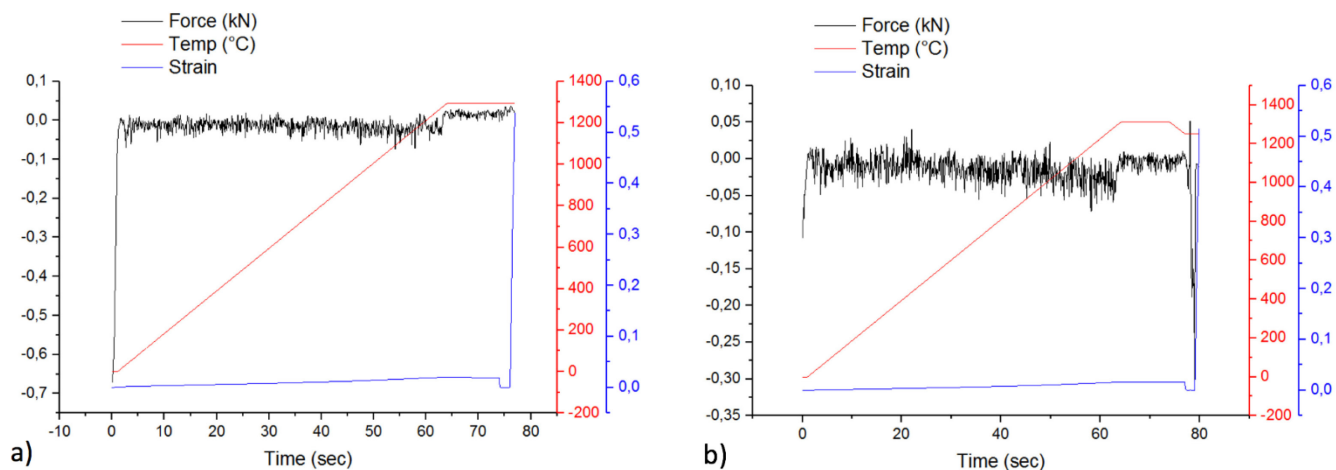
Fig. 10. Changes in strain and temperature in an Inconel 713C specimen: a) NDT test, b) DRT test

For the purposes of the study, the nil ductility temperature (NDT) was defined as the temperature at which the percentage reduction in area at fracture was smaller than 1%. The ductility recovery temperature (DRT) was defined as the temperature at which the percentage reduction in area at fracture was larger than 1%. Both experiments were conducted at a deformation rate of 20 mm/s. The changes in strain and temperature in Inconel 713C as a function of time are shown in Fig. 10a,b.

During the NDT tests, the specimens were heated within the temperature range of 1280–1330 °C, with each next specimen being heated at a temperature higher by 10° in comparison with the previous specimen, and subsequently stretched with a force of 0.1 kN (Table 4) (Fig. 10a,b). The NDT was defined as the temperature at which the deformation at fracture was smaller than 1%.
