**PROBLEMS OF RESTORATION OF WINDOW FRAMES  
IN THE 19<sup>TH</sup> CENTURY INDUSTRIAL FACILITIES  
ON THE EXAMPLE OF ŁÓDŹ**

Bartosz WALCZAK\*, Anna KURZAC

Institute of Architecture and Urban Planning, Lodz University of Technology,

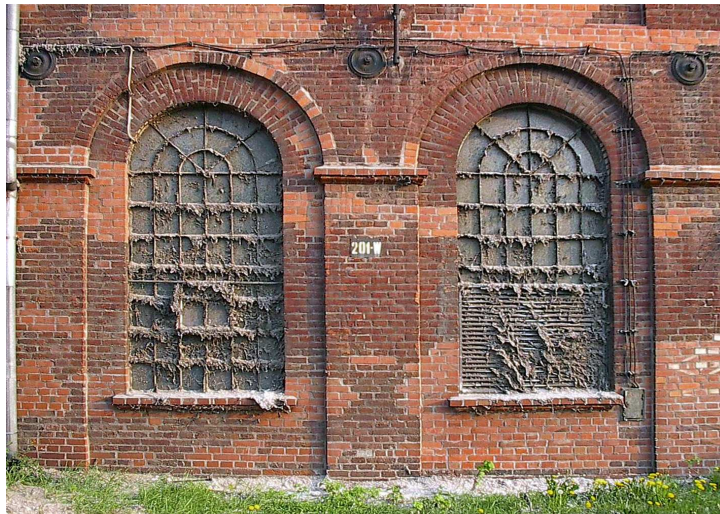
Fig. 1. Original windows in Scheibler's plant with the remains of accumulated cotton threads. Photo by W. Wiśniewska

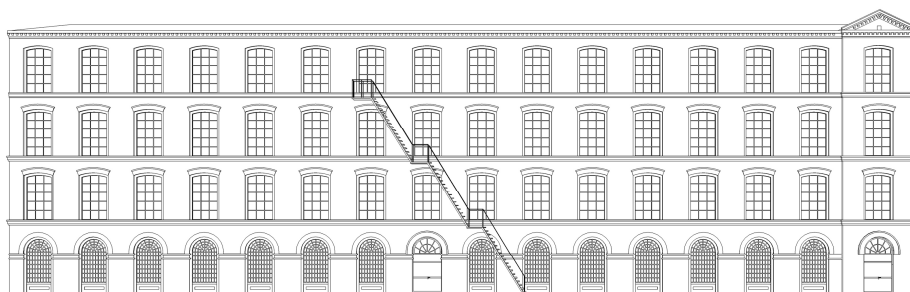
1. round-top windows (regular arches) on the ground floor,
2. segmented round-top windows (segmented arches), upper floors,
3. frames with small divisions and proportions of a vertical rectangle

Fig. 2. An example of a typical façade of a textile factory in Lodz. Author: A. Kurzac.

- The shape of window frames. The windows were usually round-topped with a full arch (on the ground floor) or segmented arch (on upper floors). The windows constituted 30% of the surface of the elevation. Later, they took a rectangular shape and their surface became greater.

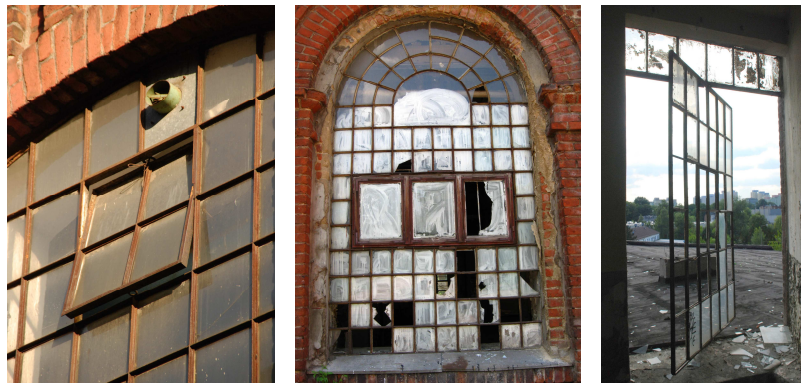
Fig. 3. Various types of hinged frames used in industrial windows. From left: Scheibler's factory, Kretschmer's spinning factory, Geyer's weaving factory. Photo by A. Kurzac

- Ways of opening the windows. The elaboration of a window with a system for window opening had always been difficult. Therefore, only a single partition of a window was openable. Typically, an additional smaller frame

or joints were installed in a large window frame, which served as a system for window opening. Sometimes, the window was supplied with a hinged wooden frame.

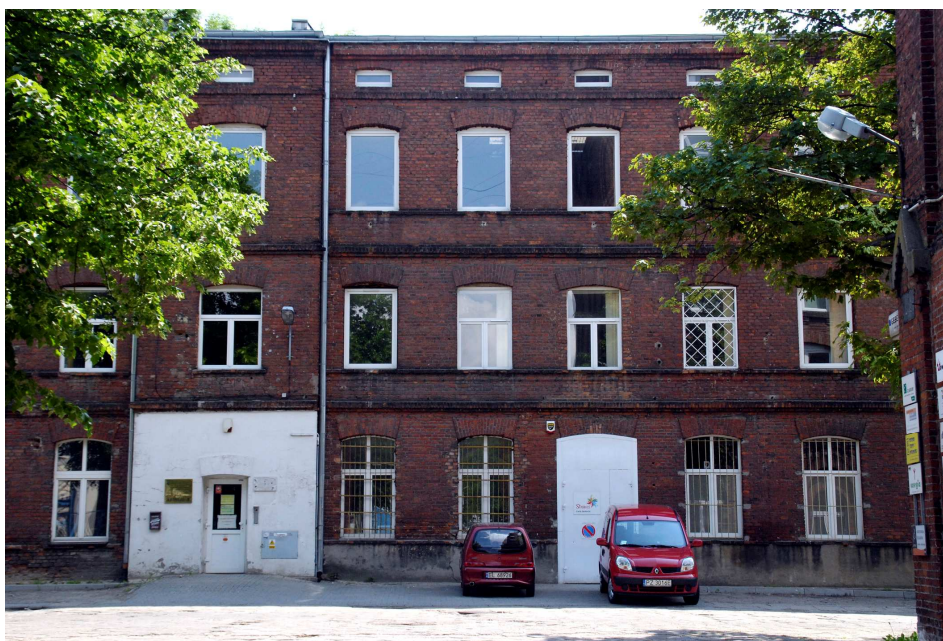
Fig. 4. An example of a building where an uncontrolled replacement of window frames led to the complete loss of the original aesthetics. Photo A. Kurzac

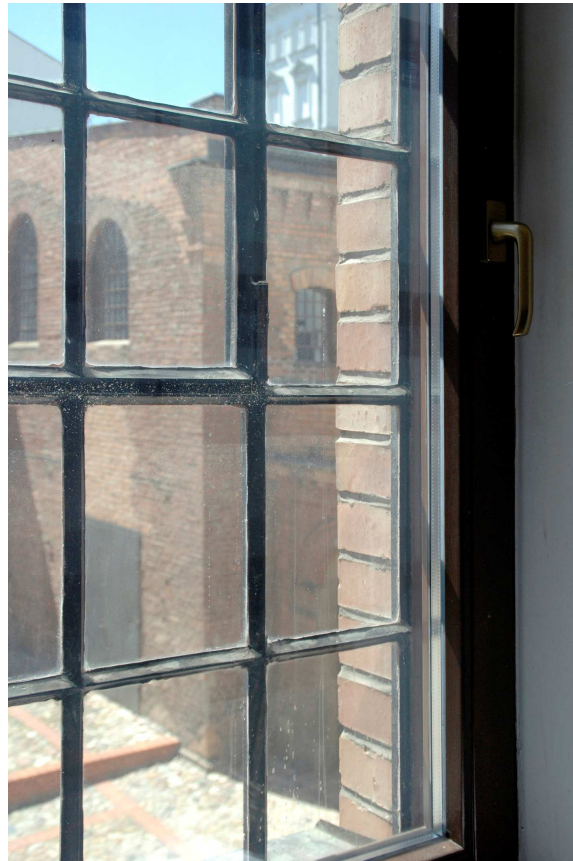
Fig. 5. Example of the installation of an additional window. Ludwig Geyer's "Biała Fabryka" (now Central Museum of Textiles), Łódź. Photo by A. Kurzac.

The original window may be left *in situ*, even if its technical condition forecloses its repair, through preserving an external window and the installation of an additional internal division. If the window survived to the present day in good condition, it is even better, because we receive a double protection from the weather.

There is a possibility of supplying the window with additional glazing along the perimeter of the window wings or doubling the number of wings, or finally, the installation of the additional glazing of the whole window opening from the inside or also providing an additional contemporary window. In many cases, introducing an additional glass sheet is a cheap, workable, and much more appropriate alternative to the installation of closed double-glazed units. It may be removed, allowing the original window to operate normally. It also solves the problem of heat losses and air streams passing through the leakage at the edges of the glass. Unfortunately, an additional glass sheet is not a popular option in Poland. The installation of an additional glass is merely an auxiliary, which may not be sufficient when the original window is in poor condition, but if connected with the renovation and repair, the results may be surprisingly good.
