Krzysztof LIGIER*, Jerzy NAPIÓRKOWSKI**, Magdalena LEMECHA***

ANALYSIS OF THE HARD-FACED MULTI-PHASE MATERIAL WEAR PROCESS BY THE BALL-CRATERING METHOD

Key words: abrasive wear, hard-faced multi-phase layers, ball-cratering method.

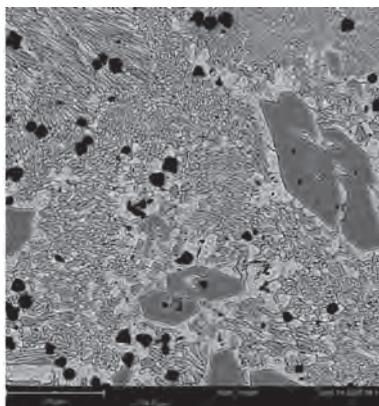
Fig. 1. Microstructure of El-Hard 67 padding weld: alloy ferrite with primary precipitates of chromium carbides and fine vanadium carbides

Due to the similar chemical composition of the materials 6715 XHD and 6070N, the microstructures of these materials are also very similar and contain large precipitates of primary chromium carbides and finer niobium carbides. On the other hand, in the microstructure of the El-Hard 67 padding weld,

in addition to the primary chromium carbides, fine vanadium carbides can be seen. The measurement of microhardness of the phases identified in the microstructures was performed by the Vickers method in accordance with standard PN EN ISO 6507-1, using an INNOVATEST 400-DAT-type hardness tester.

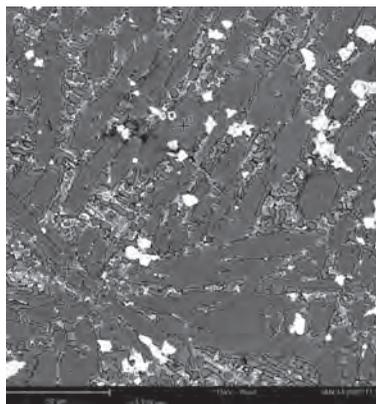
Fig. 2. Microstructure of the padding weld 6715XHD: large precipitation of primary chromium carbides and niobium carbides in the alloy ferrite matrix

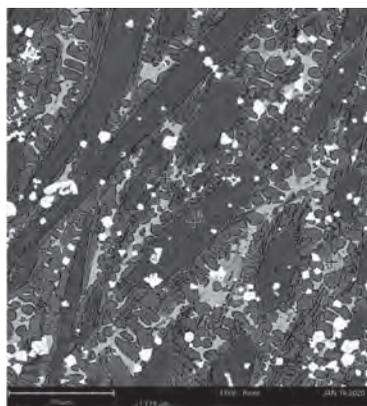
Fig. 3. Microstructure of the padding weld 6070 N: a mixture of alloy ferrite, chromium carbides and niobium carbides

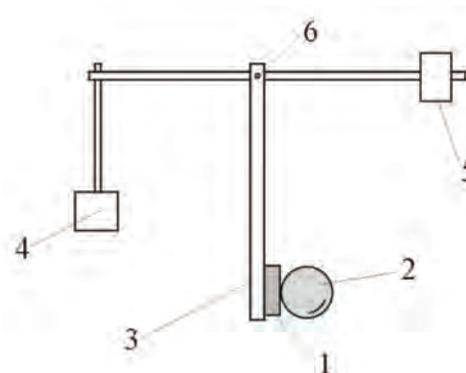
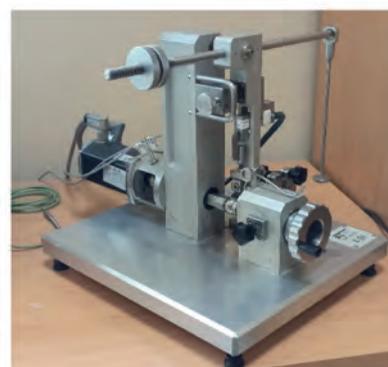
Fig. 4. Scheme and general view of the T-20 stand for testing the abrasive wear using the ball-cratering method: 1 – sample, 2 – ball (counter-sample), 3 – sample holder arm, 4 – load, 5 – counterweight, 6 – pivot

The study employed the ball-cratering method. The tests were performed using a T-20-type tribometer (Fig. 4). A 25.4 mm (1") ball made of 100Cr6 steel was used as the counter specimen.

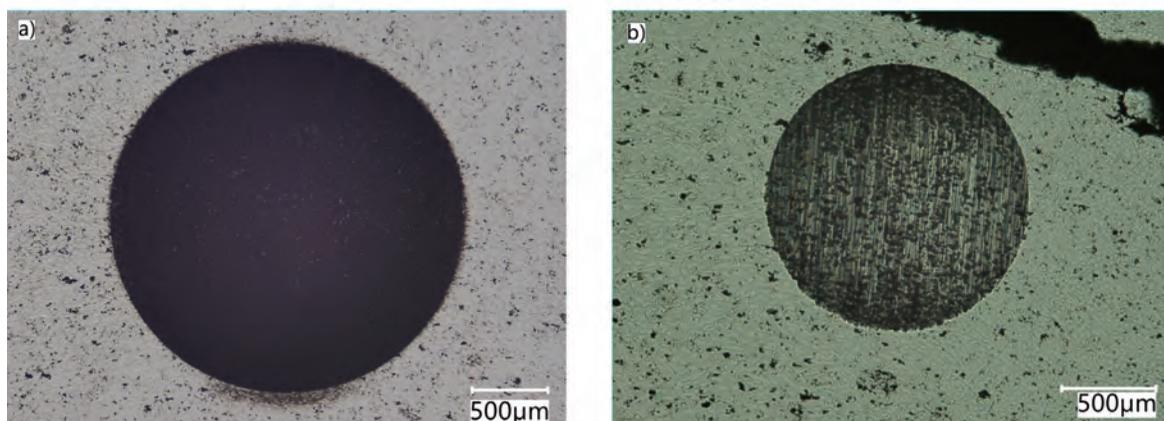
Fig. 5. Crater obtained in the 6715XHD padding weld test: a) in the presence of abrasive slurry, b) under dry friction conditions

An example of the crater obtained during the testing is presented in **Fig. 5**.

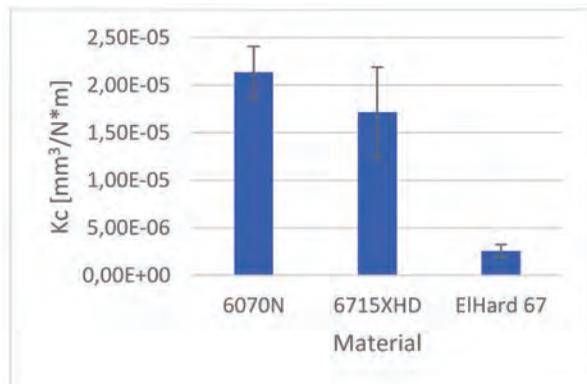
Fig. 6. Average values of the K_c index obtained in the test under the dry friction conditions. Error bars – std. dev.

The results of the wear intensity coefficient for the tested hard-faced layers being worn under technically dry friction conditions are shown in **Fig. 6**, while the results obtained during the tests in the presence of abrasive slurry are shown in **Fig. 7**.

As indicated by the obtained K_c coefficient values, in the testing variant under technically dry friction conditions, the 6070N and 6715XHD padding welds were characterised by a significantly higher wear rate than El-Hard 67. The K_c coefficient values for this testing variant were as follows: for the 6070N padding weld – $2.14E^{-5}$; for the 6715XHD padding weld – $1.72E^{-5}$; and for the El Hard padding weld – $2.5E^{-6}$. The value obtained for the El-Hard 67

padding weld is approx. ten times lower than that for the 6070N padding weld. The K_c coefficient values for the tested padding welds were similar in the testing variant, including abrasive slurry. Notably, there is a significant scattering of the K_c coefficient values for the individual materials, which is indicated by the error bar values. This is due to the heterogeneous microstructure of the tested materials, which resulted in craters of varying diameters being obtained in the individual test runs.

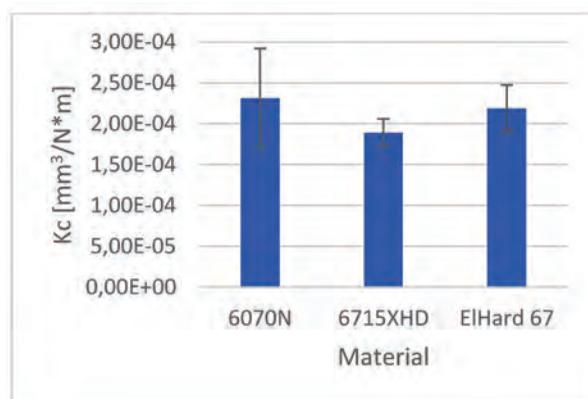
Fig. 7. Average values of the K_c index obtained in the test in the presence of abrasive slurry. Error bars – std. dev.

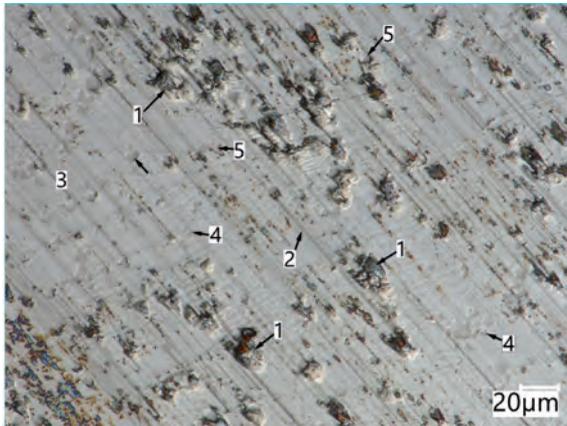
Fig. 8. The surface of the padding weld 6070N worn in dry friction conditions: 1 – point material losses, 2 – ploughing, 3 – chromium carbide, 4 – vanadium carbide

Fig. 8 shows a view of the cratered surface made in the 6070N padding weld in the non-abrasive test variant, while **Fig. 9** shows a view of the crater surface in the presence of abrasive slurry.

On the cratered surface made with no abrasive (Fig. 8), ridging marks running in the direction of relative movement and irregularly shaped spots of material losses were observed. This form of surface damage is similar to chipping. The shape of these losses indicates that they may have resulted from the shallowly embedded, fine carbide precipitates being chipped from the surface. This process was resisted, to a large extent, by fine vanadium carbide precipitates firmly embedded in the matrix and, to a lesser extent, by large chromium carbides. The cratered surface made in the presence of abrasive slurry (Fig. 9) only shows ridging marks, resulting

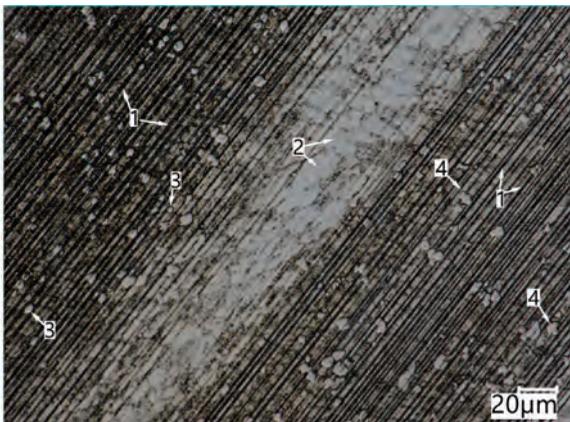
Fig. 9. The surface of the padding weld 6070N worn in the presence of an abrasive slurry: 1 – ploughing, 2 – chromium carbides, 3 – vanadium carbides, 4 – niobium carbides

in the exposure of fine vanadium carbides and large chromium carbide precipitates. The grooves cut out by sharp-edged abrasive grains of Al_2O_3 have better-defined edges. No signs of chipping were identified on the surface.

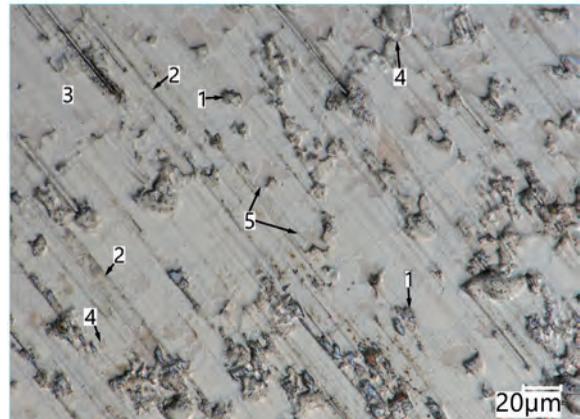
Fig. 10. The surface of the 6715XHD padding weld worn in dry friction conditions: 1 – point material losses, 2 – ploughing, 3 – chromium carbide, 4 – vanadium carbide, 5 – niobium carbide

The view of the cratered surface made in the 6715XHD padding weld is shown in Fig. 10 (a variant with no abrasive slurry) and Fig. 11 (a variant with an abrasive slurry).

As in the case of the 6070N padding weld case, the cratered surface made in the 6715XHD

weld without abrasive slurry (**Fig. 10**) exhibits ridging marks running in the relative movement direction and spots of material losses, bearing the characteristics of chipping (sharp pit edges). Fine carbide phase precipitates were chipped off. On the other hand, the cratered surface made in the presence of abrasive slurry (**Fig. 11**) bears ridging marks. The ridging mainly impacted the matrix material and, to a lesser extent, chromium carbides, while vanadium carbides and niobium carbides resisted the process. In the presence of abrasive slurry, no marks of carbides being chipped off from the padding weld surface could be observed.

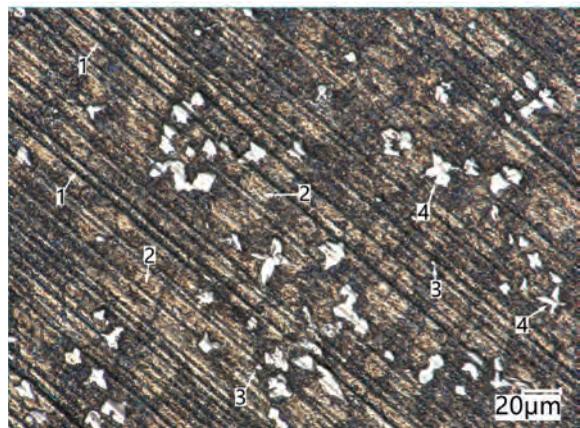
Fig. 11. The surface of the 6715XHD padding weld worn in the presence of an abrasive slurry: 1 – ploughing, 2 – chromium carbides, 3 – vanadium carbides, 4 – niobium carbides

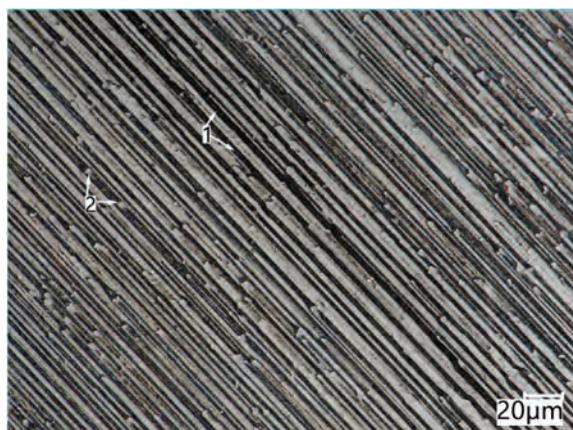
Fig. 12. The surface of the El-Hard 67 padding weld worn in dry friction conditions: 1 - ploughing, 2 - vanadium carbide

Figures 12 and 13 present the view of the cratered surfaces made in the El-Hard 67 padding weld without abrasive slurry (**Fig. 12**) and in the presence of abrasive slurry (**Fig. 13**).

Ridging marks can be found on the cratered surface made in the El-Hard 67 padding weld in both testing variants. On the cratered surfaces, numerous grooves can be seen, along with numerous exposed fine vanadium carbides, which are firmly embedded in the matrix. The pattern of the grooves indicates that these precipitates effectively inhibit the material removal process in the testing variant with no abrasive slurry (**Fig. 12**). In the presence of abrasive slurry, not only ridging marks but also small pits resulting from the rolling of abrasive grains along the surface of the material within the area of increased surface pressure, i.e., the so-called rolling abrasion, can be observed.

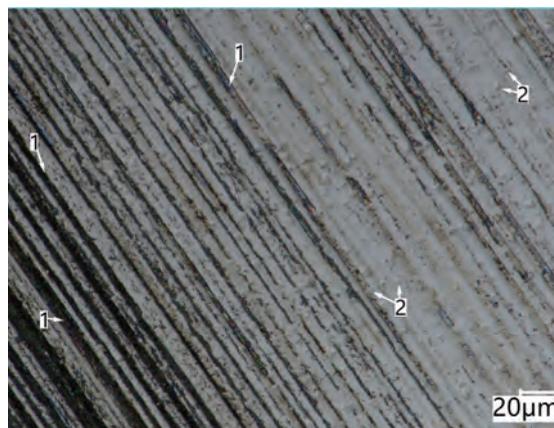
Fig. 13. The surface of the El-Hard 67 padding weld worn in the presence of abrasive slurry: 1 – ploughing, 2 – vanadium carbides

As for the testing in the presence of abrasive slurry, the ridging processes visible as grooves cut

out in the direction of abrasive grain movement were dominant on the surface of all materials. The ridging processes impacted the matrix and chromium carbides, while fine niobium and vanadium carbide precipitates, firmly embedded in the surface layer, resisted these processes, which resulted in their exposure. The counter specimen (ball) rested on the exposed, protruding carbides, and the abrasive grains could still penetrate between the specimen and the counter specimen and impact the other microstructure phases, resulting in their destruction. In this testing variant, the test material wear rate was similar.
