M. MACKIEWICZ\*, J.L. MIKULSKI\*, J. WAŃKOWICZ\*, S. KUCHARSKI\*\*,  
P. RANACHOWSKI\*\*\*, Z. RANACHOWSKI\*\*

## STUDY OF COMPOSITE INSULATOR SHEDS SUBJECTED TO WHEEL TEST

*Keywords:* composite insulators, silicone rubber, wheel test, electrical surface discharges, tracking and erosion

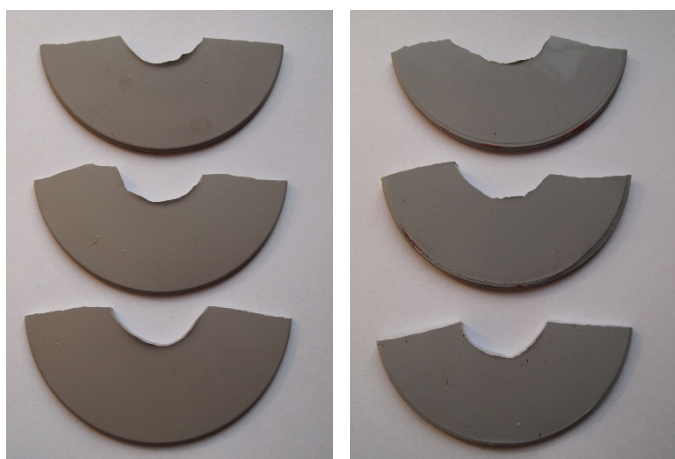
Fig. 1. The insulator shed samples designated as *Pf* – the top, middle and bottom (the upper side of the sheds) – on the left, and the samples designated as *Lt* (the bottom side of the sheds) – on the right

Tests of the original material properties were performed on two groups of samples taken from medium voltage composite insulators. The first one comprised elements of the top, middle and bottom insulator shed, designated as *Pf*. The second sample group consisted of analogous fragments of another manufacturer's insulator – *Lt*. Both insulators were factory new and subjected to no other prior testing. The samples, presented in Figure 1, were used for test surface topography – profile images and their parameters, followed by a mechanical examination of the force-penetration depth characteristics. The surface topography testing was performed both on the upper and lower sides of all samples.

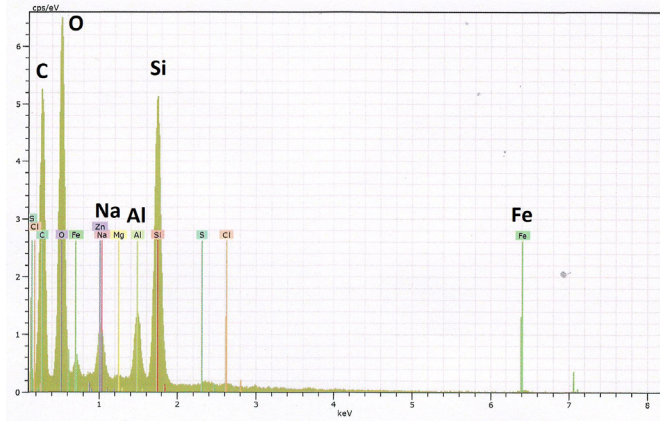
Fig. 3. The EDS diffractogram of the dark coating on the *Pf* sample surface after the wheel test

Using the EDS (energy dispersive spectroscopy) technique, an analysis was made of the chemical composition of the dark coating on the *Pf* samples following the circular test – Figure 3. As assumed, the examination demonstrated the presence of coal, silicon, oxygen and aluminium – the components of the HTV silicone rubber, which was filled with alumina and silica. The other elements came from the solution and the wheel test system.

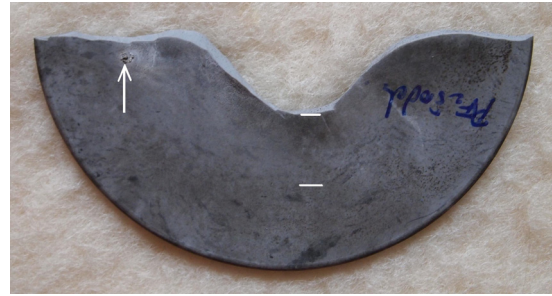
Fig. 4. The upper surface of the *Pf* insulator middle shed sample. The arrow points at the place where the shed was punctured. The lines denote the area in the vicinity of the cut-off insulator core in which the surface profile was examined. The measurement was taken downwards – towards the shed edge

The most critical damage which was observed on two out of six *Pf* samples under examination, was cross punctures of the shed. As already mentioned, a puncture of the shed as a result of electric discharges means that the result of the test – both the wheel and the salt fog ones – is reported as negative.

On the upper side of the sample, the area of the shed neighbouring the cut-off insulator core was examined. It was covered with a dark layer of coating the thickness of which was decreasing towards the edge of the shed. The measurement was being taken in this direction, which was clearly reflected on the registered surface profile – Figure 6. The profile parameters were presented in Table 2. These are raised in relation to the original surface (Table 1), however, to a lesser extent than it was observed for the surfaces of strong covering with a layer of black sedi-

It should be emphasized that irrespective of the dark coating reported on all *Pf*, samples following the circular test, and the frequently observed light erosive paths, the most important damage was the cross puncture through the thickness of the shed. The punctures, as observed on the two samples under examination, result in the negative outcome of the circular test performed on the *Pf* insulators – Figures 4,5 and 8.

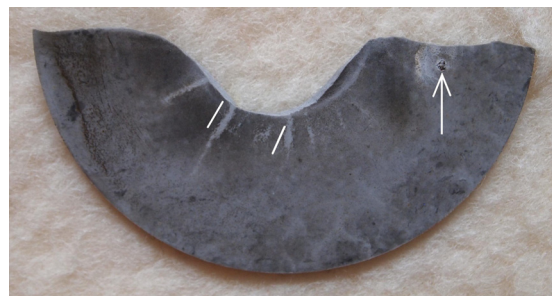
Fig. 5. The lower surface of the *Pf* insulator middle shed sample. The arrow points at the place where the shed was punctured. The lines denote the area in which the surface profile was examined. The measurement was taken from the left to the right hand side

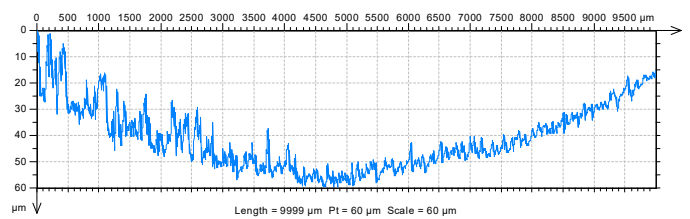
Fig. 6. The upper surface of the *Pf* insulator middle shed sample – the image of the surface profile around the area of the cut-off insulator core where surface blackening was clearly visible. The measurement was taken from the side of the biggest intensity of the coating towards the area of a lighter – grey – colour, towards the shed edge. The arched bend of the profile results from the shape of the shed

ment. This resulted from a significant decrease in the thickness of the dark layer – the further from the place where the insulator core was cut off, the more. Hence, Figure 6 clearly shows a gradual decrease of the amplitude of the registered surface unevenness.

The upper surface of the *Pf* insulator middle shed sample – the surface profile parameters within the area of a variable layer of the dark coating

Parameter	Ra	Rq	Rp	Rv	Rz
Value [μm]	2.5	3.1	8.8	6.0	14.8

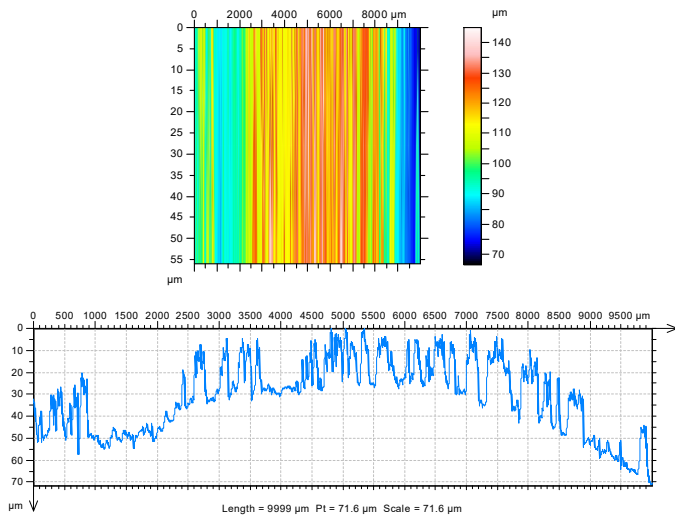
Fig. 7. The lower surface of the *Pf* insulator middle shed sample – the image of the surface profile with a clear light path. Above – the image of the fivefold profile testing at a distance of 8 µm. The arched bend of the profile results from the shape of the shed

On the lower surface of the middle shed sample, the measurement was taken within the area around the cut-off insulator core. It contained a distinct light path, clearly visible in the image of the profile – Figure 7. The profile parameters, strongly elevated with respect to the original ones (Table 1), were presented in Table 3.

The lower surface of the *Pf* insulator middle shed sample – the profile parameters of the surface of the strongly blackened area in the vicinity of the cut-off insulator core, with a clear light path

Parameter	Ra	Rq	Rp	Rv	Rz
Value [µm]	5.7	6.7	14.9	12.4	27.3

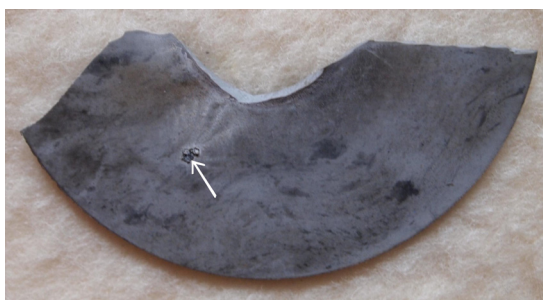
Fig. 8. The lower surface of the *Pf* insulator middle shed sample with an arrow pointing at the location of the puncture

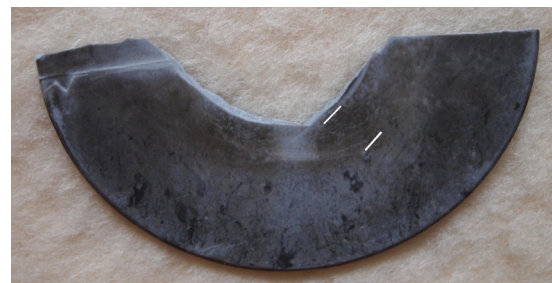
Fig. 9. The upper surface of the *Lt* insulator middle shed sample. The lines denote the area under examination with a bigger intensity of and small cracks in the dark coating. The measurement was taken towards the shed edge

As exemplary and representative, resulting from a great number of tests made on *Lt* samples, the test was presented of the middle shed sample of one of the two insulators under examination. It demonstrated clear effects of electric discharges, both on the upper and lower side. Those were, in particular, areas in the vicinity of the cut-off insulator core – Figures 9 and 10.

In addition, on the upper side of the sample, small cracks were observed in a layer of dark coating.

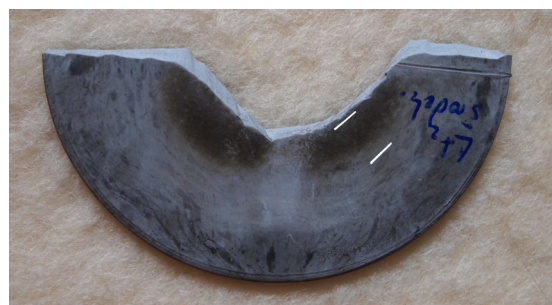
Fig. 10. The lower surface of the *Lt* insulator middle shed sample. Dark sediment covering is visible of the surface within the area around the cut-off insulator core. The measurement in the area marked with lines was taken towards the shed edge

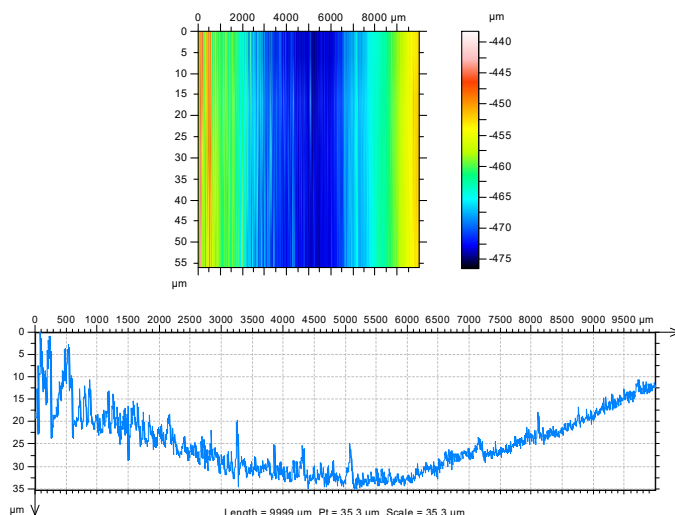
Fig. 12. The lower surface of the *Lt* insulator middle shed sample – the image of the surface profile within the area of increased intensity of black coating, in the vicinity of the cut-off insulator core. The measurement taken towards the shed edge – according to the decreasing thickness of the layer. The last part of the graph corresponds to a very weakly soiled surface. Above – the image of the fivefold profile testing at a distance of 8 μm. The arched bend of the profile results from the shape of the shed

As expected, on both surfaces neighbouring the cut-off insulator core, changes were recorded in the surface profile image and parameters – Figures 11 and 12, Tables 4 and 5. A slightly higher increase in the profile parameters was found in the case of the upper surface (Table 4). Although the coating layer on the lower side seems darker and thicker, upon closer observation, on the upper side (Fig. 9), small cracks within the layer of black sediment were observed. Their presence probably resulted in a stronger increase of the surface parameters and the occurrence of bigger peaks on its profile – Figure 11 and Table 4.

The lower surface of the *Lt* insulator middle shed sample – the parameters of the surface profile of the strongly blackened area in the vicinity of the cut-off insulator core. The values are clearly elevated with respect to the original (reference) surfaces under examination

Parameter	Ra	Rq	Rp	Rv	Rz
Value [μm]	1.2	1.6	5.5	4.0	9.5

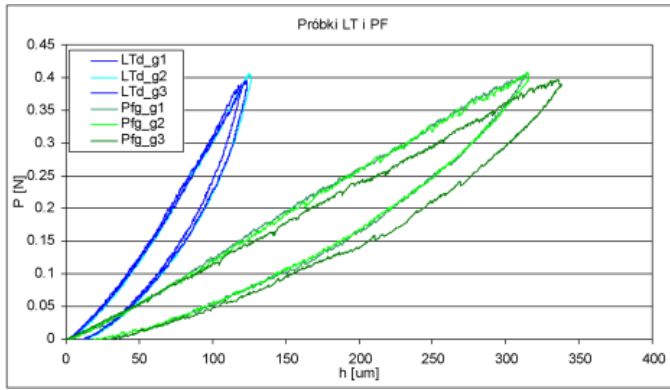
Fig. 13. The force-penetration depth characteristics compared. The measurements were taken in three places on the upper surface of the *Pf* insulator top shed sample – the green graphs, and in three places on the upper surface of the *Lt* insulator bottom shed sample – the blue characteristics

The initial testing was performed in three randomly chosen places on the upper surface of the *Pf* insulator top shed sample, and in three randomly chosen places on the upper surface of the *Lt* insulator bottom shed sample. The force-penetration depth characteristics (P-h), as compared, are presented in Figure 13.

Based on the measurements, as taken, of the original (reference) samples, good parameter recurrence was reported for the *Lt* material and slightly worse for the *Pf* material. It should also be emphasized that both elastomers demonstrate surprisingly big differences between each other. The *Lt* material is approximately three times stiffer – thus less compliant than the *Pf* material

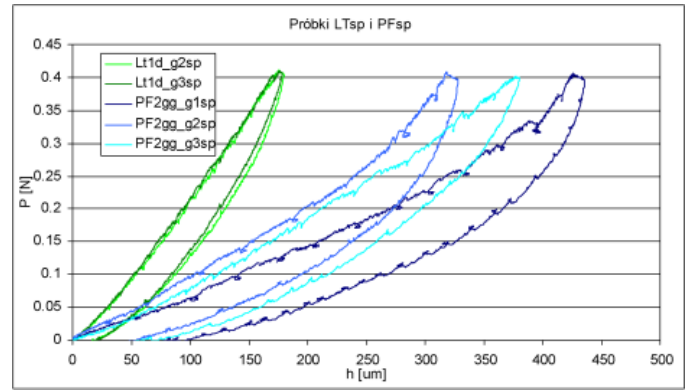
Fig. 14. The force-penetration depth characteristics, as compared, for the *Pf* sample measurements – the blue curves, and the *Lt* samples – the green curves after the wheel test. The differences are noticeable regarding the stiffness (compliance) of both materials and the recurrence of results

were performed within the area of strong blackening, whereas one measurement was taken next to it, yet on a surface that was almost void of the blackening. After the wheel test – of resistance to the effects of electric discharges – probably mainly due to the effect of temperature, there was a decrease in stiffness, hence the compliance of the *Pf* material increased. The shape of the graphs also underwent some change – becoming more bent, crescentic. The P-h characteristics of the three samples following the circular test demonstrated considerable differences from one another as well. The closest to the original – reference – curves was the characteristic of the test performed in the area almost void of the blackening. However, the results of the two measurements, as taken at a distance of 0.5 cm within the same small area of strong blackening, also demonstrated clear differences. This suggests surprisingly large variation of the stiffness-compliance of the *Pf* material as a result of the wheel test – Figure 14.

Figure 14 presents the P-h characteristics, as compared, of the *Pf* and *Lt* material samples, following the wheel test of resistance to the effect of electric discharges. One can clearly see the much higher stiffness – lower compliance, as well as the much better recurrence of the characteristics for the *Lt* material.
