J. VLČEK*, D. JANČAR*[#], J. BURDA*, M. KLÁROVÁ*, M. VELIČKA*, P. MACHOVČÁK**

MEASUREMENT THE THERMAL PROFILE OF STEELMAKING LADLE WITH SUBSEQUENT EVALUATION THE REASONS OF LINING DAMAGE

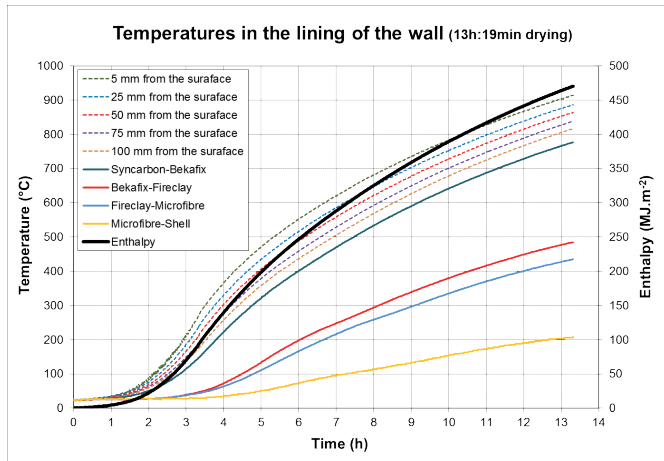
Temperature course of ladle lining was plotted into a several graphs. In Fig. 1, there are presented temperatures inside of lining during the drying process of ladle lining before the 1st tapping. Fig. 2 shows detailed view of the 1st melting.

Fig. 1. Temperatures inside the ladle lining during the drying process

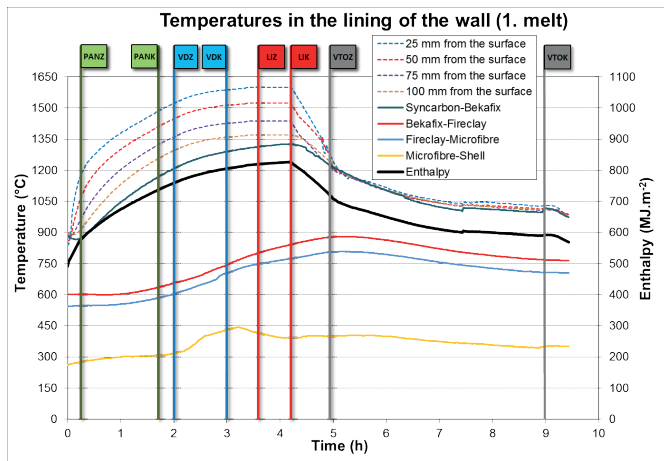
Fig. 2. Detailed view on 1st melt

Explanation of particular abbreviations from Fig. 2:

- PANZ (PANK) - start (end) of steel processing in ladle furnace
- VDZ (VDK) - start (end) of steel processing in cofferdam
- LIZ (LIK) - start (end) of casting
- VTOZ (VTOK) - start (end) of ladle high-temperature heating

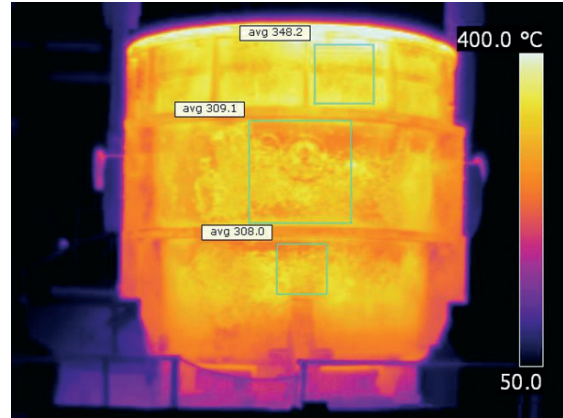
the tap age. Measurement by thermovision camera was focused on evaluation the shells temperature in dependence on ladle working time.

Fig. 3 presents thermovision view to ladle immediately after its taking out of the vacuum station cofferdam.

Fig. 3. Thermovision view of ladle
