MEASUREMENT OF DEFLECTION LINE ON BRIDGES

Rudolf Urban, Martin Štroner

Department of Special Geodesy
Czech Technical University in Prague
Faculty of Civil Engineering
Prague, Czech Republic

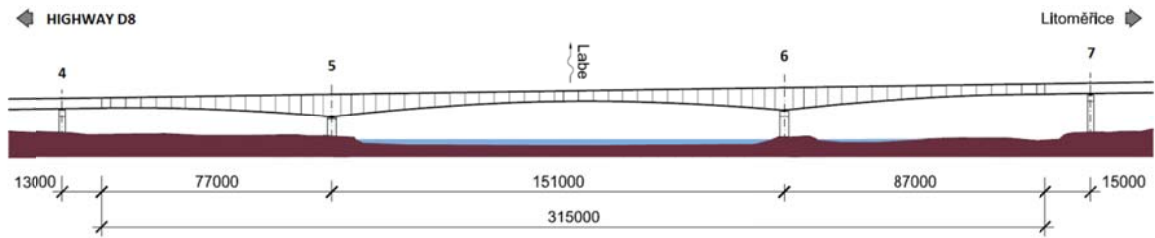
Fig. 1a. Longitudinal section of superstructure

The width of the bottom deck is 7.5 m; the width of the upper deck is 14.5. The main structure span (length 151 m) and neighbor spans (length 90 and 102 m) were constructed by balanced cantilevers method. These spans are made by two cantilevers with tapered cross section height (varies from 3.5 m in the middle of the span to 7.5 m above supports) and changing thick of the bottom slab (varies from 270 mm to 1200 mm) – see Fig. 1.

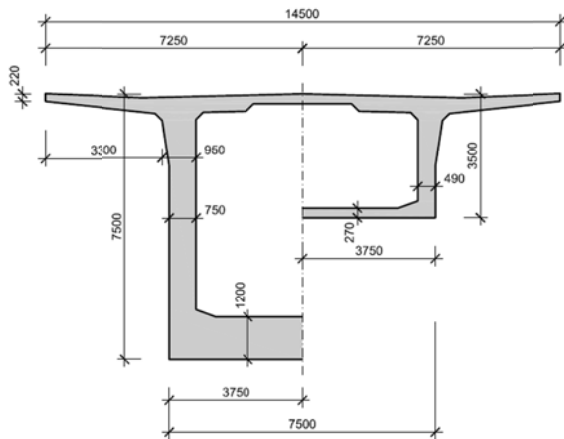
Fig. 1b. Cross section of superstructure

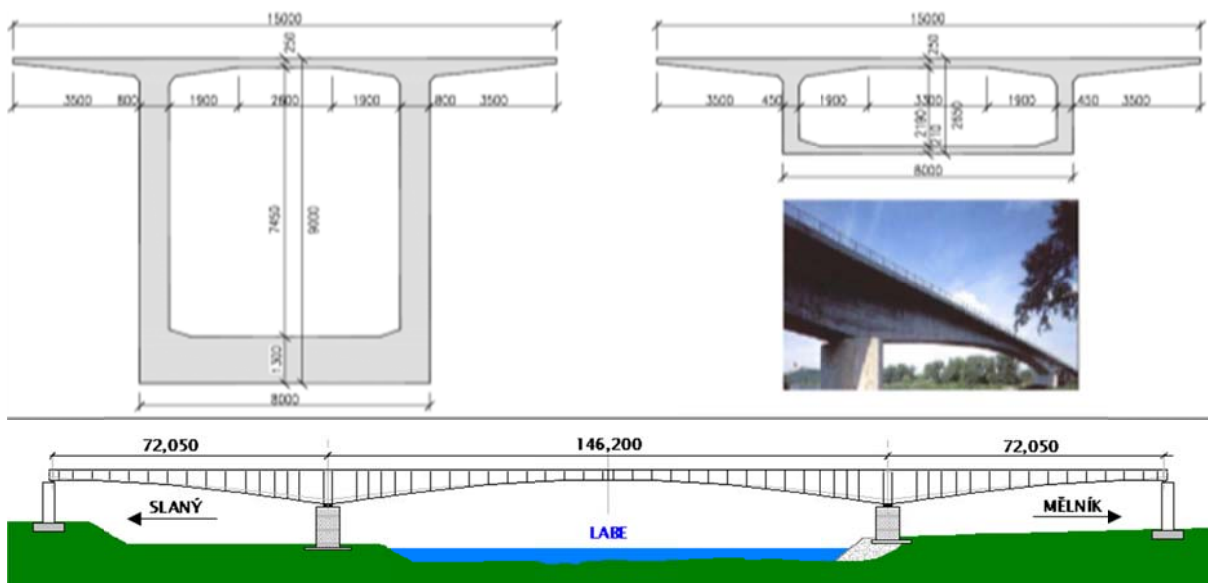
Fig. 2. The bridge near Mělník

Long span prestressed concrete bridge across the river Labe in Mělník (Fig. 2) is the main part of the bridging transferring the I/16 communication. It was designed as a through girder with span length 72.05 + 146.2 + 72.05 m. With the main span length 146.2 m it is still one of the biggest overhung concrete bridge in operation in Czech Republic.

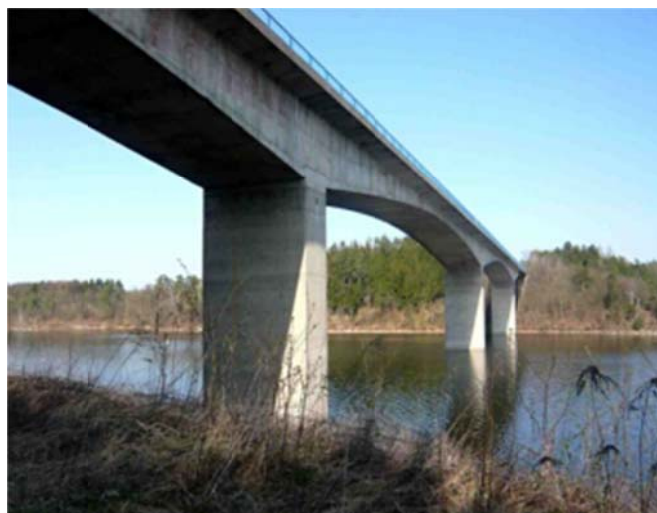
Fig. 3. The Bridge near Brzotice

The bridge over the river Želivka near Brzotice (Fig. 3) is the part of the road II/150 – connection between the valley of Sázava and D1 highway. The construction of bridge is designed as a concrete frame structure with four fields with inner joints in the 2nd and 3rd field. Length of bridge is 306 m, width 13 m and pillar are 65 m high.

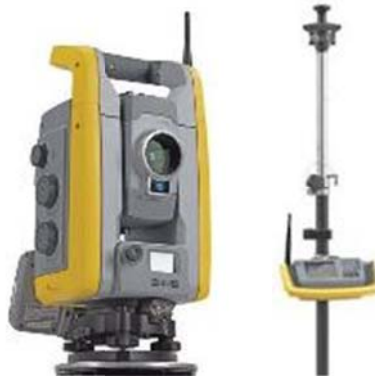
Fig. 4. Trimble S6 Robotic, a range pole with an omnidirectional prism

The Trimble S6 Robotic instrument ($\sigma_{\phi} = 0.3$ mgon, $\sigma_D = 1$ mm + 1 ppm D) with a relevant omnidirectional reflection prism was used for the measuring (Fig. 4). It is a total station with automatic observation of an aim and spacing, which also enables automatic targeting on an omnidirectional reflection prism.

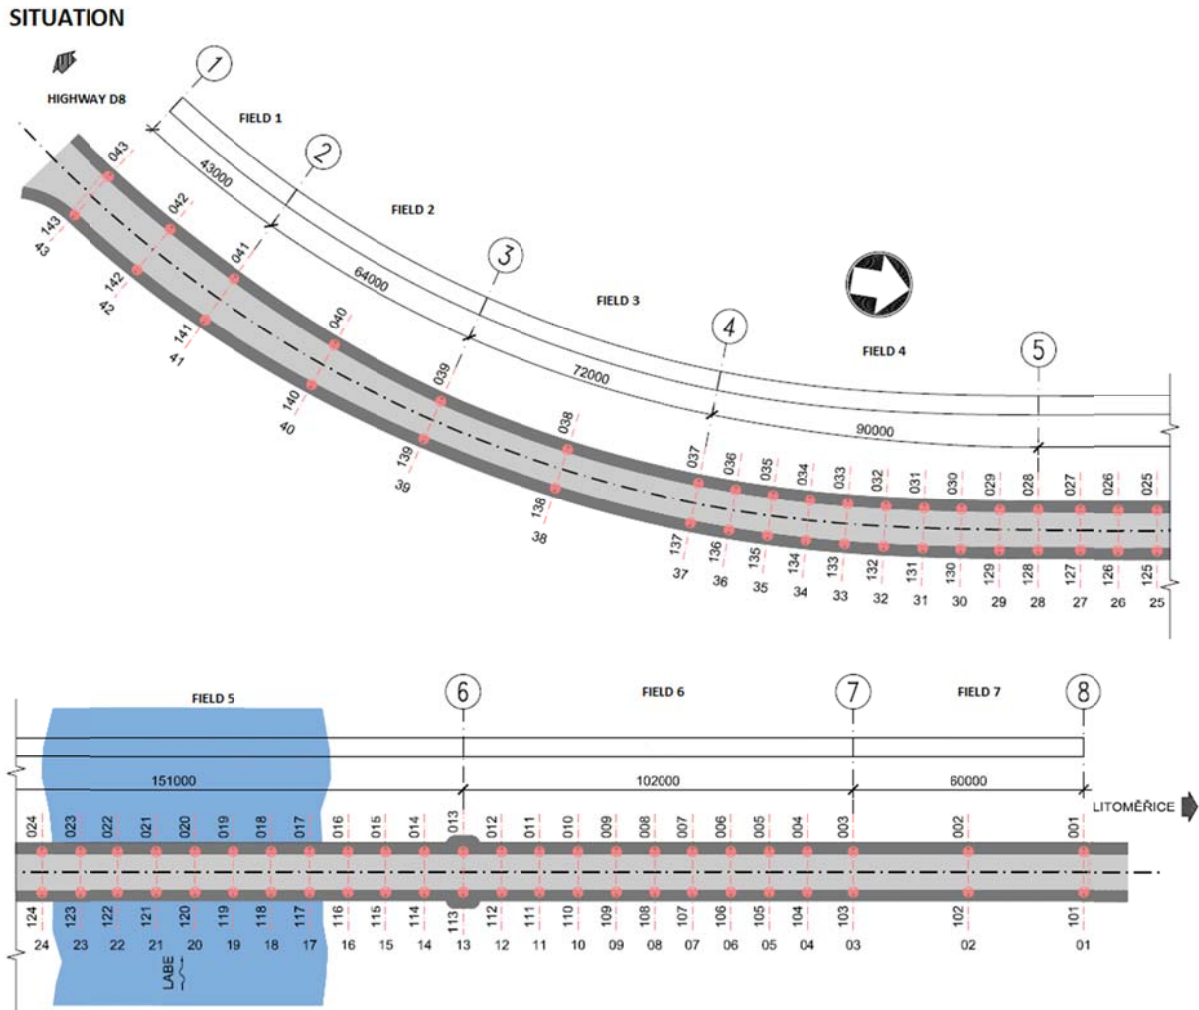
Fig. 5. Monitored points (Litoměřice)

The measuring configuration is shown in Fig. 5 for bridge near Litoměřice and in Fig. 6 for bridge near Mělník. Configuration of measuring on bridge near Brzotice was very simple. 88 points with exactly the same spacing were situated on the right side of the bridge. The bridge structure shape was changing in the course of measuring. When designing the configuration measuring the assumption was that the bridge temperature is stable (measuring was realized at night). In case of temperature instability, the „time sample method“ was used for correction.

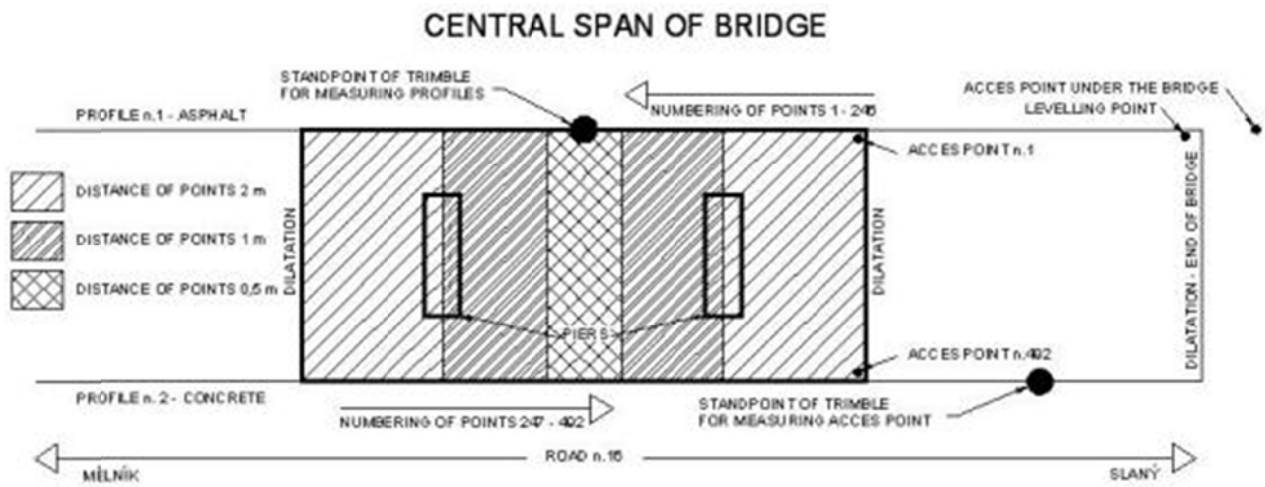
Fig. 6. Monitored points (Mělník)

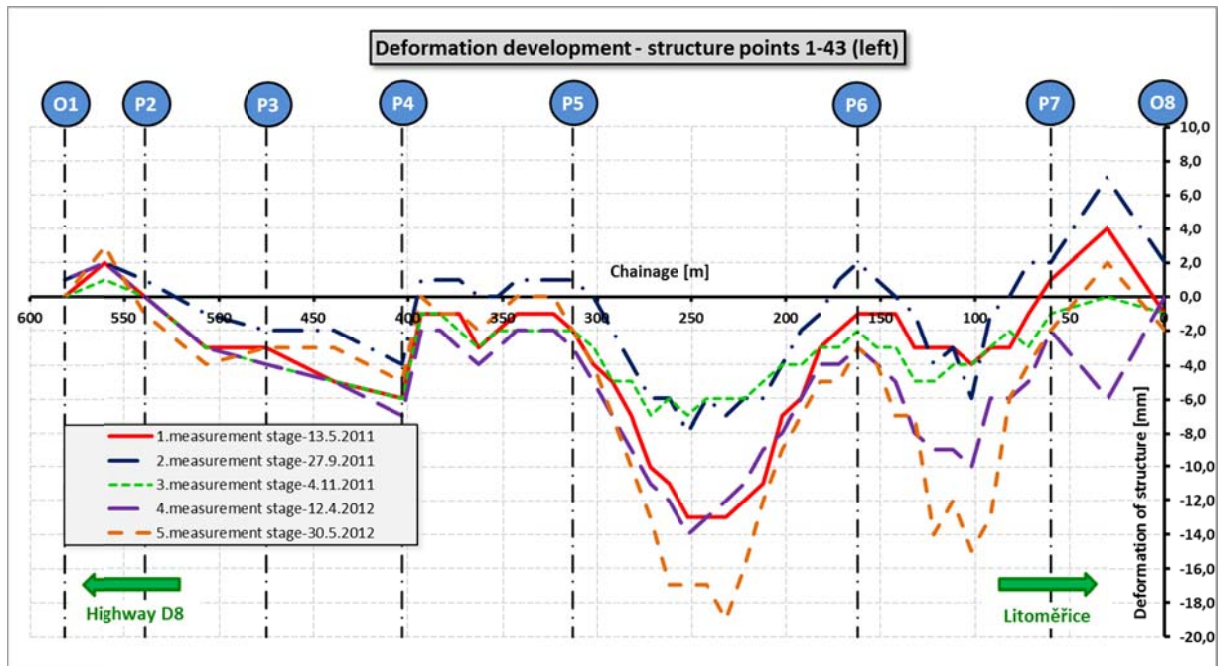
Fig. 7. Development of structure deformation compared 0th measurement stage (left)

Six measurements were determined by the relative heights of all monitored points from the reference geodetic connection point. Displacements (structure deformation) of each point relative to the base 0th stage are shown on Fig. 7 and Fig. 8. These pictures show significant decrease in the main field, which is situated above river.

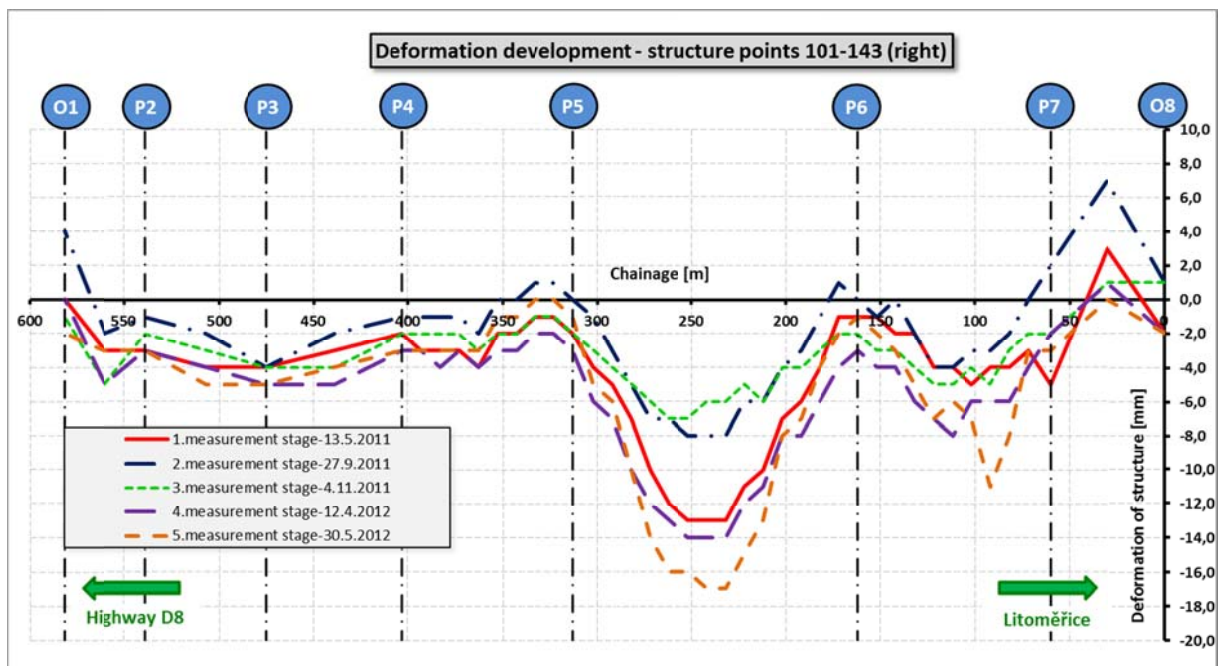
Fig. 8. Development of structure deformation compared 0th measurement stage (right)

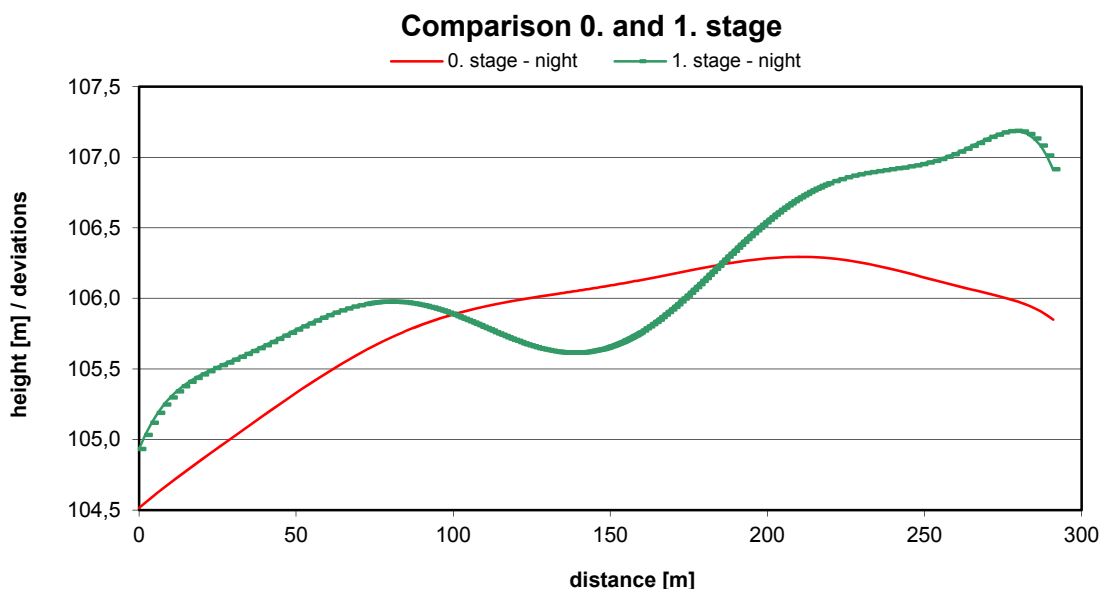
Fig. 9. Comparison 0th and 1st stage (night)

Three measurements were determined by the relative heights of all monitored points from the reference geodetic connection point. Displacements (structure deformation) of 1st stage to the base 0th stage are shown on Fig. 9. There is a comparison for study of development of construction in the longer term (3 months). On Fig. 10 are compared 2nd and 3rd stages for study of development due to temperature changes. Height of deformation (deviation) in figures was magnified a hundred times. The deformation in the main field is clearly visible.

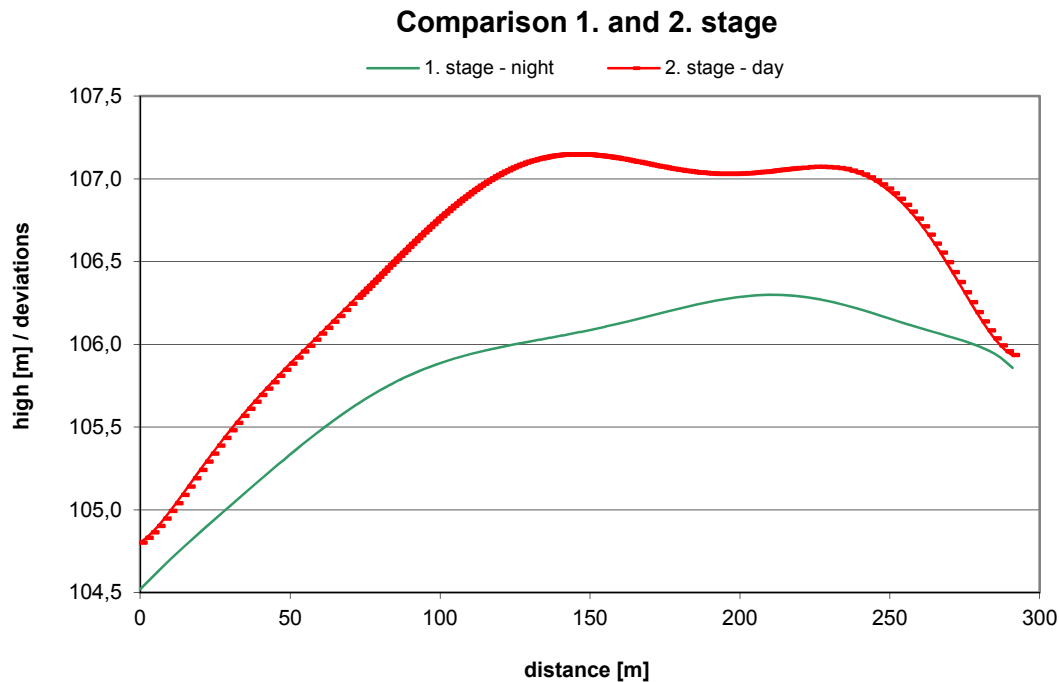
Fig. 10. Comparison 1st and 2nd stage (night – day)

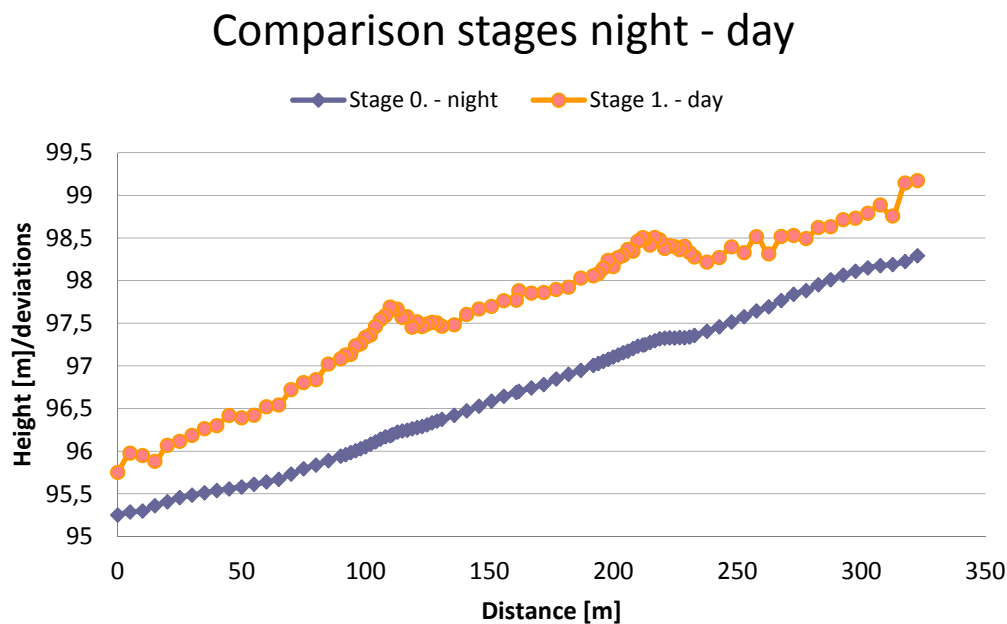
Fig. 11. Comparison 0th and 1st stage (night – day)

Two measurements were determined by the relative heights of all monitored points from the reference geodetic connection point. Displacements (structure deformation) of 1st stage to the base 0th stage are shown on Fig. 11. There is a comparison for study of development due to temperature changes. Height of deformation (deviation) in figure was magnified a hundred times. Two raised significant places in the picture correspond with inner joints of structure.
