P. RANACHOWSKI*, Z. RANACHOWSKI*#, K. WIECZOREK**,
M. JAROSZEWSKI**, S. KUDELA JR***

STUDY OF MODIFIED ALUMINOUS PORCELAIN SUBJECTED TO MECHANOACOUSTIC TESTS

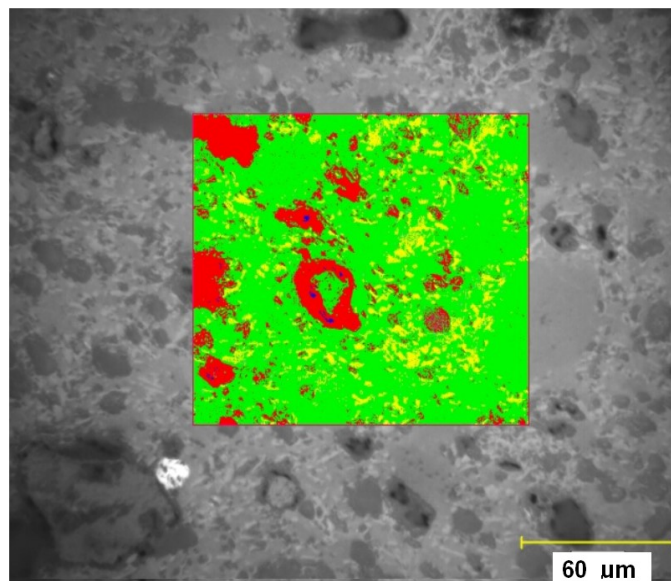
Fig. 1. Typical image of the microstructure of the investigated material, magnified $\times 500$. In the middle particular phases are shown with different colours. Yellow indicates corundum grains, red – chipped elements of the microstructure (mainly cullet), blue – sporadic pores. The green background included glassy matrix, mullite fragments and quartz grains

Figure 1 shows the microstructure after formatting and processing the picture with Photo Paint-Corel. In the middle of the image different phases were separated into different colours using binary masking. Yellow indicates corundum grains, red – chipped elements of the microstructure (cullet and quartz grains or their fragments), blue – sporadic pores. The green background included glassy matrix, mullite fragments and non-isolated in this image processing – quartz grains.

The material was well-fired aluminous porcelain and demonstrated big similarity to the reference material [6]. However, worse homogeneity was observed, especially in the distribution of mullite phase. There occurred slight – a few percent – differences in the amount of particular phases between tested samples.

The corundum contents changed within a few percent, its mean amount in different observation fields being equal to 15%. As in the reference material, corundum occurred in the form of elongated, a few micrometers long grains. However, its amount fell to about 4%, in a less homogeneous distribution in the matrix. Corundum grains were well bound with the glassy phase and their agglomeration was limited.

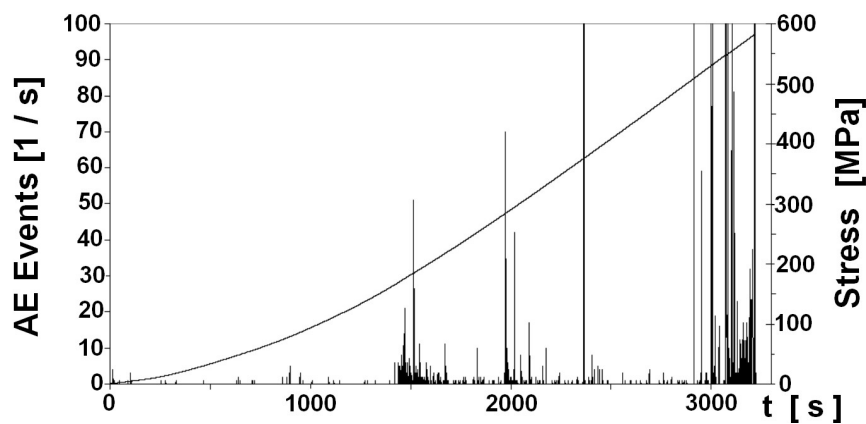
Fig. 2 Mechanoacoustic characteristics of the weaker specimen of the investigated material whose strength was equal to 582 MPa

Mechanoacoustic characteristics recorded for the specimens of the investigated material demonstrated a marked diversification. It is, however, typical of all ceramic aluminosilicate materials and is connected with a large spread of their compressive strength. The nature of degradation effects recorded for the investigated material is similar as in the reference material and consists of three well-defined stages: preliminary, subcritical and critical [6,7]. Microscopic examination of the effects of compressive stress was carried out on the specimens in which the application of compression was stopped at selected values: 275 MPa – after preliminary degradation, 504 and 582 MPa – in advanced subcritical stage and 690 MPa – where bigger fragments of the destroyed sample were examined (critical stage). Selected mechanoacoustic characteristics of the investigated material samples are presented in Figs. 2,3.

the diversified strength of the material samples, the scope of development of subcritical effects was different for individual specimens – Figures 2 and 3. The recorded EA signals showed very varied intensity during the subcritical stage. However, weaker signals dominated and occurred individually or less frequently – Figure 2 – in longer ranges of continuous activity.

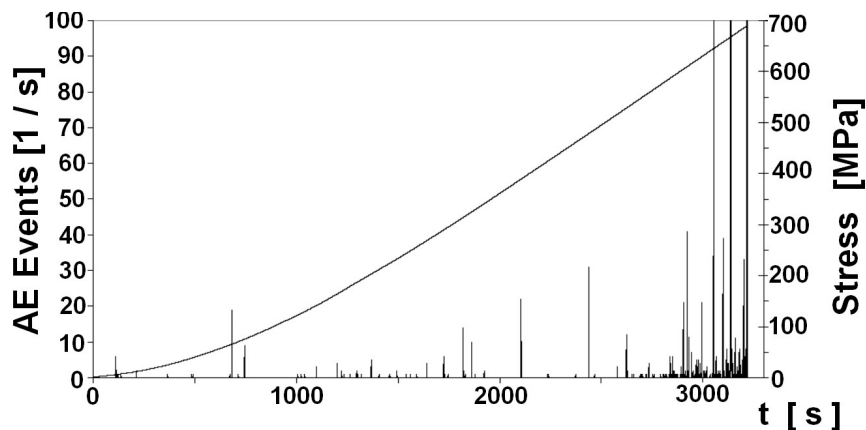
Fig. 3 Mechanoacoustic characteristics of the strongest specimen of the investigated material whose strength was equal to 690 MPa

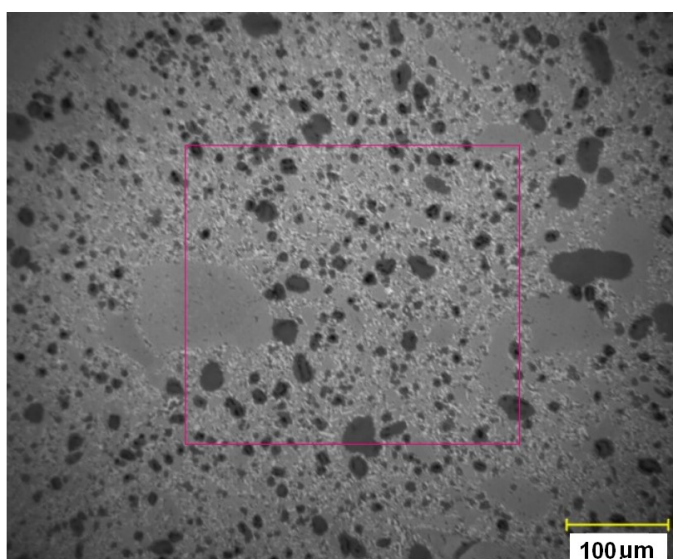
Fig. 4. Image of the tested material after the preliminary stage of degradation, $\times 200$. The sample was loaded to 275 MPa. There are visible dark areas of crushed out cullet particles, quartz grains and to a small extent – fragments of mullite precipitates. They constitute about 10% of the surface area

Elements of the microstructure, destroyed and crushed out from the surface of the test specimens at the end of the preliminary stage, accounted for about 10% – Figure 4. This applied to almost all cullet particles, a large majority of quartz grains and few fragments of mullite precipitates. In the case of the reference material, the number of crushed out fragments was clearly lower, and the degradation of the mullite precipitates in the preliminary stage was hardly seen. The reference porcelain, presented in detail in [6], showed better homogeneity and also the cohesion of the microstructure, resulting from a stronger connection of the material building phases.

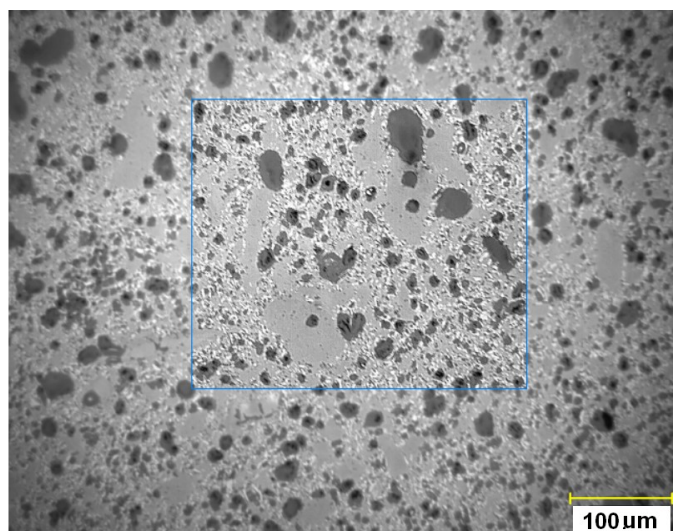
Fig. 5. Image of the microstructure of the central part of the tested sample loaded up to 504 MPa, $\times 200$. There are visible smaller dark areas after crushed out particles of cullet and quartz, and larger – after fragments or even whole mullite precipitates. There are also numerous microcracks in the areas of concentration of small, bright corundum grains. Crushed out elements cover about 19% of the surface

For individual microscopic observation areas of samples loaded to an advanced subcritical level (504 and 582 MPa), crushed out elements of microstructure included quite a wide range – from 15% to even twenty-several percent, usually around 17%. Particularly many damaged elements were observed in the middle part of the samples – Figure 5. Figure 6 shows the size distribution of crushed out elements of microstructure in the samples of the tested material, which were loaded to 275, 504 and 582 MPa. Quantities of elements in the range of $5 \div 15 \mu\text{m}$ were definitely predominant, with the average value equal to $11 \mu\text{m}$. They came from particles of cullet and smaller grains of quartz or their fragments. Larger crushed out elements, in particular

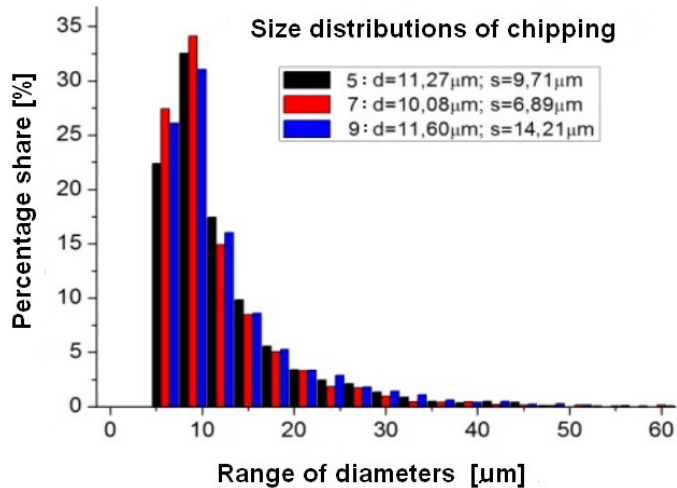
Fig. 6. The size distribution of the areas of crushed out elements of microstructure in the samples of the tested material, which were loaded up to 275, 504 and 582 MPa. The average value is equal to 11 μm (d denotes mean value, s – standard deviation for the particular sample)

over 30 μm , originated mainly from fractured and separated fragments of mullite precipitates and possibly accompanying them concentrations of corundum particles.

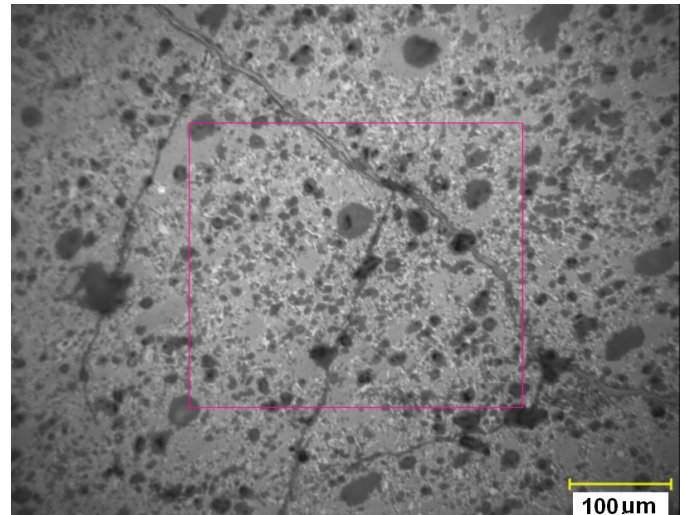
Fig. 7. The cracking system in the middle part of the sample of the tested material, subjected to destruction at 690 MPa, $\times 200$. There are numerous dark areas after crushed out elements of the microstructure – particles of cullet, quartz, mullite precipitates and corundum agglomerates. They constitute a total of 22% of the surface area

During the critical stage, further fragments or even whole precipitates of mullite as well as corundum agglomerates were damaged and crushed out, especially in the vicinity of the mullite phase. Therefore, the surface of damaged and broken elements of the microstructure increased to more than 20%, but with significant differences for individual microscopic observation areas. The most important and characteristic effect occurring during the critical stage was the formation and propagation of large, usually little branched cracks. Their development was facilitated by numerous damaged and separated from the matrix elements of the microstructure. Starting from loose fragments of cullet and quartz grains, through cracked mullite precipitates and finally – strongly fractured areas of corundum grains concentration. At sufficiently high stress, there took place a sudden increase of cracks and destruction of the entire specimen, which was accompanied by very strong but short-lasting acoustic activity. The effects of critical degradation of the microstructure of the tested material are presented in Figure 7.
