Ewa Netczuk-Pol*

*The influence of the foreign invader
on the shape of wooden architecture
of the end of the 19th and beginning of the 20th century
in the Lublin region*

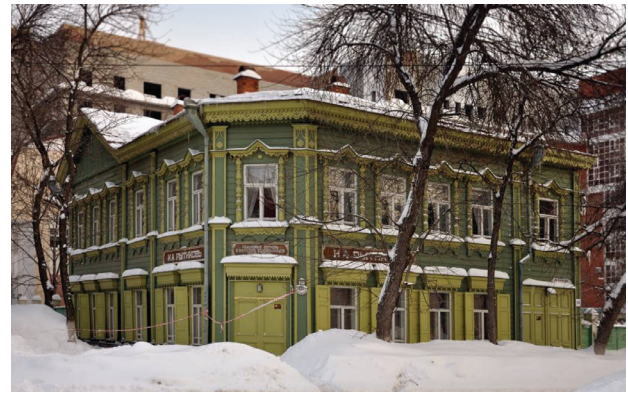
Fig. 1. An example of traditional Russian wooden buildings in Samara (photo by E. Pol, 2011)

Russian wooden buildings were characterized by a great variety, both in terms of functional and spatial arrangements and decorations (Fig. 1). The simplest type were one-story, two-room houses, most often belonging to the less wealthy population. Their spatial arrangement resembled a country cottage, to which utility rooms could be added. Objects with a more extensive program were also erected. Apart from single-storey buildings, two-storey buildings were put up for wealthier people⁴.

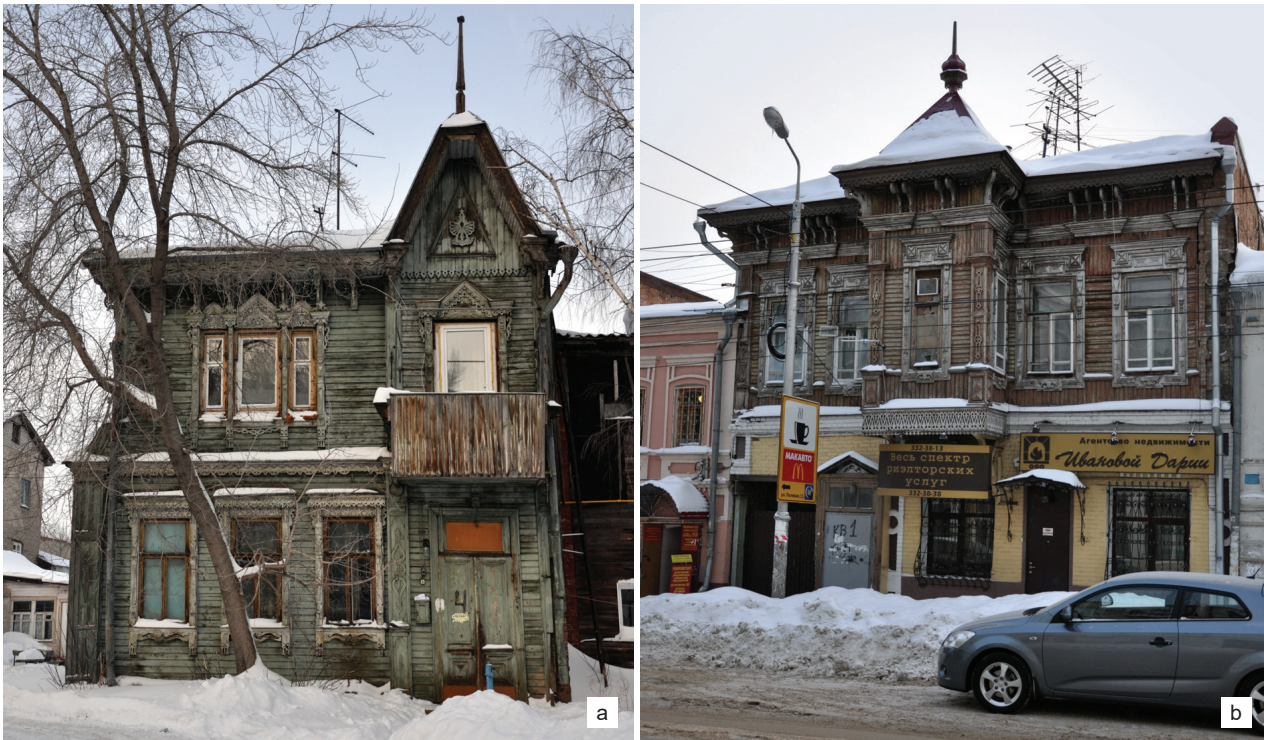
Fig. 2. Two-story wooden houses in Samara (photo by E. Pol, 2012)
 Il. 2. Dwukondygnacyjne domy drewniane w Samarze (fot. E. Pol, 2012)

Russian architecture was characterized by rich decorations referring to phytomorphic, zoomorphic and geometric forms [20]. The elevations of these buildings were accentuated, among others, by through bay windows, towers (at the corners), breaks (emphasizing the entrance area), balconies and dormers. Towers and bay windows were most often crowned with a hipped roof with a spire, less often bulbous roof or gable roofs were used (Fig. 2).

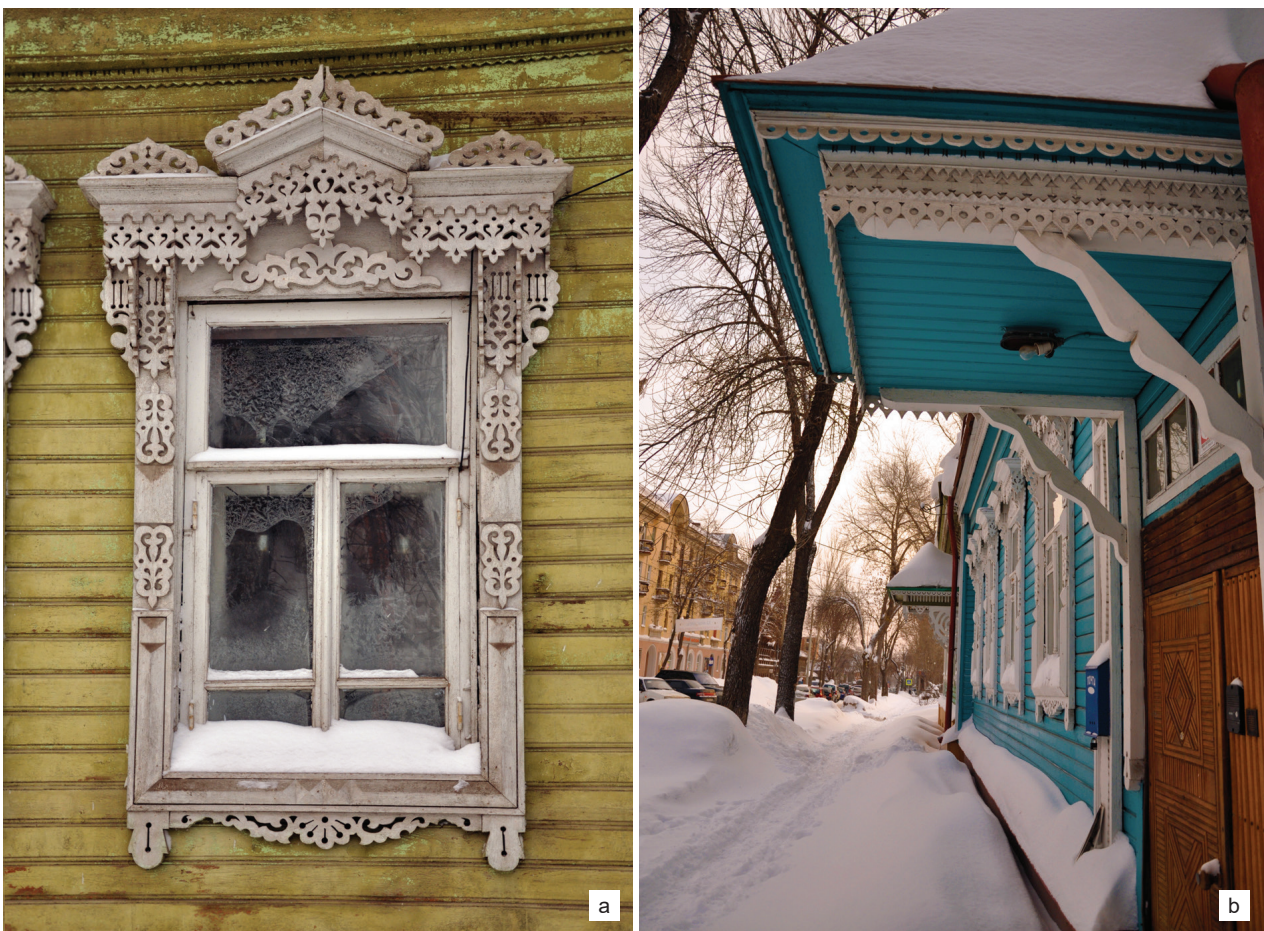
Fig. 3. An example of traditional Russian wooden buildings in Samara: a) window detail, b) porch detail (photo by E. Pol, 2012)
 Il. 3. Przykład tradycyjnej rosyjskiej zabudowy drewnianej w Samarze: a) detal okna, b) detal ganku (fot. E. Pol, 2012)

Wooden built-up windows were an important element with the richest decoration. It could consist of drip and window sill, which together with the window framing formed a decorative frame (Fig. 3a). In addition, shutters were used mainly in the homes of less wealthy society, which were treated as a simpler version of window decoration. Another characteristic element of this type of development are wooden porches (Fig. 3b). They appeared in many forms, from fully built-up ones, to simpler ones, reduced only to the roof above the main entrance.

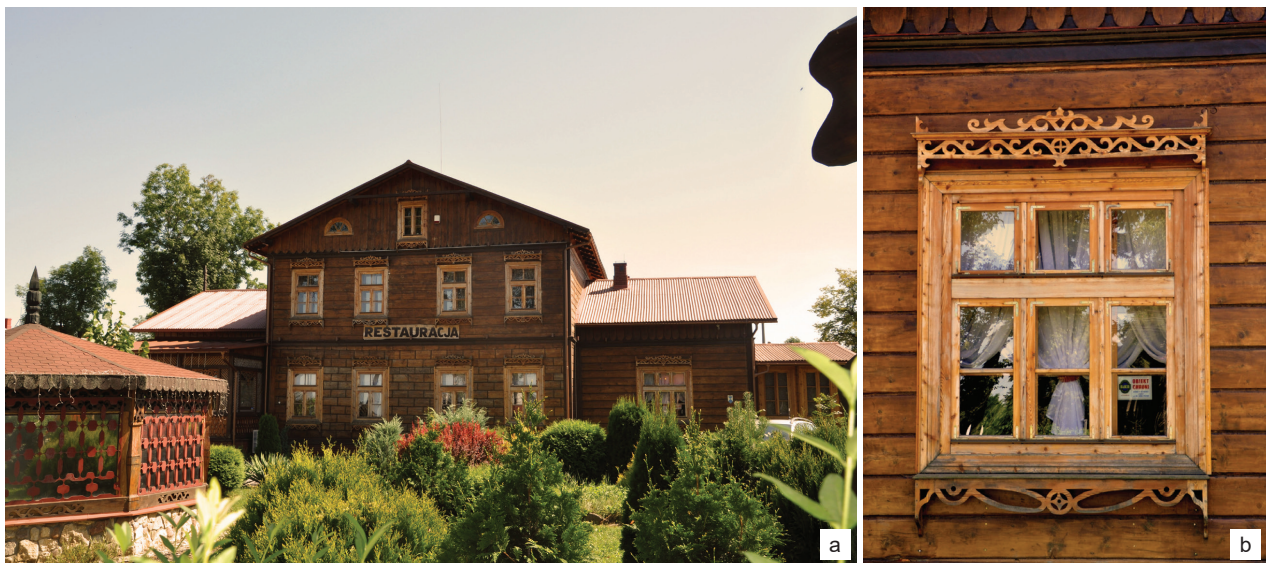
Fig. 6. A residential building from 1895, located in Słodka Street in Szczepieszyn – formerly the house of the director of the Sugar Factory Klemensów, now a restaurant:
a) view from Skłodowskiej Street, b) detail of the window (photo by E. Pol, 2013)

An interesting example is a two-story log house built in 1895 for the director of a sugar factory in Klemensów⁸. It has a much more extensive functional and utility program. As in the previous building, its windows have characteristically decorated drip and window sills, as well as vertical and horizontal planks with no architectural details (Fig. 6).

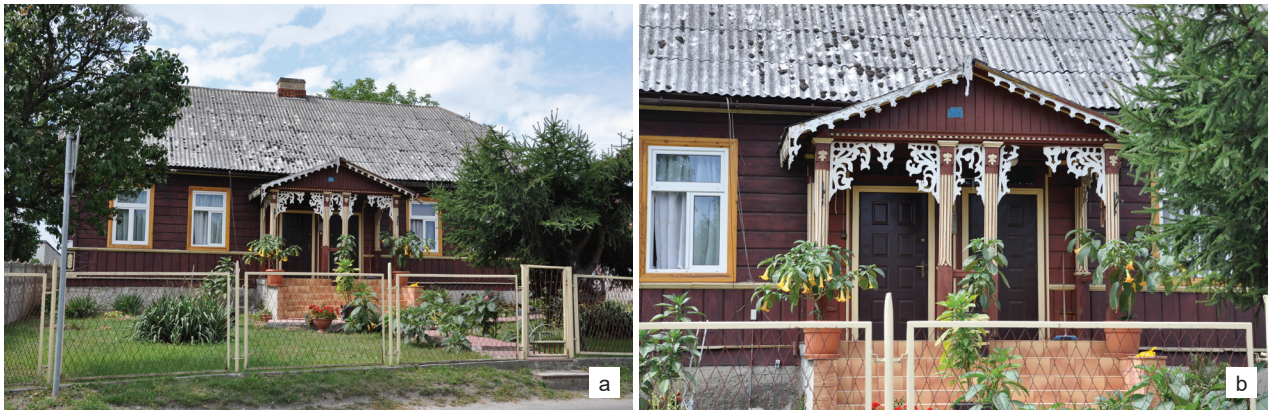
Fig. 7. A one-story residential house in Zamojska Street in Hrubieszów: a) front elevation, b) porch details (photo by E. Pol, 2013)

Along with the development of rail transport, the movement of the population also increased, which introduced its building traditions along with settling in these areas. Hrubieszów is a city where the influence of the invader on the appearance of architecture was significant, which is mainly reflected in architectural details. Most of the one-story houses had decorated porches (Fig. 7). In the case

of one-story buildings with an attic, the entrance area was accentuated by attics with loggias or bay windows.

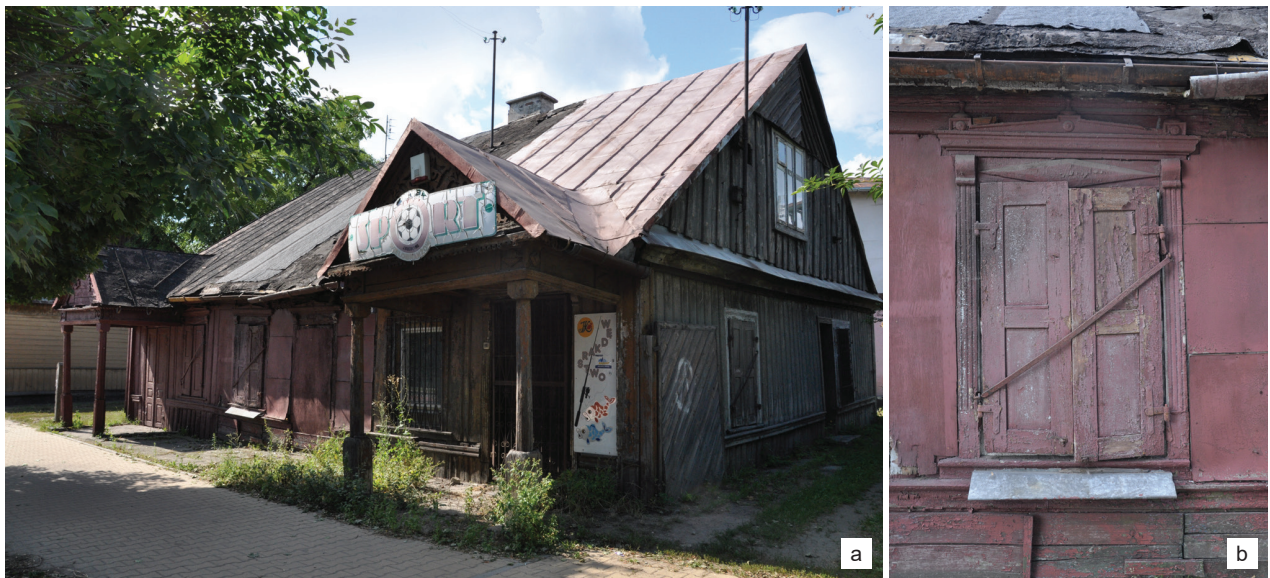
Fig. 8. House in Warszawska Street in Dęblin: a) general view, b) detail of a window with a shutter (photo by E. Pol, 2013)

ings. In one of the main streets, wooden buildings were built, referring to traditional Russian architecture. It is visible mainly in the decoration of window trims and porch gables (Figs. 8, 9).

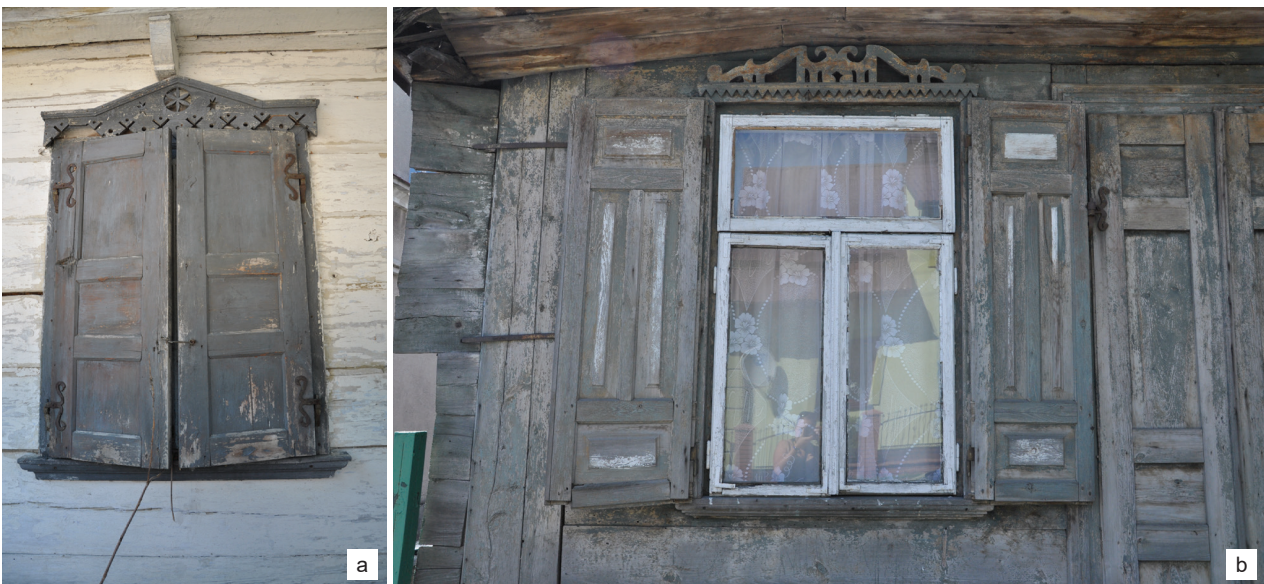
Fig. 10. A window frame with a decorative window drip and shutters in a one-story single-family house:

a) in July 22 Street (currently May 3 Street) in Kock (defunct), b) in Czerwonego Krzyża Street in Ostrów Lubelski (photo by E. Pol, 2013)

References to the traditional Russian wooden buildings can also be found in other cities of the Lublin region. Examples include houses in Ostrów Lubelski or Kock (Fig. 10).
