## Towards Alternative Strategies for the Post-disaster Recovery of Cultural Heritage Sites: A Case Study of the Basilica of St. Benedict in Norcia, Italy

**Keywords:** architectural heritage, post-disaster recovery, post-disaster reconstruction, masonry, reinforcement, Basilica of St. Benedict in Norcia

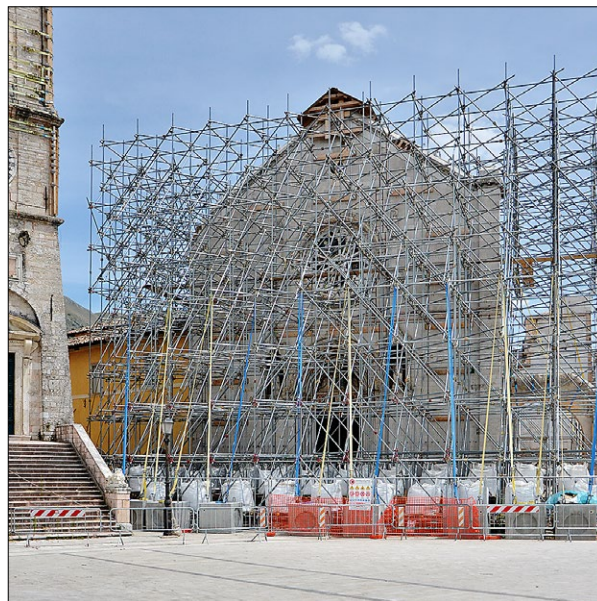
Fig. 2. St. Benedict Church in Norcia, Italy, damaged during the AVN seismic sequence, 2017; photo by A. Rogulska

arguing for an “identical” Basilica (Comitato pro Basilica identica di Norcia) was formed immediately. The special commission, headed by prof. Antonio Paolucci and composed of representatives of the Ministry of Cultural Heritage and Activities (Ministero dei beni e delle attività culturali e del turismo), the National Institute of Architecture (Istituto nazionale di architettura IN/ARCH), and of the Umbria region, is responsible for both the reconstruction and organization of the above mentioned international architectural competition that, at the time of writing this article, is still to be announced. The commission claims the aim is to preserve the spirit of the place,<sup>7</sup> yet their approach seems unrealistic. There is the risk that the site, situated in the central part of the city, will remain a ruin for a long time—too long for any spirit to survive (Fig. 1, 2 and 4).

Figures 1–4 present, through Nolli’s graphic, the significant change that occurred in the area of St. Benedict Square after the earthquake. After such a strong, sequential seismic activity, the scale of downgrading accessibility of public buildings and spaces is not surprising. However, the acceptance of this state of things for years to come, in the light of what we can learn from the past, should be alarming.

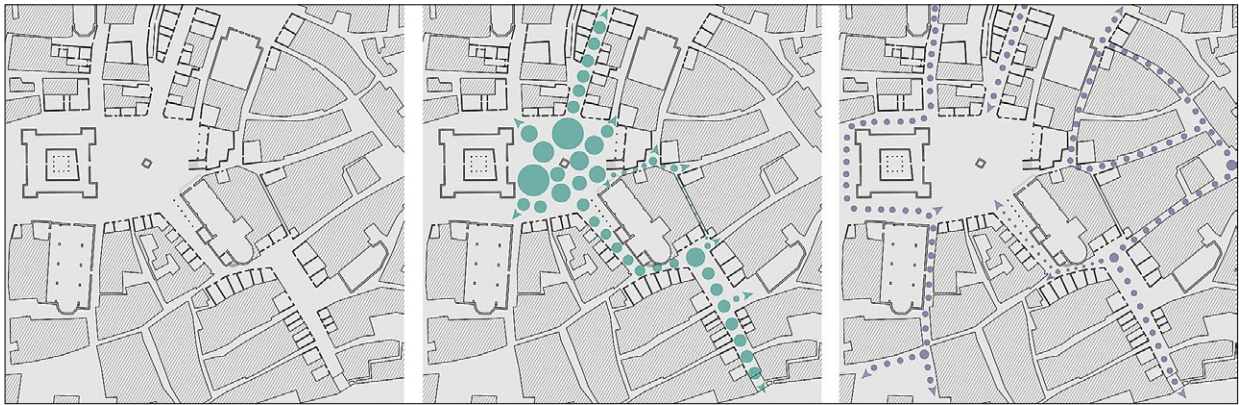
Fig. 3. The area of St. Benedict Square in Norcia, Italy, prior to the 2016 AVN seismic sequence; from the left: a) urban tissue, b) walkability, c) accessibility for vehicles; by A. Rogulska

The research presented here thus includes a comparative analysis of accessibility and mobility in the neighborhood of the Basilica of St. Benedict in Norcia before the 2016 seismic sequence (Fig. 3) and after the protection of the buildings damaged by it (Fig. 4). This was carried out on the basis of a site visit in 2017 (Fig. 1,2 and 4). Based on the description of the technical condition of the building provided by Iannelli [2020], three functional-spatial scenarios are presented, assuming the possibility of restoring, at least partially, the accessibility of the building, and analyzing accompanying engineering challenges (Fig. 5–7). The variants analyzed in the context of available structural and material solutions allow to define the parameters for future innovations and possible solutions.

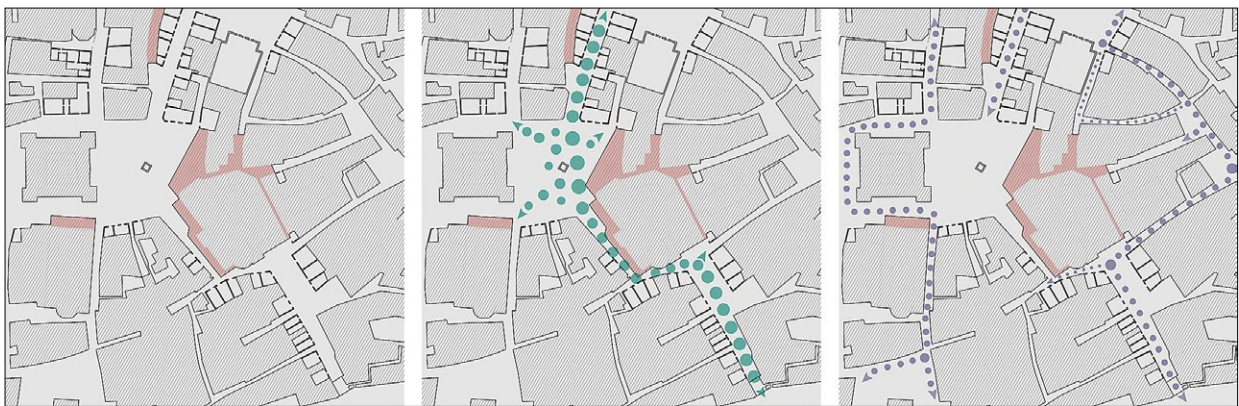
Fig. 4. The area of St. Benedict Square in Norcia, Italy, after the 2016 AVN seismic sequence; from the left: a) urban tissue, b) walkability, c) accessibility for vehicles; by A. Rogulska

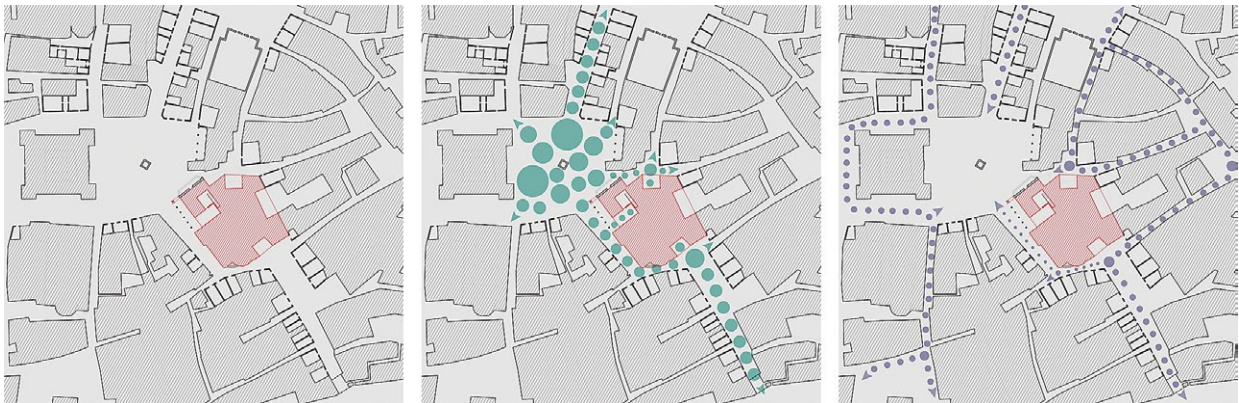
Fig. 5. The area of St. Benedict Square in Norcia, Italy, after the 2016 AVN seismic sequence: minimal intervention scenario; from the left: a) urban tissue; b) walkability; c) accessibility for vehicles; by A. Rogulska

Bearing in mind that safety measures are not allowed to be permanent, hypothetical scenarios presented in Figures 5–7 speculate on alternatives. They are only demonstrative as it was not possible to conduct the necessary field studies and appropriate static simulations. Their goal is to highlight the potential of the use of new, unforeseen visual openings and cracks in the city’s structure.

The variant presented in Figure 5 assumes a very limited possibility of interfering with the perimeter of the ruins. The difference between this proposal and currently applied solutions lies in the emphasis given to the surroundings and open spaces, in particular those important from the point of view of urban composition, urban design and mobility. Micro-spaces, with shapes and dimensions arising from the logic of existing spaces (the visual culmination of street axes, compositionally important points, etc.) help increase awareness regarding the city’s vulnerability and emphasize its resilience, however superficial. This can be seen as a preliminary intervention preceding those requiring more detailed studies and surveys and applicable for scenarios presented in Figures 6 and 7.

Variant 1 assumes that the building cannot be made accessible and thus focuses on the development of micro-spaces in compositionally and functionally important points of the former outline of the building. Variant 2 would partially open the undisturbed parts of the building, with particular emphasis on the crypt, with the use of mixed structural systems (lightweight structures for temporary functions, alternative safety solutions for the parts not open). Variant 3 optimizes the functional and compositional terms by proposing the introduction of new non-permanent cubic elements (modular and prefabricated systems). Such a solution is also possible due to how a temporary facility in the context of areas affected by natural disasters is defined.

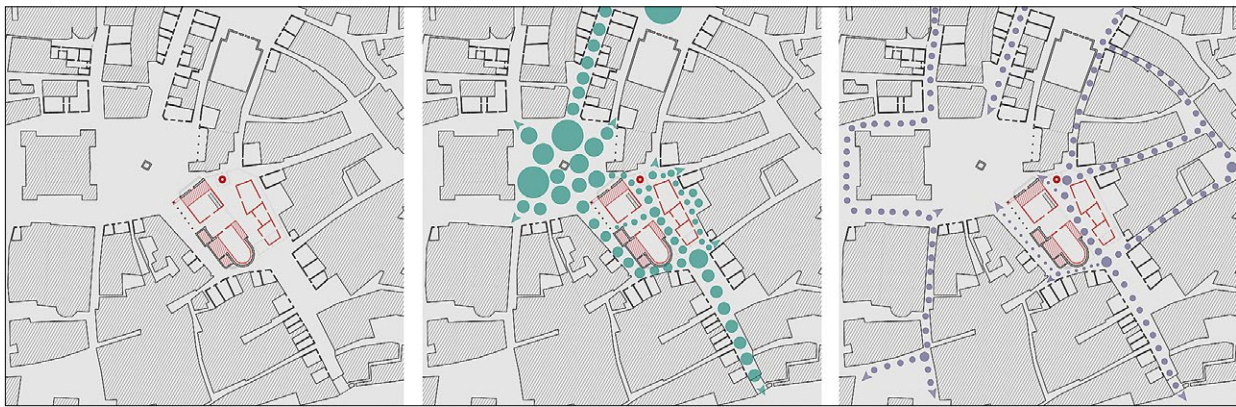
Fig. 6. The area of St. Benedict Square in Norcia, Italy, after the 2016 AVN seismic sequence: site-specific intervention scenario; from the left: a) urban tissue, b) walkability, c) accessibility for vehicles; by A. Rogulska

The variant presented in Figure 6 assumes opening of new links and the introduction of new functions. This is combined with the use of small buildings or

lightweight structural systems aligned with pre-existing structures that maintained structural capacity, as well as those detached from old structures. Most importantly, it provides access to the critical and still-intact fragment of the Basilica—its crypt and the ruins of the Roman house thought to be the birthplace of St. Benedict and St. Scholastica.

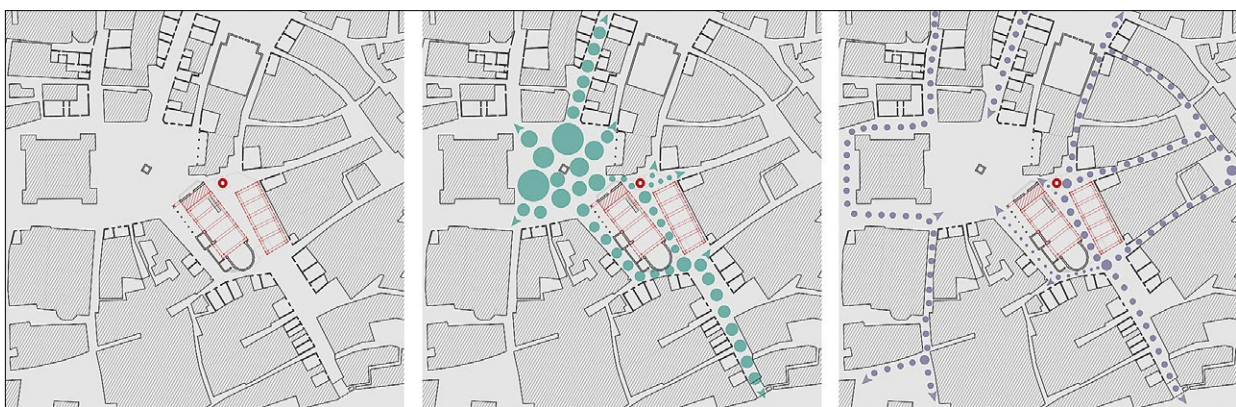
Fig. 7. The area of St. Benedict Square in Norcia, Italy, after the 2016 AVN seismic sequence: modular and reusable system scenario; from the left: a) urban tissue, b) walkability, c) accessibility for vehicles; by A. Rogulska

The variant presented in Figure 7, introduces instead an option that would require using modular technology. Prefabricated, reusable elements would ensure the safety and integrity of the compromised structure. The original function could be restored, if only to a limited extent, or new functions introduced.
