THE VERIFICATION OF THE TECHNICAL CONDITIONS OF A COMBAT-TRAINER JET'S AIRFRAME

Air Force Institute of Technology, ul. Księcia Bolesława 6, 01-494 Warsaw, Poland

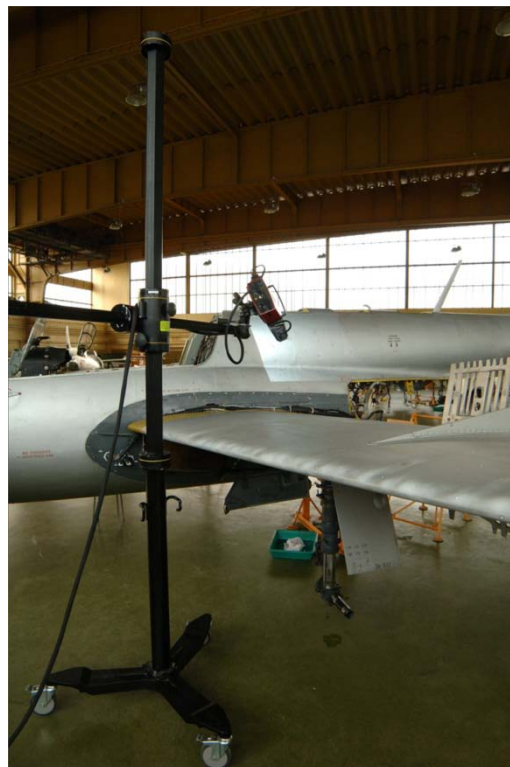
Figure 5. ATOS III is an industrial optical 3D scanner

The ATOS III optical scanning system, produced by GOM mbH, was used for the measurements. In the measurements, a series of special line patterns was projected onto the measured surface and the line shapes were analyzed by the system to produce a digital 3D representation of the geometry.

The measurements involved taking snaps of the measured surface until the complete structure was scanned. The resulting multiple scanned patches were sewn together automatically by the ATOS software with the use of markers randomly placed on the measured surface. Markers were placed randomly because the system relied on the pattern recognition to orient the scans in the reference system so that the marker pattern should be different for each scanned patch.
