CONDITIONS OF PROPER INTERACTION OF LOW-PRESSURE INJECTION PILES (LIP) WITH STRUCTURE AND SOIL, CARRYING CAPACITY OF PILE ANCHORAGE IN FOUNDATION

HENRYK PACHLA

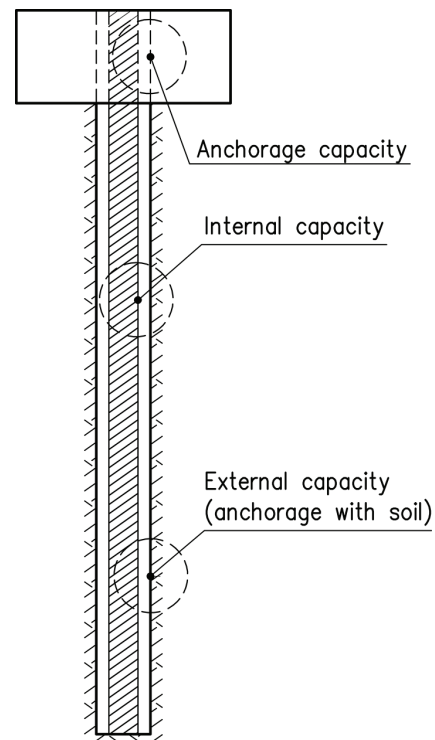
Fig. 2. Foundation-pile-soil connection surface

The ability to transfer loads to soil by foundation-pile-soil structure is determined by the interaction between these three elements (Fig. 2). For low-injection piles each of these elements is made of different material. The amount of load which can be applied is determined by the interaction of these elements. First, it is the interaction between foundation and pile, often called pile anchorage. In this case the bonding between the material of which the foundation is made and the grout which forms the pile.

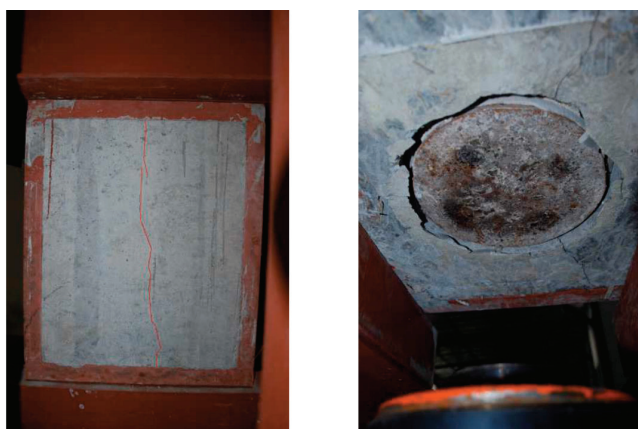
Photo 1. Specimen cracking and pulling the pile out of specimen

The form of damage was the same in all seventy specimens. In Photo 1, cracking of a specimen and pile dislocation are shown after the load reached the value which caused pulling the pile out of specimen. Photo 2 presents the form of damage after the reinforcement is split. The adhesion on the contact surface is totally lost. The separated pile rests loose in the specimen hole. In none of the specimens was the pile failure observed. The growth of positive transverse strains in the pile pushed into the specimen causes a positive strain state in the concrete part of the specimen. After the positive strain in concrete reaches the limit value, failure of test-piece modelled foundation is observed.

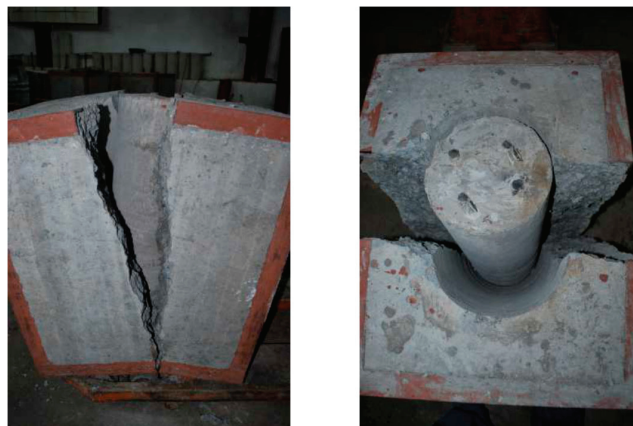
Photo 2. Form of specimens failure

What decided of the bearing capacity of pile anchorage in the foundation was the foundation bursting resistance. It should be noted that the original solution (anchorage of piles directly in a column) does not change the form of failure, i.e., foundation bursting. Not only the forces acting on piles but also the deformations of piles in holes drilled through the foundation remain unchanged. The presented study has been done for contract purposes, therefore the test program was limited to the testing of the bearing capacity of this kind of anchorage.

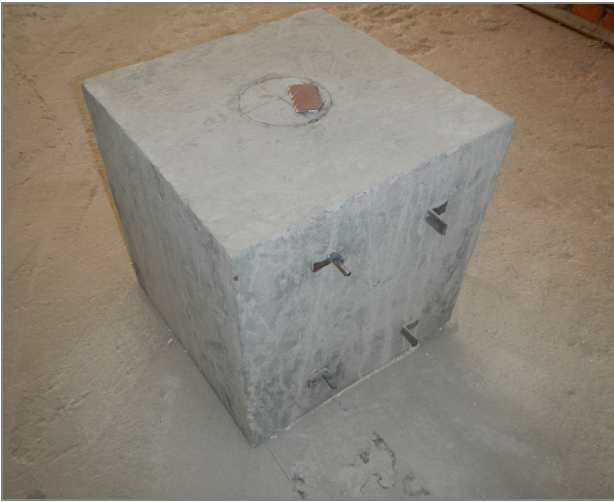
Photo 3. Specimen modelling foundation made of concrete

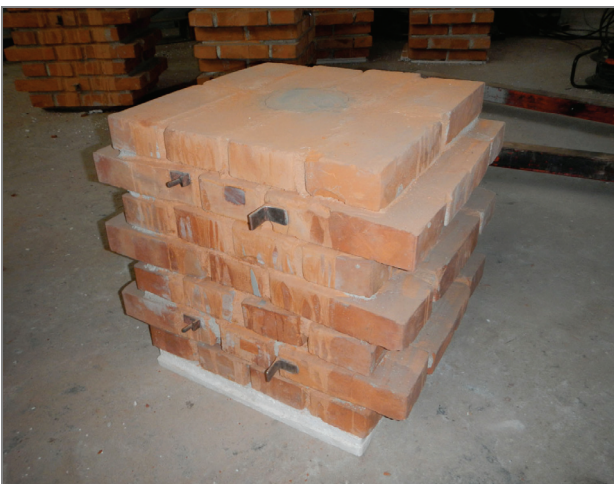
Photo 4. Specimen modelling foundation made from brick

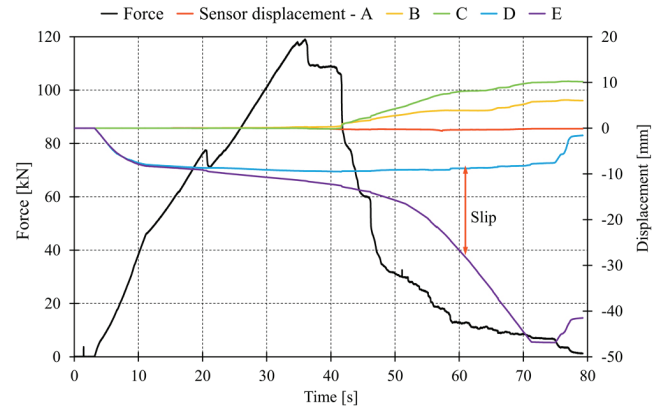
Fig. 10. Changes of displacements in a selected brick specimen

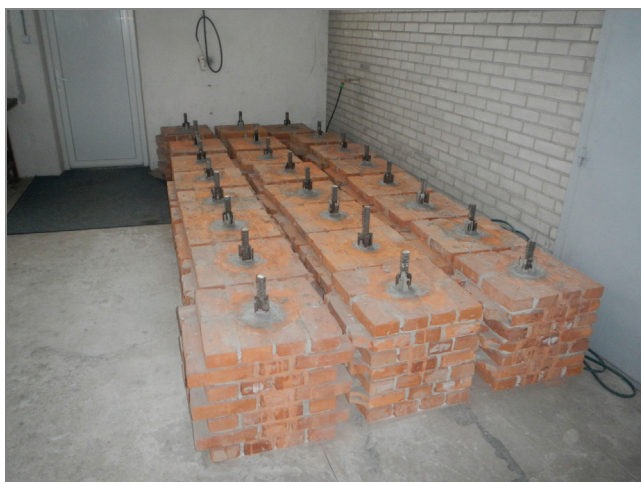
Photo 10. Test specimens modelling brick foundations

In both masonry and concrete specimens after the curing period holes were drilled through foundation using a 150 mm diameter core. In the holes piles identical as in the case of pushing the pile into the foundations were installed but tips of SAS system thread bars were welded between the rebars to execute a force pulling out the pile (Photos 10, 11).

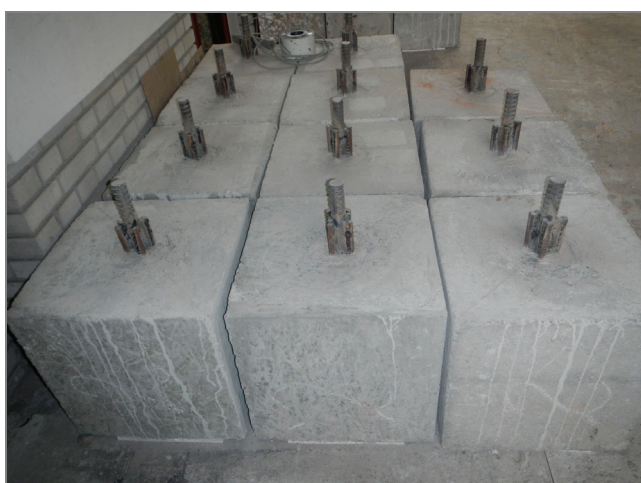
Photo 11. Test specimens modelling concrete foundations

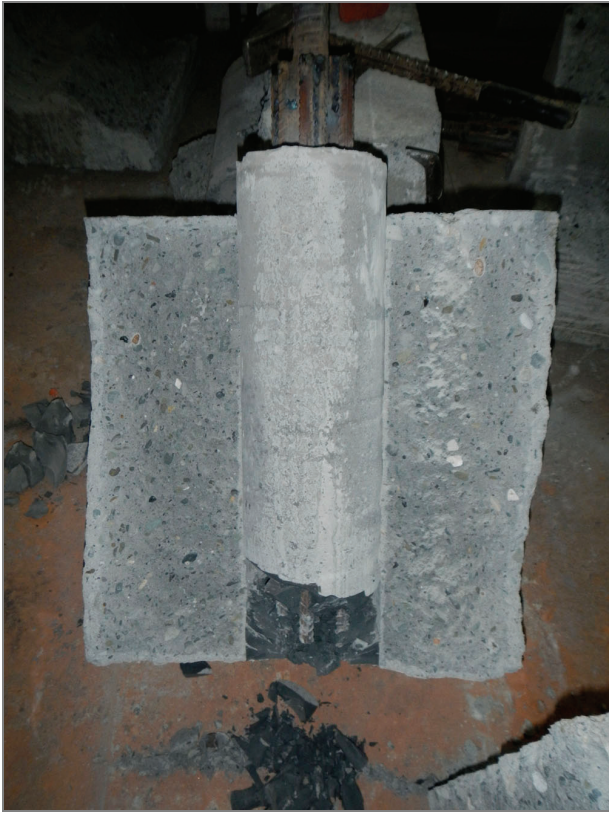
Photo 15. Damaged concrete foundation specimen

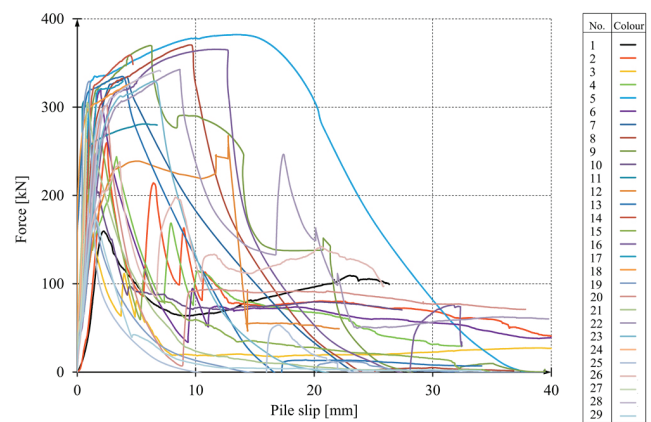
Fig. 22b. Relationships between forces applied to pile and slip on a contact surface in concrete specimens
