VIBROACOUSTIC ANALYSIS IN THE ASSESSMENT OF THE TECHNICAL CONDITION OF THE AIRCRAFT AIRFRAME COMPOSITE ELEMENTS

Daniel MOKRZAN ¹, Julia MILEWICZ ¹, Grzegorz M. SZYMAŃSKI ¹, Sławomir SZRAMA ²

¹ Poznan University of Technology, Institute of Transport

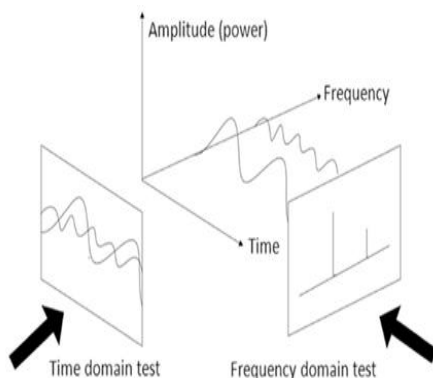
Fig. 1. Difference between the domain of time and the domain of frequency [13]

The visualization of the differences between the signal presented in the domain of time and the domain of frequency has been shown in Fig. 1.

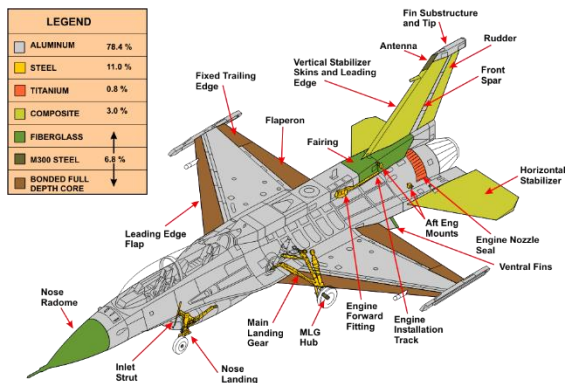
Fig. 2. Schematics of the F-16 aircraft and materials used for its production [17]

The design schematics including the materials used for the construction have been shown in Fig. 2.

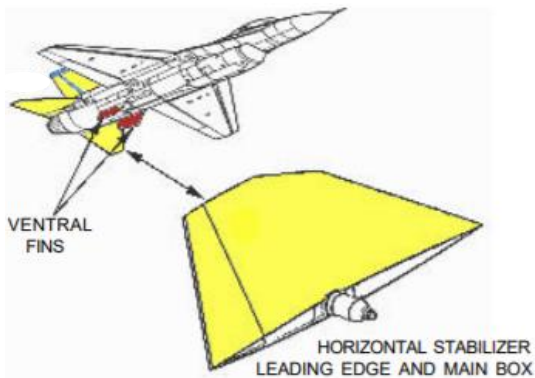
Fig. 3. Schematics of the horizontal stabilizer [17]

The object under analysis is a component of an element referred to as the 'horizontal stabilizer', and more specifically its leading edge. Its more detailed schematics have been shown in Fig. 3.

The component shown in Fig. 3 is made from composite materials. The aluminum core is covered with a sealing material and a graphite paneling. The binder is the epoxy. The acoustic signal of a structurally undamaged element was compared with the damaged one at the spot where the structure continuity was lost due to the interaction with a foreign object (Foreign Object Damage, FOD). The actual view of the investigated object has been shown in Fig. 4.

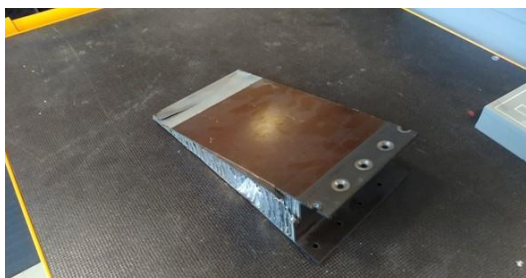
Fig. 4. Horizontal stabilizer– the tested example

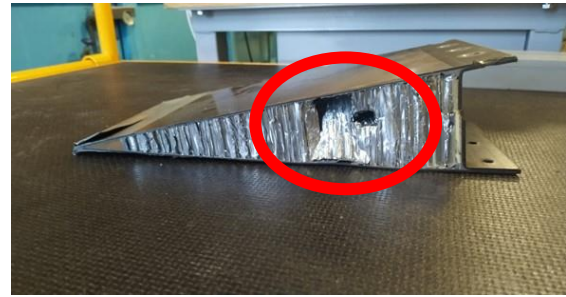
Fig. 5. Horizontal stabilizer damage

The distortion of the continuity of the element structure has been shown in Fig. 5.

The damage in the structure of the stabilizer, as shown in Fig. 5, is visible with the naked eye upon element disassembly. It is sufficiently extensive for the component to be assigned for renewal.

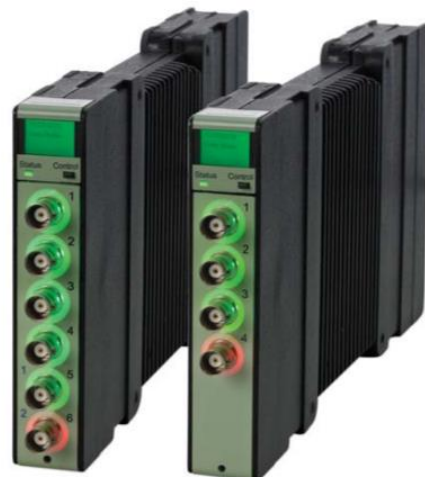
Fig. 6. Data acquisition module (Brüel & Kjær 3050) – image provided by the manufacturer

For the acquisition and processing of the recorded data, the authors used the fast-varying signal processing unit (3050) by Brüel&Kjær shown in Fig. 6. The equipment allows measuring the sound

and vibration using 6 input channels simultaneously and supplies power to the microphones of the voltage of 200V. The acquisition unit can record signals with the sampling frequency of 131072 samples per second.

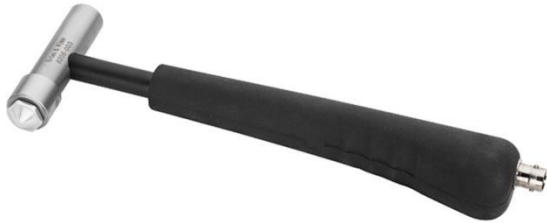
Fig. 7. Impact hammer – Brüel&Kjær typ 8206 – image provided by the manufacturer

In the impulse test, an impact hammer (8206) by Brüel&Kjær was used (Fig. 7) of the sensitivity of 22.7 mV/N fitted with an accelerometer allowing the measurements of the response of the tested structure to the impacts.

The hammer was fitted with an accelerometer allowing the measurements of the response of the tested structure to the impact with the possibility of application in the FRF calculations.

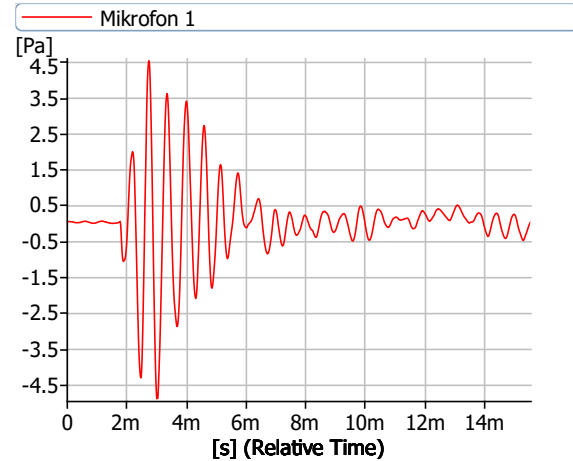
Fig. 9. Time tracing of the signal of the undamaged element from microphone 1

The tracings of the recorded signal in time for the measurements of the correctly performed impacts on the undamaged element have been shown in Fig. 9. and Fig. 10.

Based on Figs. 9-12 one can observe that the positioning of the microphones was impactful on the way they recorded the sound. Microphone 1 received a more unified signal, of high amplitude and short period, while the signal received by microphone 2 had the nature of an extended echo of lower amplitude and longer period.

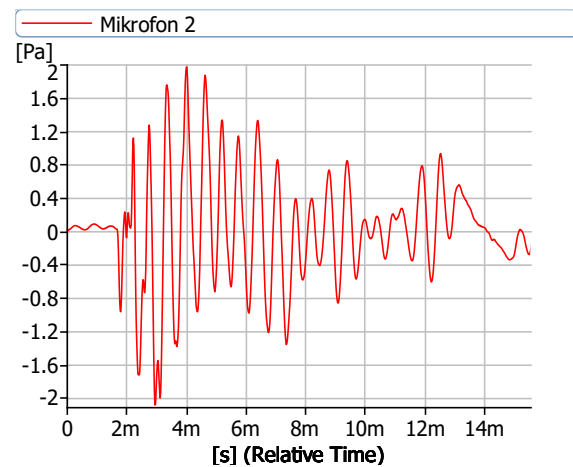
Fig. 10. Time tracing of the signal of the undamaged element from microphone 2

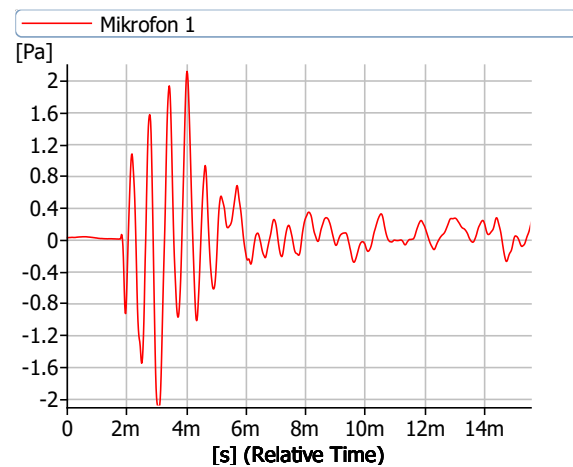
Fig. 11. Time tracing of the signal of the damaged element for microphone 1

The tracings of the recorded signal in time for the performed measurements for correctly performed impacts have been shown in Fig. 11. and Fig. 12.

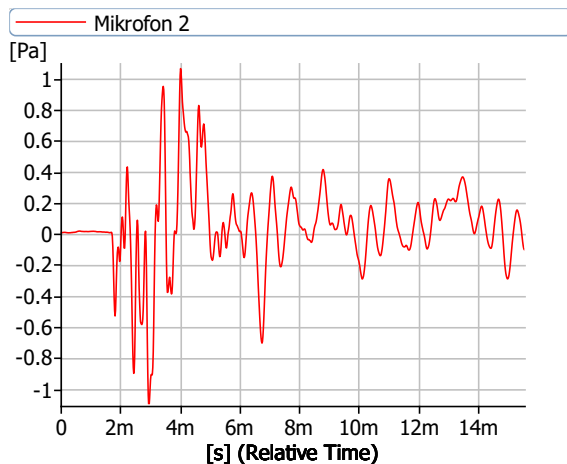
Fig. 12. Time tracing of the signal of the damaged element for microphone 2

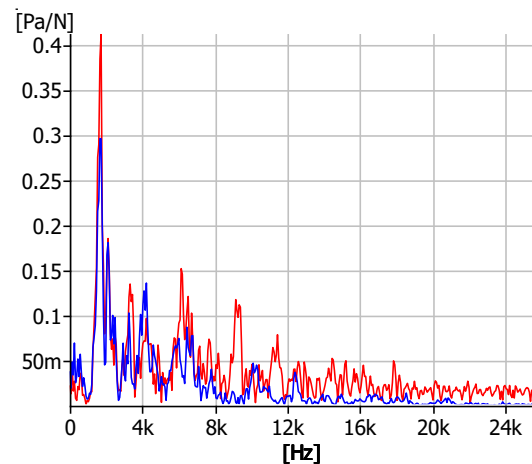
Fig. 13. Comparison of the FRF tracing for the damaged (blue) and undamaged (red) elements for microphone 1

The transformation was performed for the signal recorded by microphone 1 for the impacts on the damaged and undamaged elements. Thus, obtained amplitude spectrum for both measurements was overlain on a single graph and compared in Fig. 13.

Based on Fig. 13, we can distinguish two tracings in the domain of frequency. The red tracing visualizes the signature of the sound for the undamaged element, and the blue one for the damaged element.

The difference between the tracings we can see by reading the amplitude and the shift of the frequency. The amplitude difference at low frequency ranges results from the differences in the impact force. When analyzing the tracings in the higher frequency ranges one can observe a damping in the damaged element.

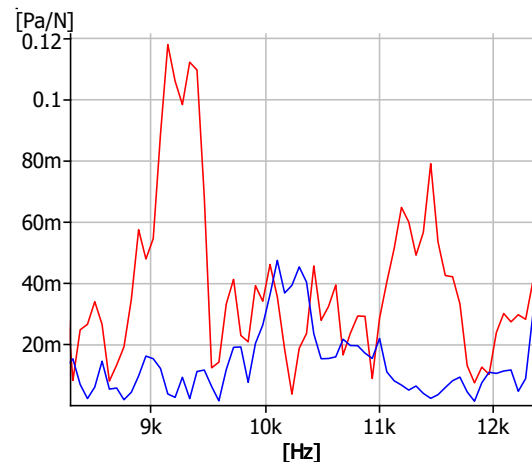
Fig. 14. Comparison of the FRF tracing for the damaged (blue) and undamaged (red) elements (enlarged)

The diagnostically significant differences can be seen upon enlarging to the range of 9000-10000 Hz in Fig. 14.

In Fig. 14 one can see an already significant damping in the higher frequency range, which is characteristic of structural damage. In order to confirm the influence of the defect on the signal damping, six impacts on the undamaged element and six impacts on the damaged element were analyzed and compared on the decibel graphs.

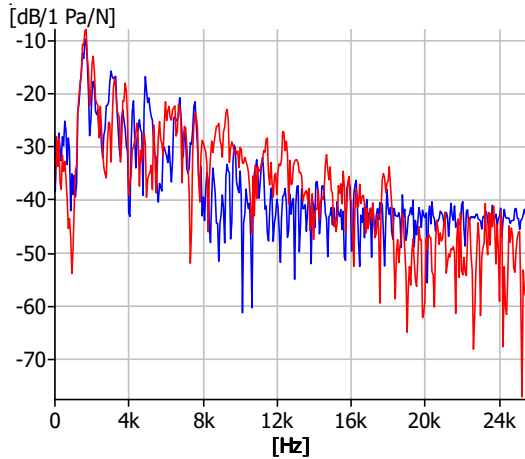
Fig. 15. Comparison of the FRF tracing for the damaged (blue) and undamaged (red) elements for the first impact of the hammer

When analyzing the FRF graphs, we can observe in the logarithmic scale that in the lower frequency range up to 8000 Hz the tracings of the acoustic pressure levels are convergent and there are no diagnostically significant differences. The differences can be observed only for the frequencies above 8 kHz and the greatest differences are visible for the frequencies oscillating around 9 kHz and 15 kHz where the divergence between the points representing the acoustic pressure level of the undamaged and damaged elements in a given range reaches 30 dB (6 dB is sufficient to identify structural damage).

The comparison of the frequency tracings for all 6 impacts indicated that in the case of the damaged element acoustic damping occurs at higher frequencies (reaching 30 dB) compared to the element without a defect, which confirms the assumption that structural damages have a clear damping effect on the spectrum.

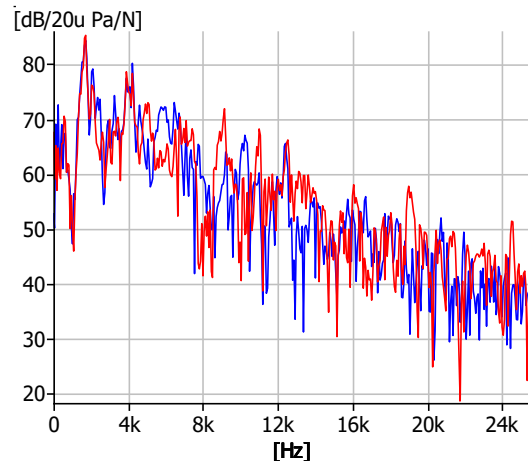
Fig. 18. Comparison of the FRF tracing for the damaged (blue) and undamaged (red) elements for the fourth impact of the hammer

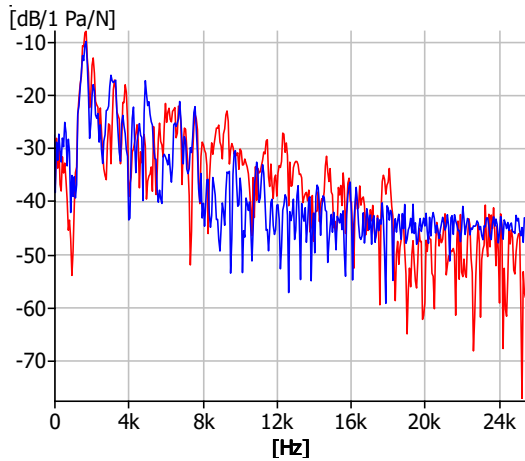
Fig. 16. Comparison of the FRF tracing for the damaged (blue) and undamaged (red) elements for the second impact of the hammer

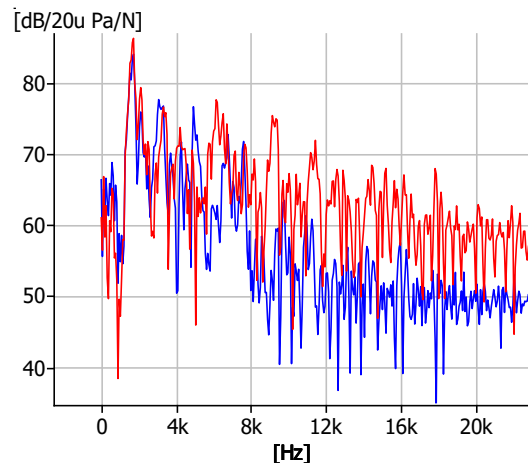
Fig. 19. Comparison of the FRF tracing for the damaged (blue) and undamaged (red) elements for the fifth impact of the hammer

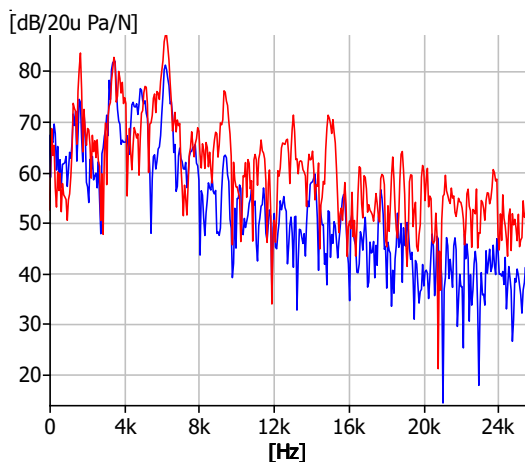
Fig. 17. Comparison of the FRF tracing for the damaged (blue) and undamaged (red) elements for the third impact of the hammer

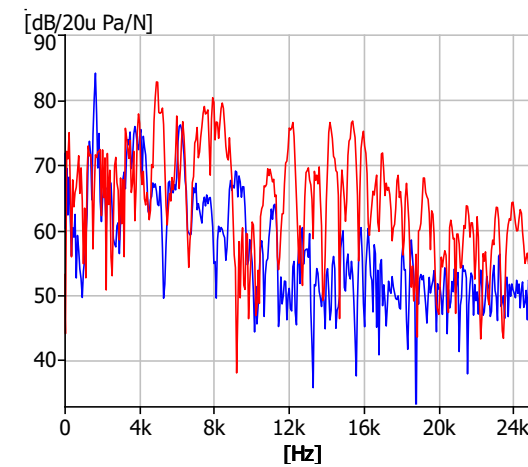
Fig. 20. Comparison of the FRF tracing for the damaged (blue) and undamaged (red) elements for the sixth impact of the hammer
