Piotr SZCZYGLAK\*, Jerzy NAPIÓRKOWSKI\*\*, Artur WODZYŃSKI\*\*\*

## METHOD FOR ASSESSING WINDSCREEN ABRASIVE WEAR

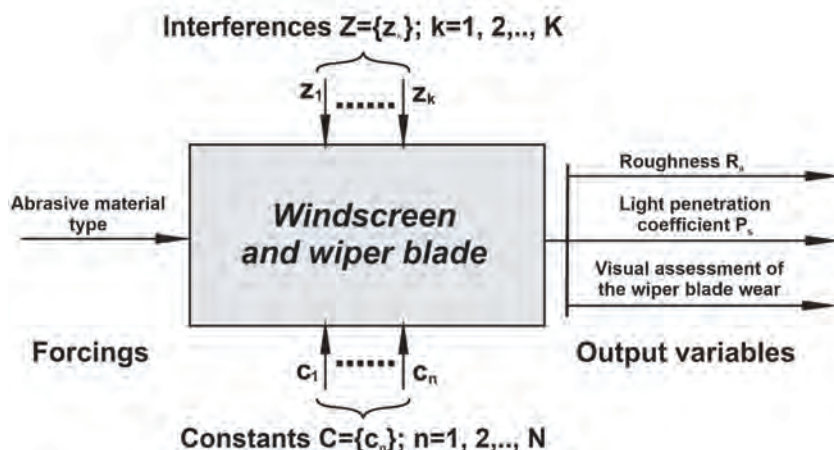
**Fig. 1. Windscreen and wiper blade as the subject of the study**

The windshield interacted with an articulated wiper with a blade length of 0.28 m. The wiper blade was coated with a thin layer of graphite to increase its durability (reduction of friction between the windshield and the blade). During the study, an active experiment option was adopted. The windshield and the wiper blade as the subject of the study are presented in Figure 1.

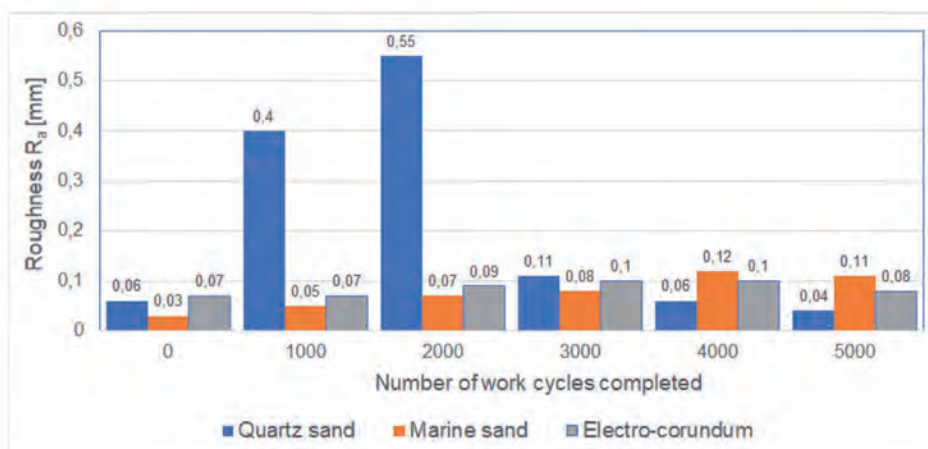
**Fig. 5. Graphical interpretation of the roughness  $R_a$  values measured**

The roughness values measured during the testing are presented in **Table 3**, and their graphical interpretation is in **Figure 5**. During the testing, changes in roughness were observed for subsequent measurements. For quartz sand, the initial roughness was 33% higher than the value measured for the

maximum number of completed cycles. As for marine sand and electro-corundum, the situation was the opposite. For marine sand, roughness increased by 266%, and for electro-corundum, it increased by 14%. In all cases considered, the roughness initially increased and then decreased to a value below  $12\mu\text{m}$  after reaching the maximum. Only for quartz sand, an almost eight-fold increase in roughness was noted, with a mean deviation for

the results obtained of 0.18  $\mu\text{m}$ . For marine sand and electro-corundum, the rate of changes was much lower, and the mean deviations obtained were 0.026  $\mu\text{m}$  and 0.011  $\mu\text{m}$ , respectively.

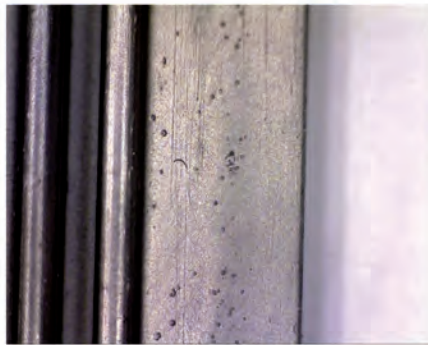
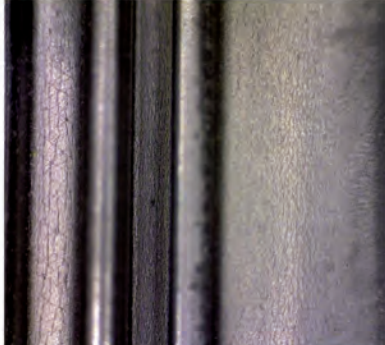
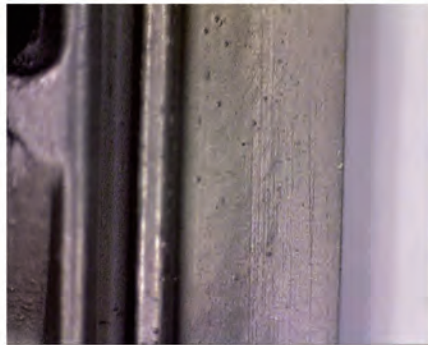
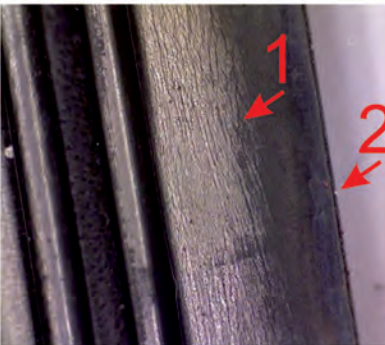
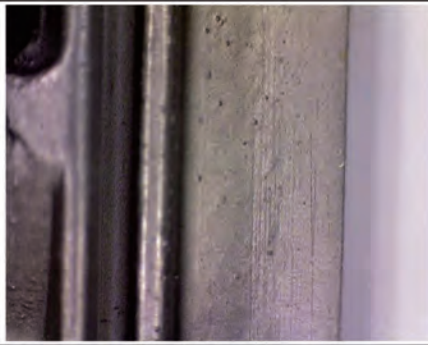
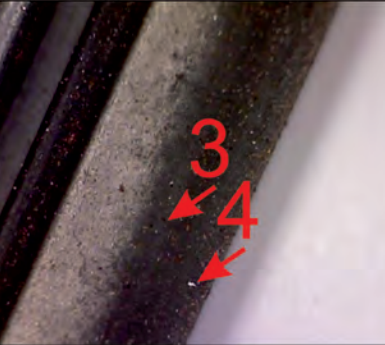
**Table 5.** Specification of views of wiper blades magnified 200 times

1 – local scratches 2 – grains stuck into the edges of the wiper blade 3 – local cavities 4 – grains stuck in the wiper blade

Photographs of wiper blades taken during the tests at 200 times magnification are presented in **Table 5**. A visual inspection of the wiper blades showed that only for quartz sand had the graphite coating of the blade not been significantly damaged

(minor wear marks on the edge). For marine sand and electro-corundum, significant damage occurred. The graphite coating wore down from the blade edge towards the joint, and the coating loss amounted to approx. 50% of its surface. For

- quartz sand – smoothing the surface, no grains that have stuck to the surface of the feather.
- Marine sand – smoothing the surface and its local drawing (**Tab. 5/1**), a few visible grains stuck into the surface of the feather, mainly located on its edge (**Tab. 5/2**).
- Electro-corundum – smoothing the surface of the wiper and local losses after tearing out the nested grains (**Tab. 5/3**), numerous visible grains stuck into the entire surface of the blade (**Tab. 5/4**).

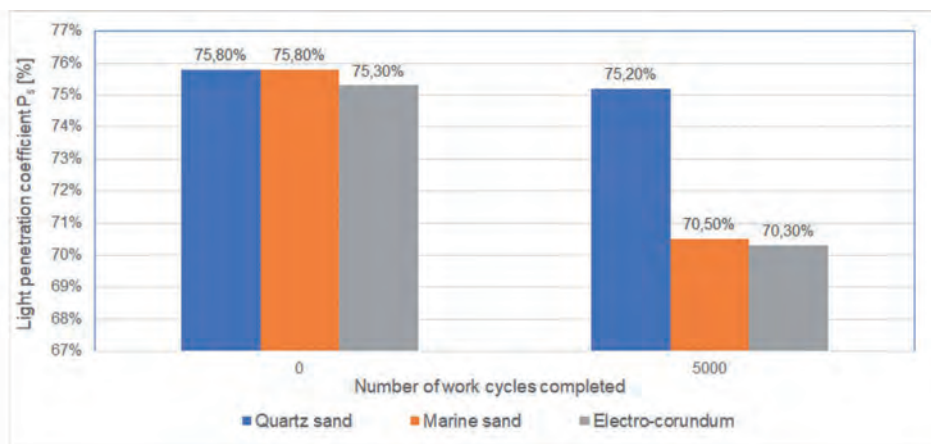
**Fig. 6. Graphical interpretation of the light penetration coefficient  $P_s$  values**

The values of the coefficient of light penetration through the windscreen measured during the tests are presented in **Table 4** with their graphical interpretation in **Figure 6**. Observation of the light penetration coefficient showed its decrease in all cases. The lowest decrease value was noted for quartz sand. In this case, the lowest roughness value was also noted after completing the maximum number of work cycles. As for marine

sand and electro-corundum, the light penetration coefficient value decreases were at the same level (approx. 5%).

It should be noted that the light penetration coefficient for the windscreen should be at least 70%. Therefore, in all cases considered, the windscreen met this requirement, and after the completion of the maximum number of cycles, the reserve of this coefficient value was at a safe level only for quartz sand. In two other cases, these values are dangerously approaching the limit beyond which the windscreen should be either replaced or repaired.
